CIVIL AERONAUTICS BOARD

ACCIDENT INVESTIGATION REPORT

WESTERN AIR LINES, INC.,—MT. LAGUNA, CALIFORNIA, DECEMBER 24, 1946

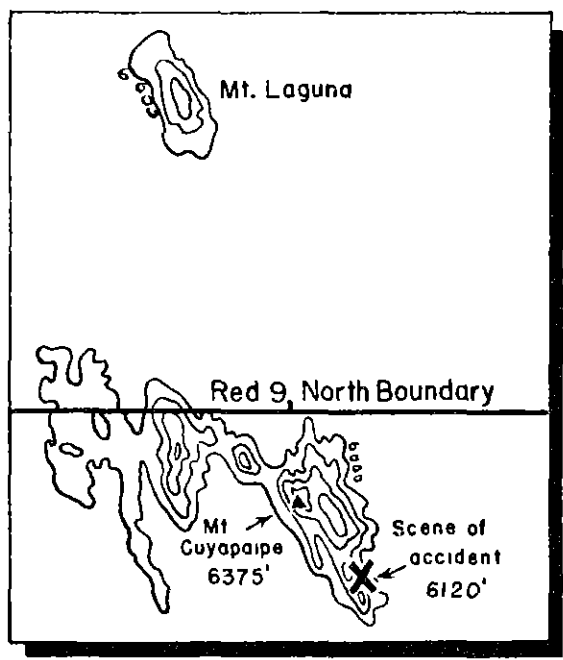
Probable Flight Path of Flight 44

10. The flight's position report "over Mt. Laguna" was in error as the aircraft was east of the reported position.

The Board determines that the probable cause of the accident was the conduct of the flight at an altitude which would not clear obstructions, due to an error by the pilot in determining his position with respect to Laguna Mountain.
