CIVIL AERONAUTICS BOARD

ACCIDENT INVESTIGATION REPORT

AMERICAN AIRLINES—MICHIGAN CITY, INDIANA, DECEMBER 28, 1946

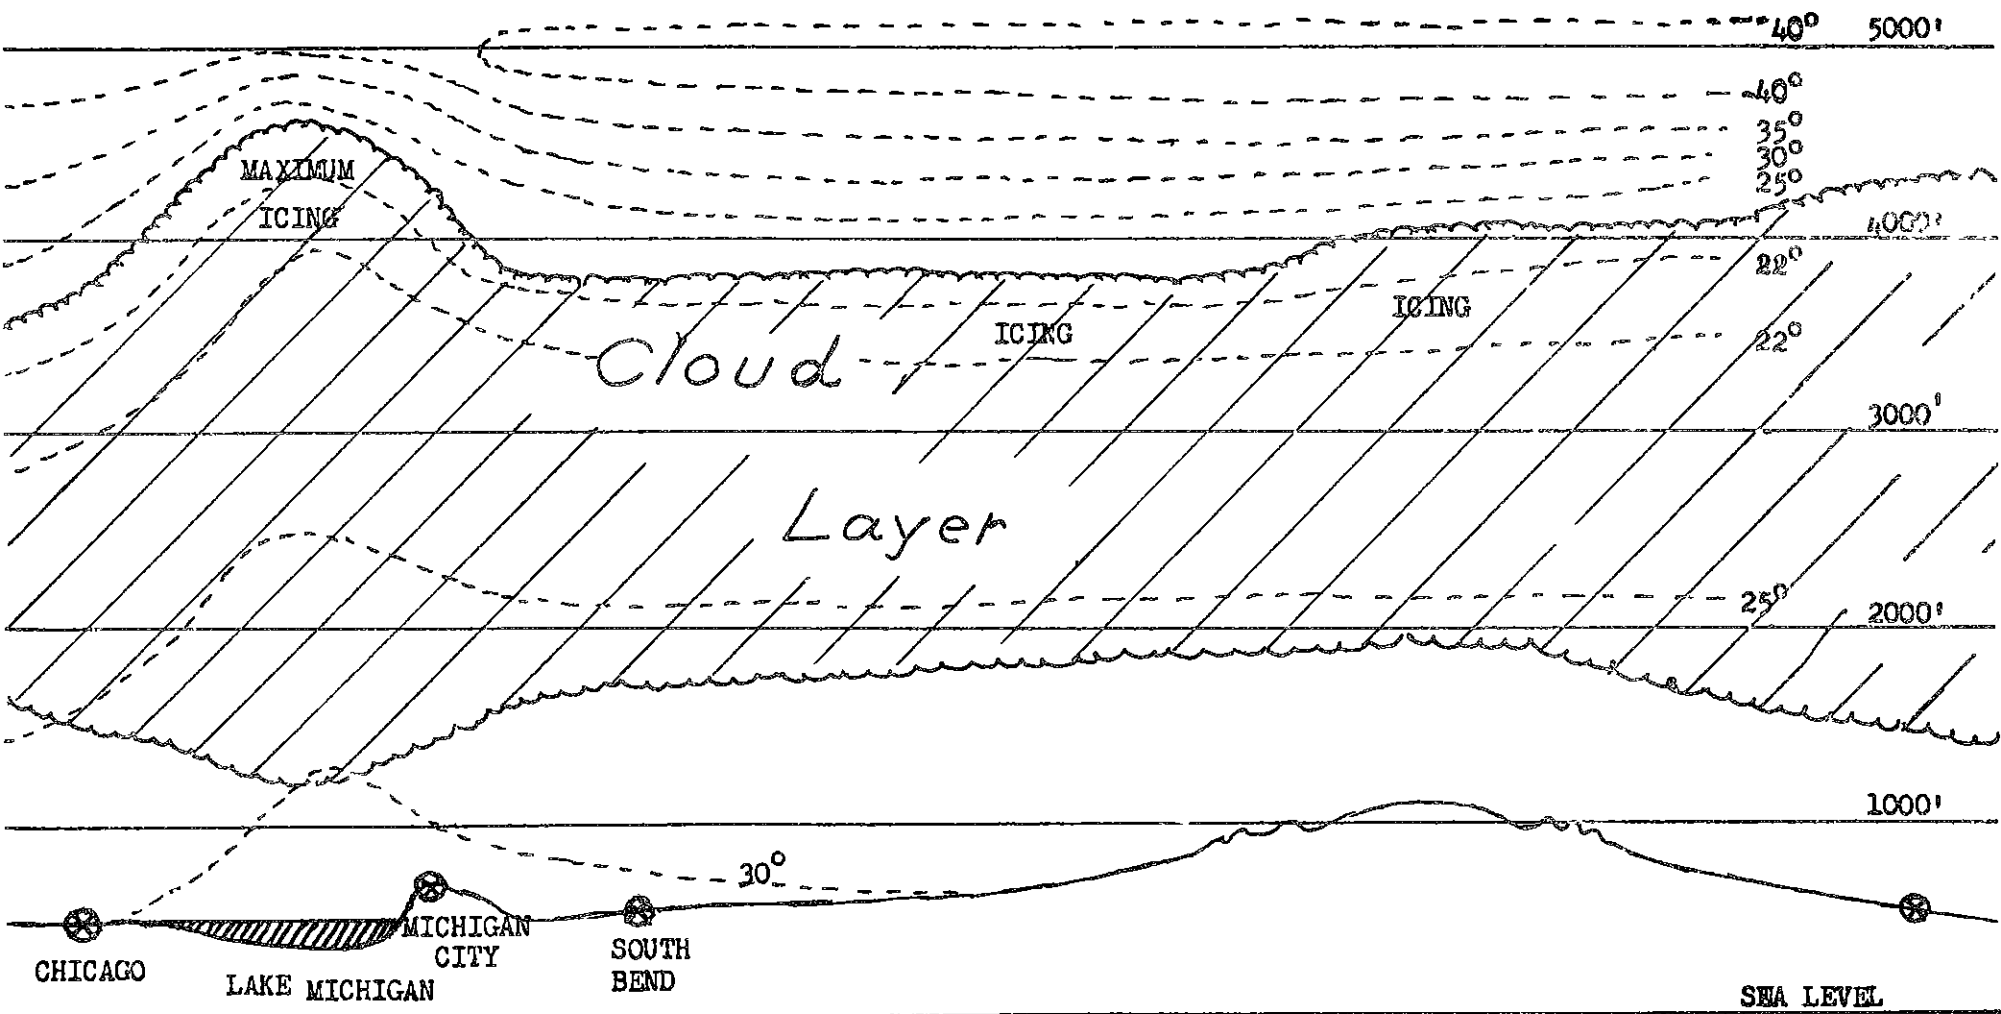
PROFILE OF PROBABLE WEATHER AT TIME OF AMERICAN AIRLINES ACCIDENT AT
 MICHIGAN CITY, INDIANA, DECEMBER 28, 1946

Weather, both forecast and actual, at the time and place of the accident included an overcast with its top at about 4,000 feet and its base at about 1,000 feet. Within the overcast there existed conditions favorable for light to moderate icing. A profile of these weather conditions is attached.
