## CIVIL AERONAUTICS BOARD

## ACCIDENT INVESTIGATION REPORT

## TRANSCONTINENTAL &amp; WESTERN AIR—SHANNON, EIRE—DECEMBER 28, 1946

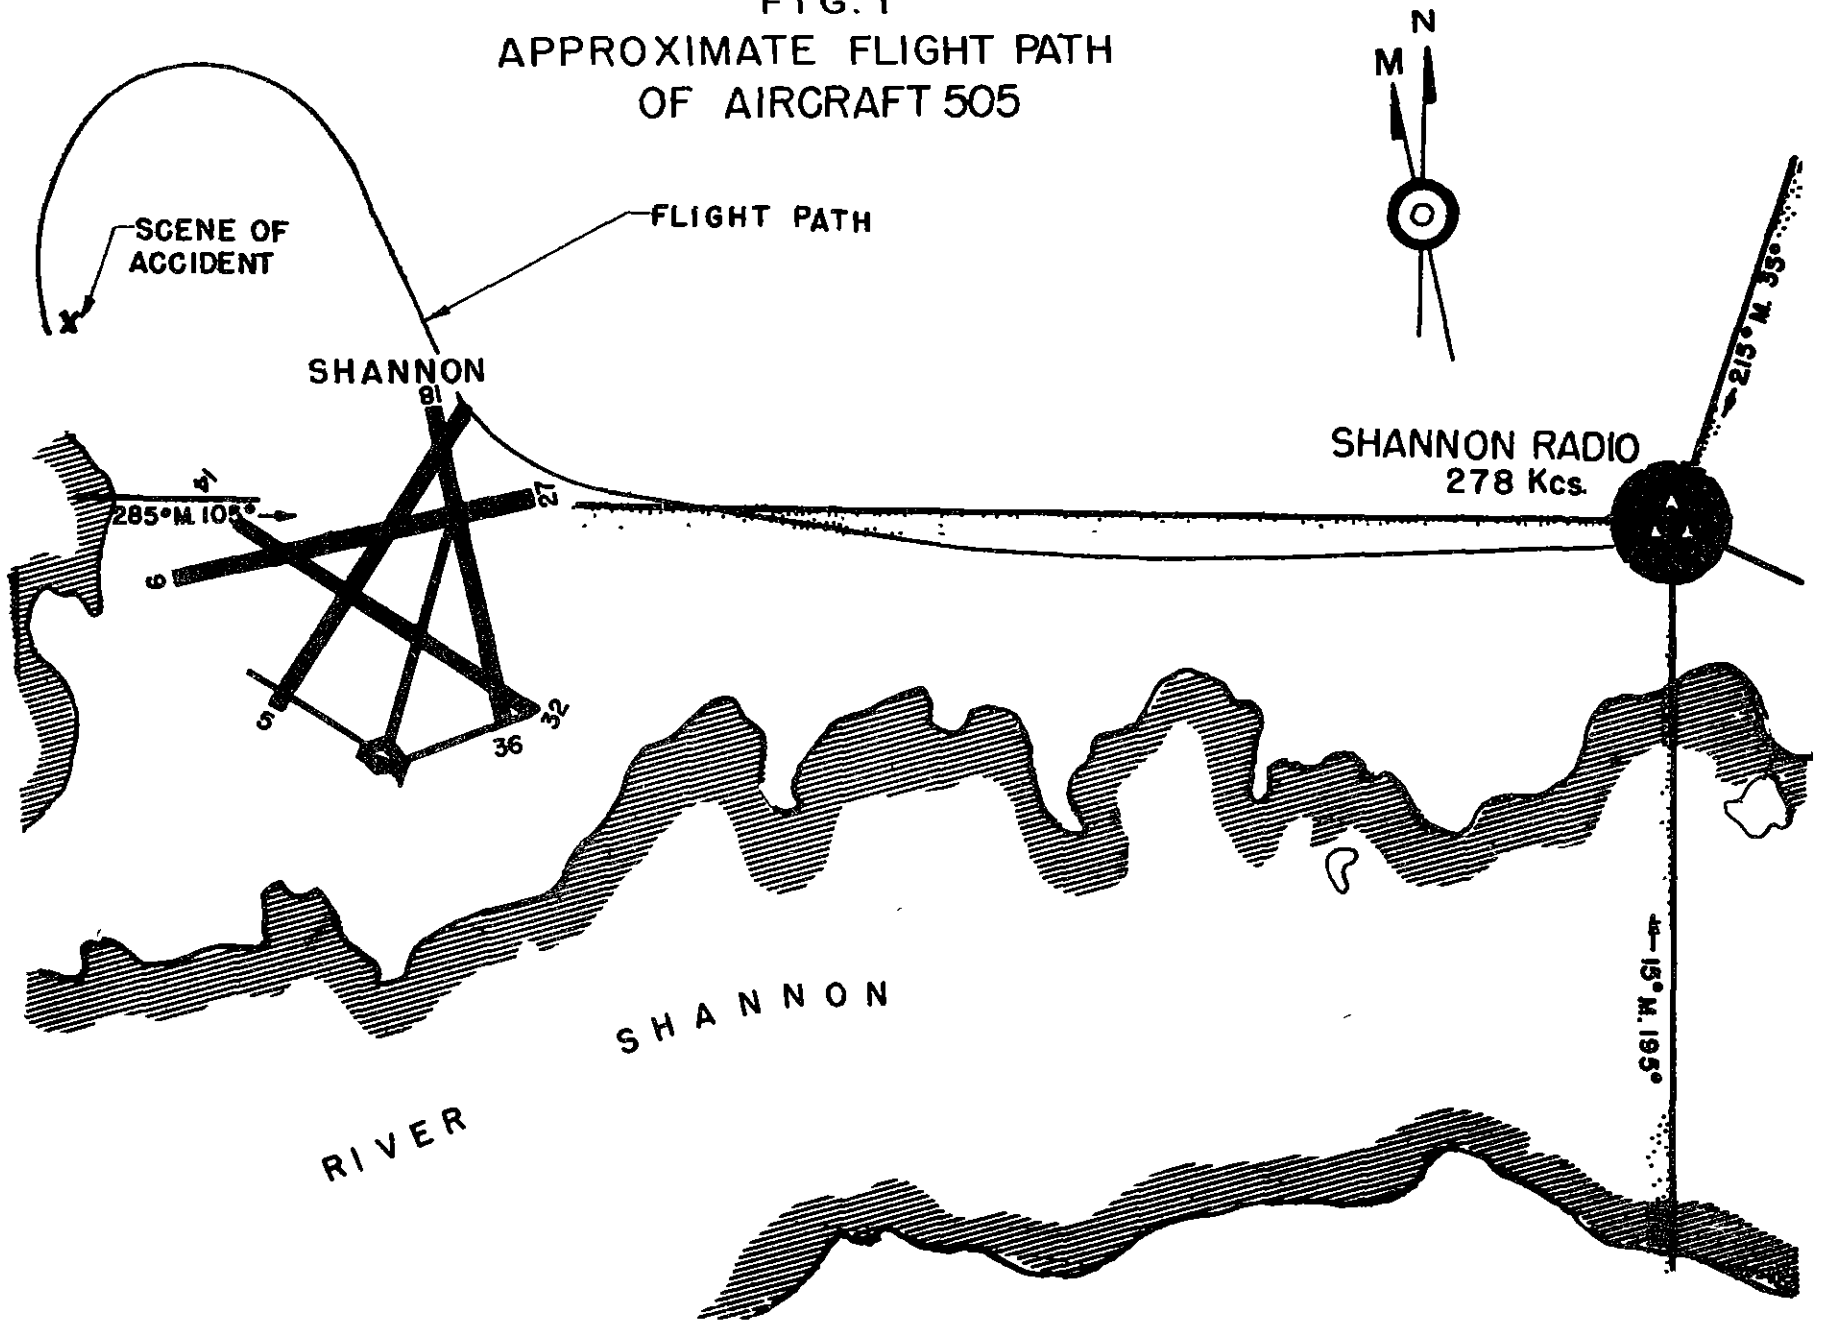
FIG. 1  
APPROXIMATE FLIGHT PATH  
OF AIRCRAFT 505

In reconstructing the flight path, therefore, it is evident that the aircraft passed over the northern boundary of the field at an altitude of approximately 300 feet, although the pilot believed the flight to be at 600 feet. After passing beyond the airport the pilot no longer had any ground reference by which to determine either attitude or altitude, Shannon Airport being the only well lighted area in that section of Eire. He therefore continued his procedure solely by reference to instruments. After passing over the airport he descended to an indicated altitude of 500 feet or an actual altitude of approximately 200 feet above the ground. In the subsequent turn to the left a loss of altitude of at least 150 feet was experienced, during which the wing tip struck the ground. The accident occurred at a location with respect to the approach end of Runway 14 at which, because of its proximity to the airport, it would have been normal for the pilot to begin a descent, had the aircraft been at an altitude in excess of 500 feet. Such a maneuver cannot be regarded as completely satisfactory, however, in view of the limited visibility and the existing wind direction and because of the absence of straight-in approach facilities to the particular runway used, alternate approach procedures were not practicable.

In this portion of the flight it would have been necessary for the pilot to look over his left shoulder and through fogged windows to keep the airport in sight. As the turn continued, a progressively greater percentage of his attention was required outside the cockpit and it is probable that in the final stages of the turn the nose of the aircraft was depressed, either consciously or inadvertently, permitting the left wing to contact the ground. During these maneuvers the aircraft descended to an altitude sufficiently low that at least one small hill lay directly between the flight and the airport. This fact may have accounted for the testimony of ground observers who lost sight of the aircraft at this time and may also have accounted for the statement of the pilot that the airport lights suddenly disappeared from his view immediately prior to the crash.

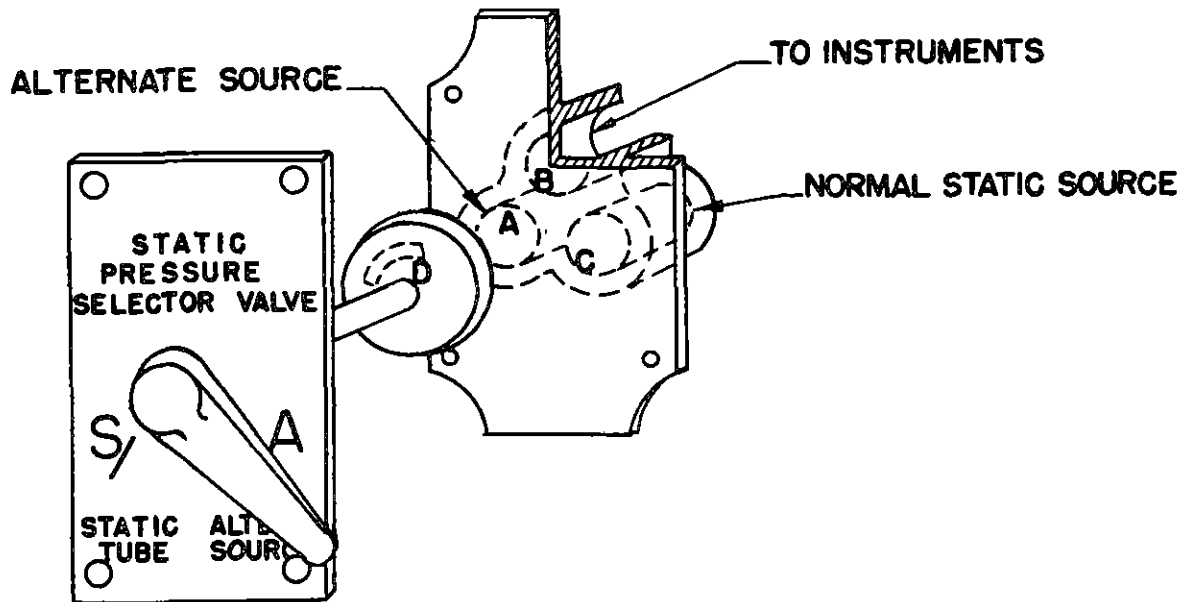
FIG. 2

The settings of all altimeters were found to be within .01 of an inch of the last recorded altimeter setting at Shannon Airport. The discrepancies among the three altimeters recovered from the wreckage, the indicated altitudes of which could be read from the instruments, were such that no conclusions could be drawn as to their altitude indications at the time of impact. In tracing the pitot-static lines from the primary and alternate sources to their respective connections in the static valve behind the pilot and co-pilot instrument panels, it was discovered that the alternate and primary lines were reversed from their normal positions. It was apparent that an error in installation had been made in some prior maintenance activity. Such an installation would result in actuating both pilot and co-pilot altimeters from the alternate static source when the cockpit selector switches were placed in the primary source position. Company maintenance records indicated that the pilot and co-pilot instrument panels had been removed from the aircraft December 10, 1946, and the investigation disclosed that during the reinstallation of these panels the static lines had been inadvertently reversed.

The installation of the instrument panels in Model 049 aircraft requires the mechanic to work from the cockpit when connecting the static pressure tubing to the valve. During this operation the panels may be pulled away from the supporting structure approximately seven inches. This distance is sufficient to permit the mechanic to complete the reconnection, but will not permit him to observe the back of the valve. Because the fittings on both lines and on the valve are the same size, no check other than visual reference to the tubing identification existed as a precaution against inadvertent reversal. The primary source position of the selector valve is on the left side of the valve when viewed from the cockpit, however, the primary static line must be connected to the right side of that portion of the valve behind the panel (see sketch). Because such marking is misleading, TWA has changed the size of the fittings on the valve and of the static pressure lines so that these lines cannot be reversed. A similar result has been achieved by Lockheed by the use of reversed threads on these two fittings in new Model 049 aircraft.

STATIC VALVE - ALTERNATE POSITION  
WITH HANDLE IN POSITION "A" CHANNEL "D"  
CONNECTS "A" (ALTERNATE STATIC SOURCE )  
TO "B" (INSTRUMENTS)..

IT WILL BE OBSERVED THAT THE CONNECTION FOR THE NORMAL STATIC SOURCE IS ON THE SAME SIDE AS THE "ALTERNATE" POSITION OF THE VALVE LEVER WHEN VIEWED FROM THE COCKPIT. THE LINES LEADING TO CONNECTIONS A AND B IN BOTH THE PILOT AND CO-PILOT SELECTOR VALVES WERE REVERSED IN AIRCRAFT 505 .
