CIVIL AERONAUTICS BOARD
ACCIDENT INVESTIGATION REPORT

PIPER J-3, NEAR FORT LAUDERDALE, FLORIDA, MAY 26, 1947

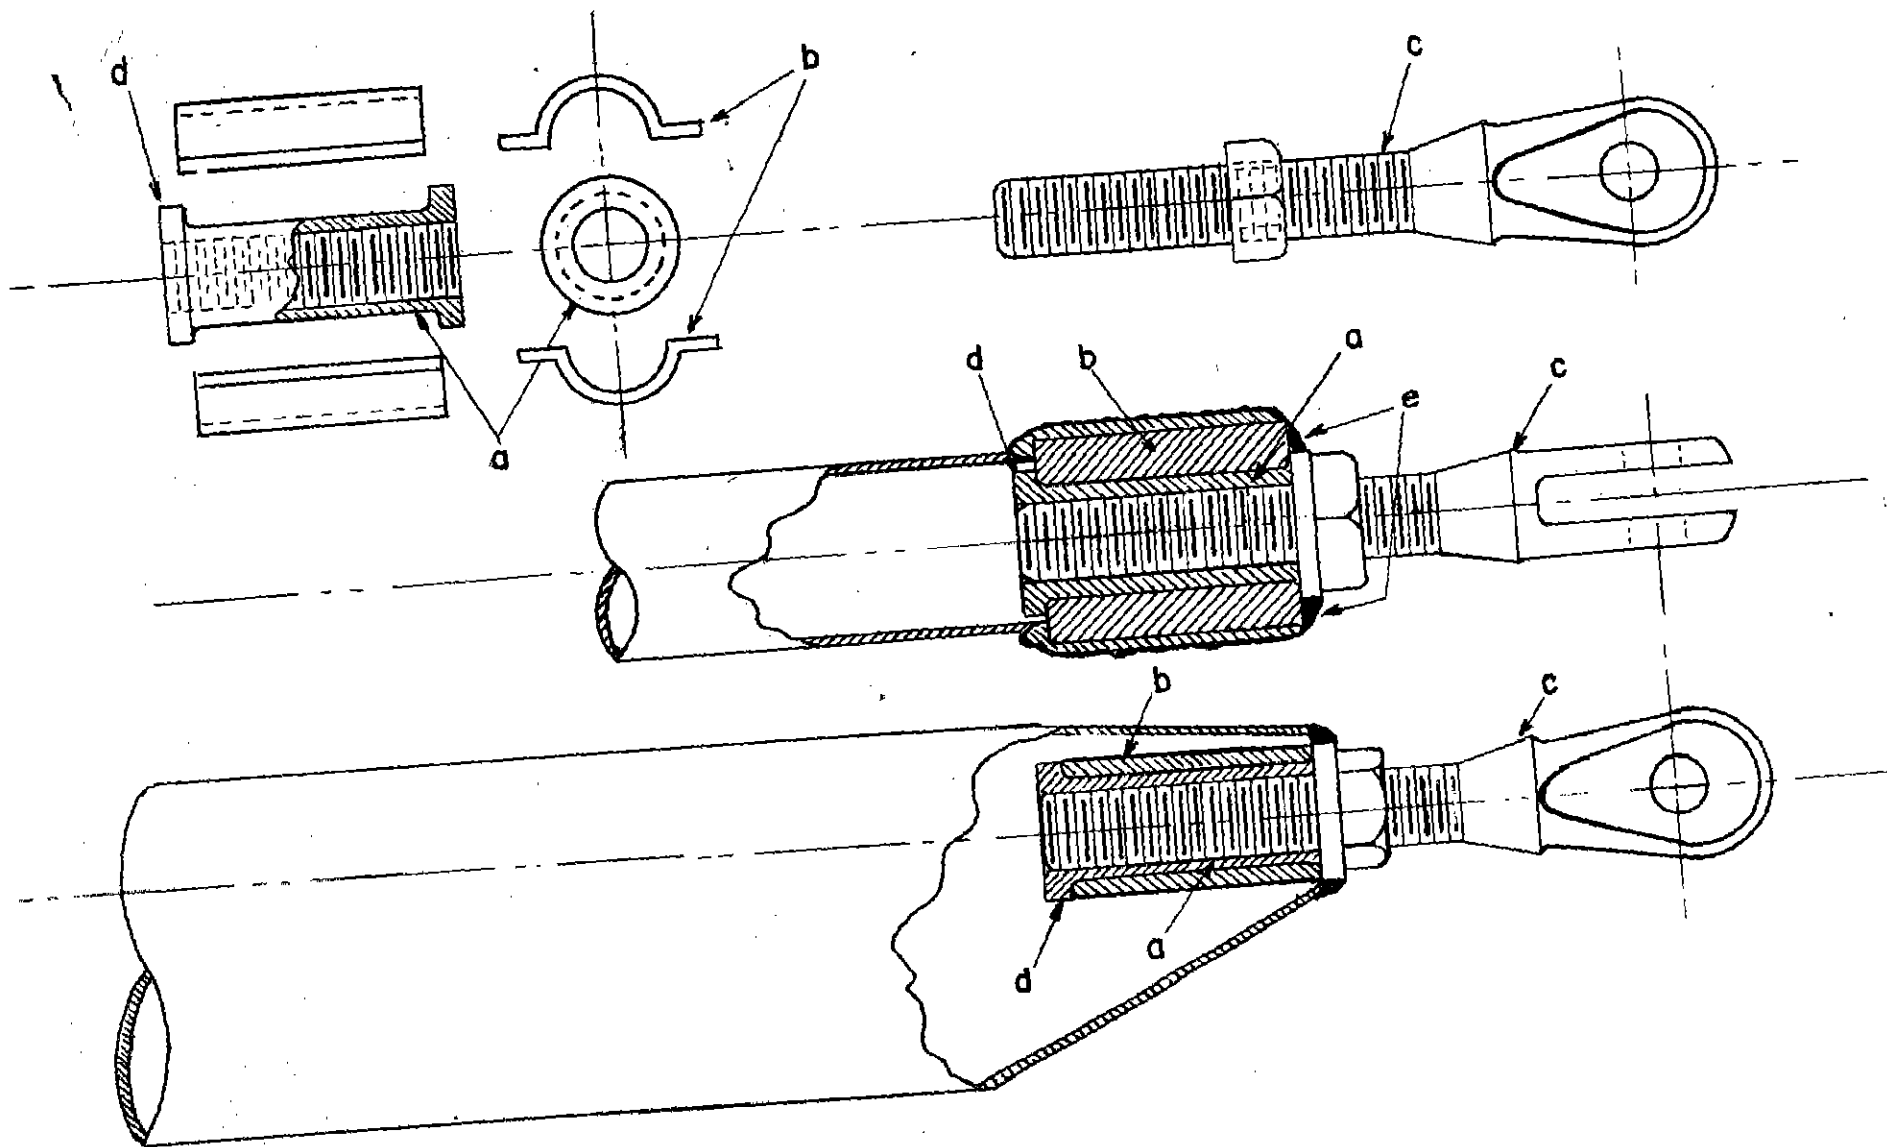
LOWER LIFT STRUT FITTING ASSEMBLY

The various parts of the structure in question, namely, the lower end of the left front lift strut and fitting, with the attaching adjustable eyebolt were shipped to Washington for study. For comparison, a lower lift strut fitting assembly cross-section was obtained from a similar aircraft so that the detail design could be observed. On close examination of the lift strut fitting removed from this aircraft it was noted that the threaded insert (a)* at the outer clevis end had almost no weld material (e) connecting it to the strut end or to the two half-sleeves (b) which are inserted in the end of the strut and welded directly to the strut. The threaded insert normally has a shoulder at the inner end (d) which rests against and is welded to the end of the split sleeve, as can be seen from the specimen of a similar aircraft. The split sleeve containing the threaded insert is placed in the

strut with the shoulder end of the threaded insert inside the strut. In this way, any tension load is carried in the shoulder of the threaded insert bearing against the end of the split sleeve, which, in turn, is carried through the weld material connecting the sides of the split sleeve to the strut.

In this particular case, however, the threaded insert at the inner end was found minus the shoulder, which is the reason that the adjustable clevis bolt (c) with the threaded insert pulled out of the split sleeve. It is apparent, on close examination of this end under the binocular microscope, that a shoulder had at one time been machined on the threaded insert and had failed because of fatigue. The fatigue started at diametrically opposite ends of the diameter on the outside and worked its way inward toward the thread. The characteristic clam-shell markings of fatigue failure are very plainly indicated. There are, also, deposits of the weld material on the ends of the split sleeve which connected the sleeve to the shoulder of the threaded insert, which, again, indicates that the shoulder was on at one time. The shoulder end of the threaded insert has no fillet between the shoulder and the barrel. This sharp change of the section is very prone to fatigue failure, due to heavy stress concentration at this point.

Upon the basis of all the available evidence, the Board finds that the probable cause of the accident was the failure of the wing as a result of fatigue failure at the shoulder end of the threaded insert of the lower fitting in the left front lift strut.
