## CIVIL AERONAUTICS BOARD

**ACCIDENT INVESTIGATION REPORT**

**EASTERN AIR LINES—NEAR BAINBRIDGE, MD., MAY 30, 1947****The Accident**

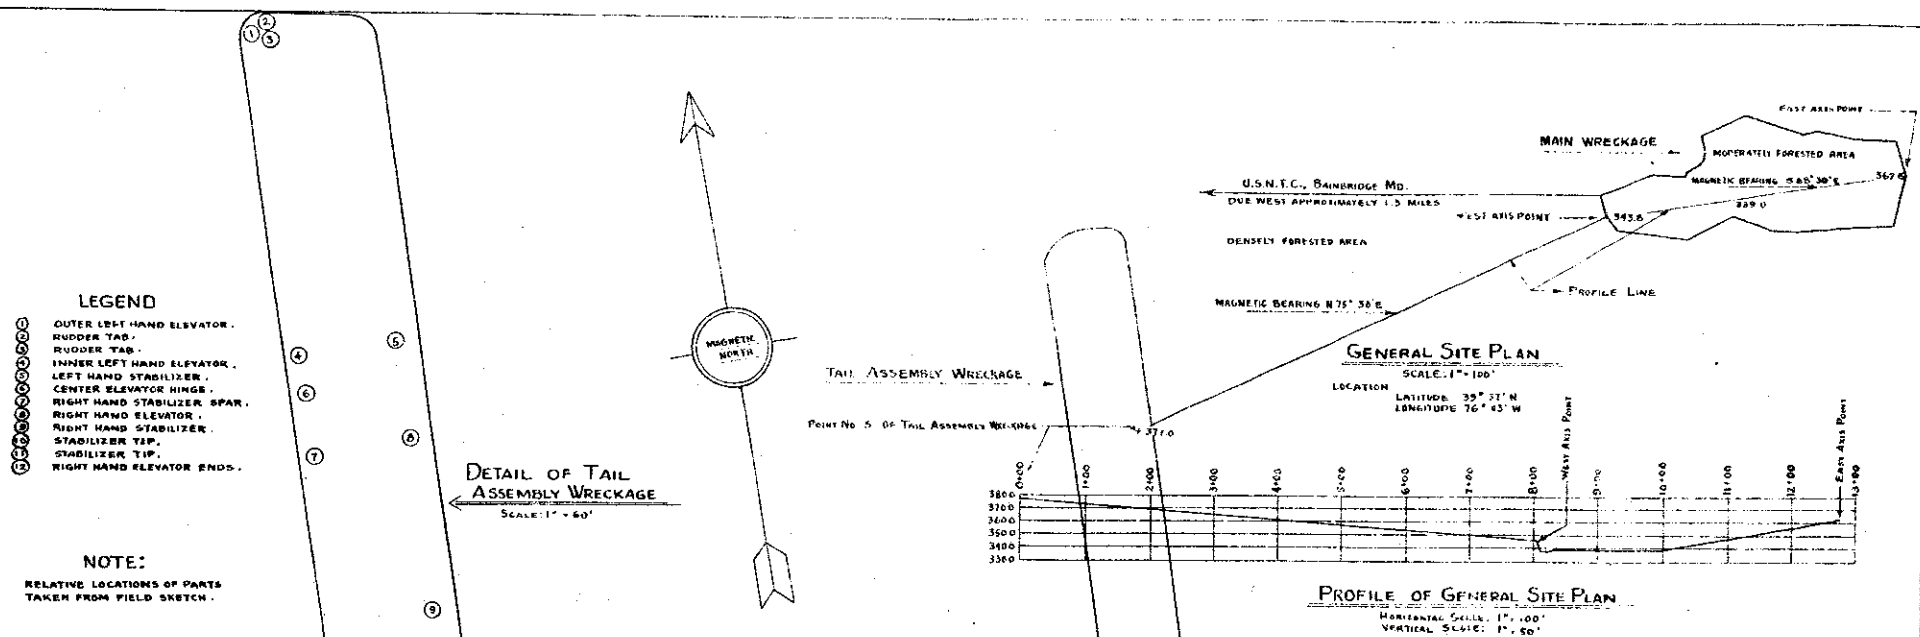
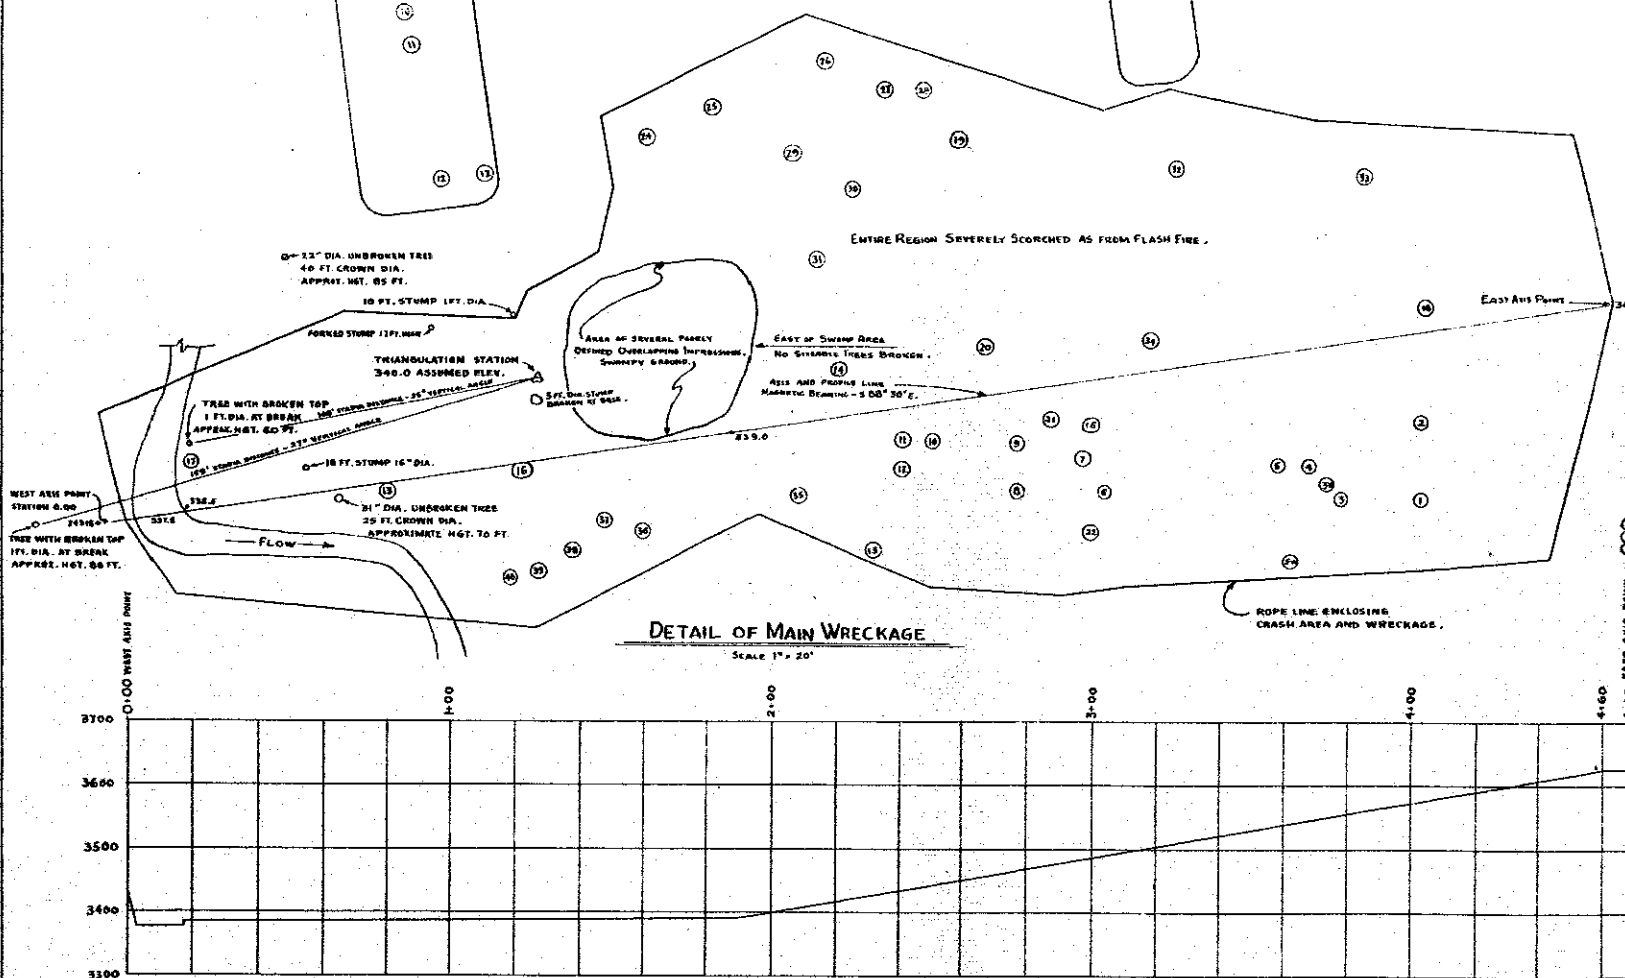
NAVAL TRAINING CENTER, BAINBRIDGE, MD.  
**WRECKAGE DISTRIBUTION**  
of  
CRASH OF EAL-C54B-DC-NC88014  
NEAR BAINBRIDGE, MD. ON MAY 30, 1947

Impact with the ground was about 2 miles east of Bainbridge, on Amber 7 Airway, in a moderately to densely wooded area with trees 60-70 feet high. The aircraft broke up into a large number of pieces which were strewn irregularly over an area roughly 500 feet long and 150 feet wide with the explosive-like violence common to high-speed crashes. The direction of the long axis of this area, from the initial impact end, was about 90° or nearly east, and opposite to the flight's original westerly course. A quite clear-cut path of trees, broken at decreasing heights, indicated that the plane came through them at an angle of 28°-30° below the horizontal. Near both sides of this line of broken trees were closely-spaced unbroken trees. Examination of the wreckage indicated that the plane was inverted at impact with its left wing low. A flash fire which followed burned leaves and foliage and scorched tree trunks throughout the wreckage-strewn area, there was no sustained or concentrated fire. (A detailed sketch of the crash site is attached.)

All major portions of the horizontal tail surfaces were found in a similarly heavily wooded region some 300 yards west of the crash site. These pieces were concentrated in a comparatively small area under the path of final inverted approach.

A study of the distribution of the wreckage indicates that parts of the empennage left the aircraft at about the same time, and at low altitude, otherwise their resting places would have been far more scattered. No part of the aircraft was found anywhere except in the areas of the main wreckage or of the tail wreckage.
