## CIVIL AERONAUTICS BOARD

## ACCIDENT INVESTIGATION REPORT

## PAN AMERICAN AIRWAYS—ANNETTE ISLAND, ALASKA—OCTOBER 26, 1947

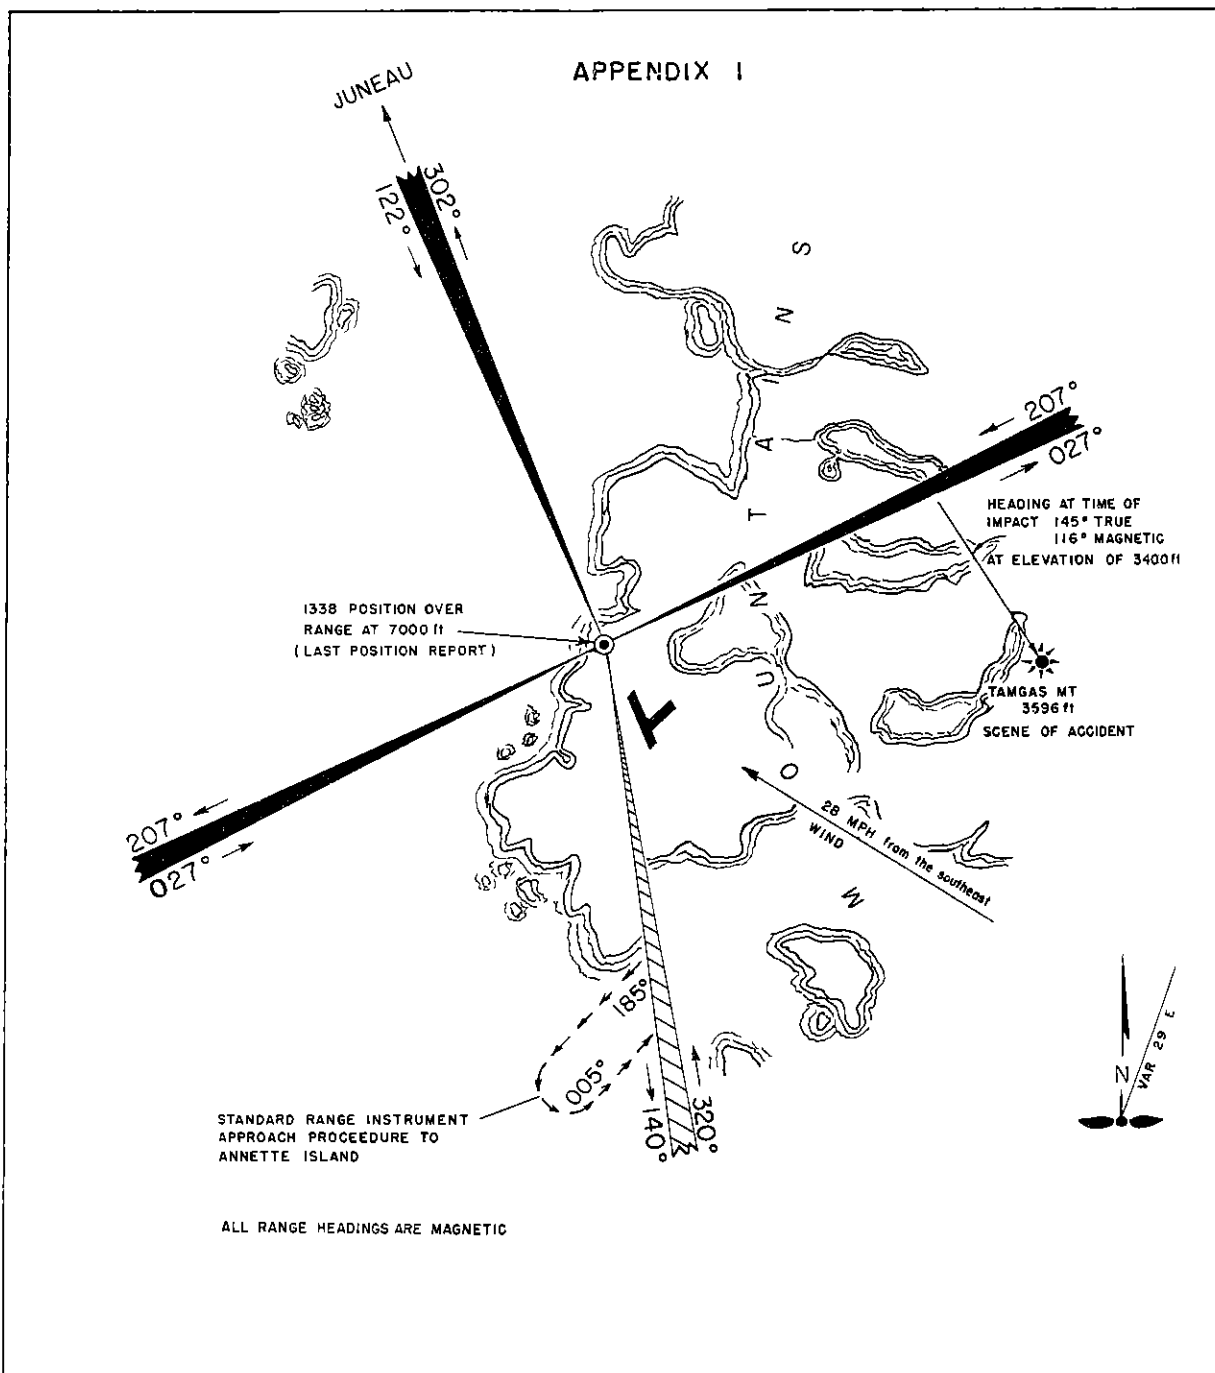
APPENDIX I

Airway Traffic Control cleared the flight to pass over the radio range station located 1.5 mile northwest of the airport at 7,000 feet and then to proceed with a normal instrument letdown and approach to the field. The flight acknowledged this clearance, and reported its position over the radio range station at 7,000 feet at 1338. The normal instrument procedure for Annette Island was established with regard to the mountainous terrain east and northeast of the airport, which rises to an elevation of 3,596 feet on Tamgas Mountain. This procedure required the flight, after approaching from the south at 7,000 feet and reporting over the radio station, to remain west of the south course of the range while on instruments.<sup>2</sup>

Displacement of the northwest course of the Annette Island Radio Range cannot be considered contributory to the accident. Even if deflected 3 1/2 degrees east, the northwest course of the range would not at the closest point be less than 10 miles from the mountains northeast of the radio range station. It is evident, therefore, that had the flight followed this course, it could not have flown into Tamgas Mountain. Furthermore, the Army Air Force pilot who used the range and landed at Annette 23 minutes before Flight 923 arrived, reported the operation of the range to be substantially normal <sup>5</sup>
