## CIVIL AERONAUTICS BOARD

**ACCIDENT INVESTIGATION REPORT**

**NORTHWEST AIRLINES, INC.—WINONA, MINNESOTA—AUGUST 29, 1948****The Accident**

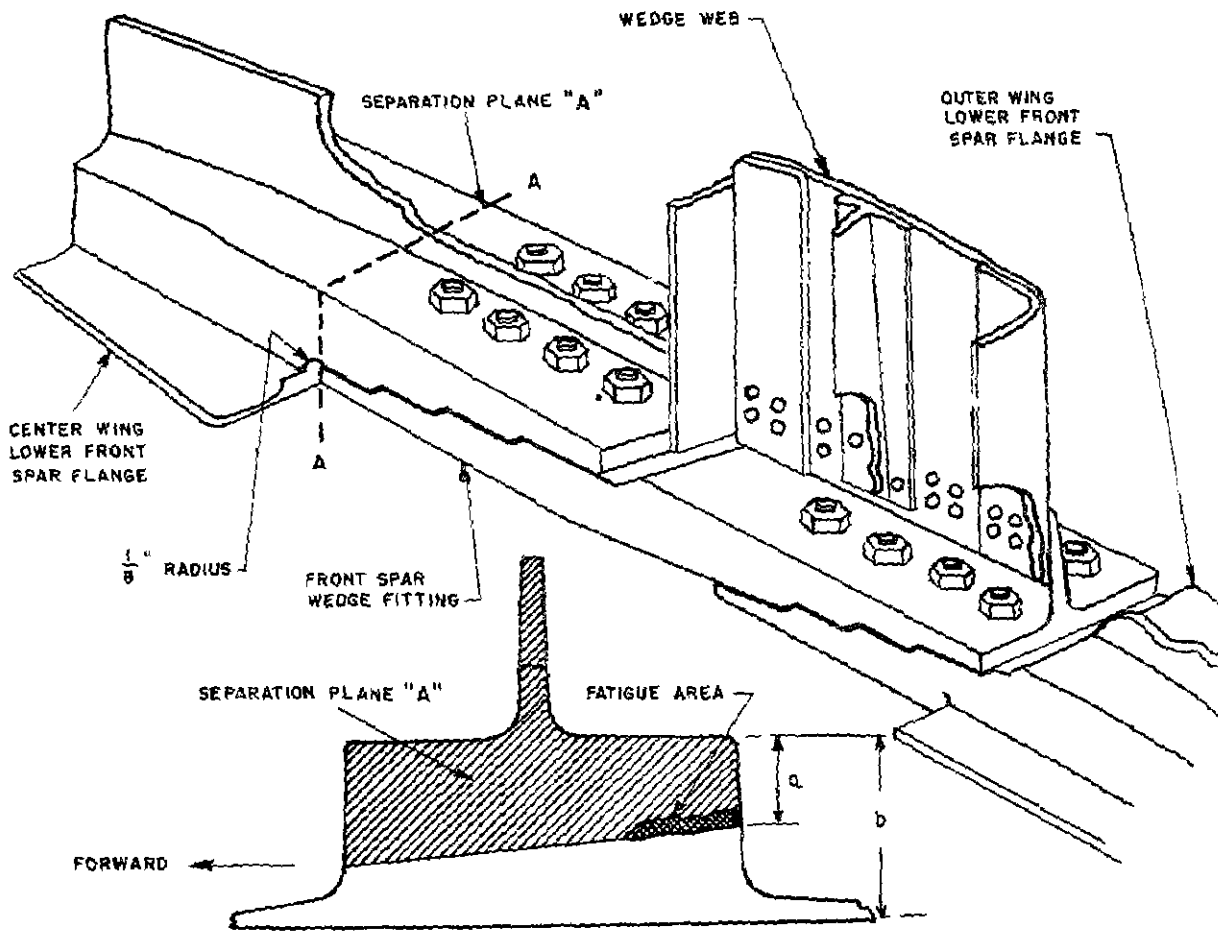
WING ROOT FITTING

The outer wing front and rear lower spar flanges attach to the center wing front and rear lower spar flanges by means of a dihedral wedge as illustrated in the attached drawing. Originally, the spar flanges were bolted directly together, but tests of the prototype airplane demonstrated a need for a greater lateral stability. Therefore, the outer wing was rotated seven degrees upward by means of incorporating the dihedral wedge in the attachment of the outer wing to the center section. It will be noted in the drawing of this part that the attachment ends of the lower spar flanges and dihedral wedge have four steps or vertical increases in thickness. In each step the vertical increase in thickness is approximately 13/64 of an inch, except for the fourth step inboard on the center section spar flange where the vertical increase in the thickness is approximately 3/4 of an inch. The radius in the fillet of these steps is approximately 1/8 of an inch.

Evidence indicated that the outer wing had first separated from the center section in the fillet of the fourth step of the lower front center section spar flange. Examination of this fracture revealed that the separation had started from a fatigue crack approximately 7/8 of an inch long, and 3/32 of an inch deep, the remaining cross section of the material at this point failing from tension.

The particular design of the connection of the lower flange for the front spar of the outer panel to the center panel for the Martin 202 is conducive to high local stress concentration. Hence, it is readily susceptible to fatigue. These high local stress concentrations are due to the following characteristics: the fitting contained fillets of a small radius in the step down of 1/8 inch, there was a large sudden change in cross section in the fourth step down inboard from the attachment, increasing the depth to approximately twice its thickness, and the cross sectional area was designed to a high percentage of the ultimate strength of the material.

SCHEMATIC SECTION OF SEPARATION OF LOWER FLANGE SHOWING FATIGUE AREA AND ALSO SUDDEN INCREASE OF DEPTH OF FLANGE "a" TO APPROXIMATELY TWICE THE DEPTH AS INDICATED BY "b"

At the present time the wing root fittings on the Martin 202s are being given frequent and thorough inspections for the development of fatigue cracks, and the operating speeds have been reduced ten percent. In addition, the front center section spar flange has been modified so as to include five steps or vertical increases in thickness to avoid any radical change in cross section. The radius in the fifth step fillet has been increased from 1/8 of an inch to 3/4 of an inch; two bolts have been added, and all parts have been polished. In general the above constitutes present corrective action approved by the Administrator of Civil Aeronautics. It is considered to be temporary in nature, but sufficient for safe operation until 3,000 hours of flight. After 3,000 hours of flight have been accumulated on the aircraft or before, the airplane will be modified at the Martin Company with a permanent correction which involves extensive structural changes to the wing.
