CIVIL AERONAUTICS BOARD

ACCIDENT INVESTIGATION REPORT

PIEDMONT AIRLINES—NEAR BRISTOL, TENNESSEE, DECEMBER 28, 1948**The Accident**

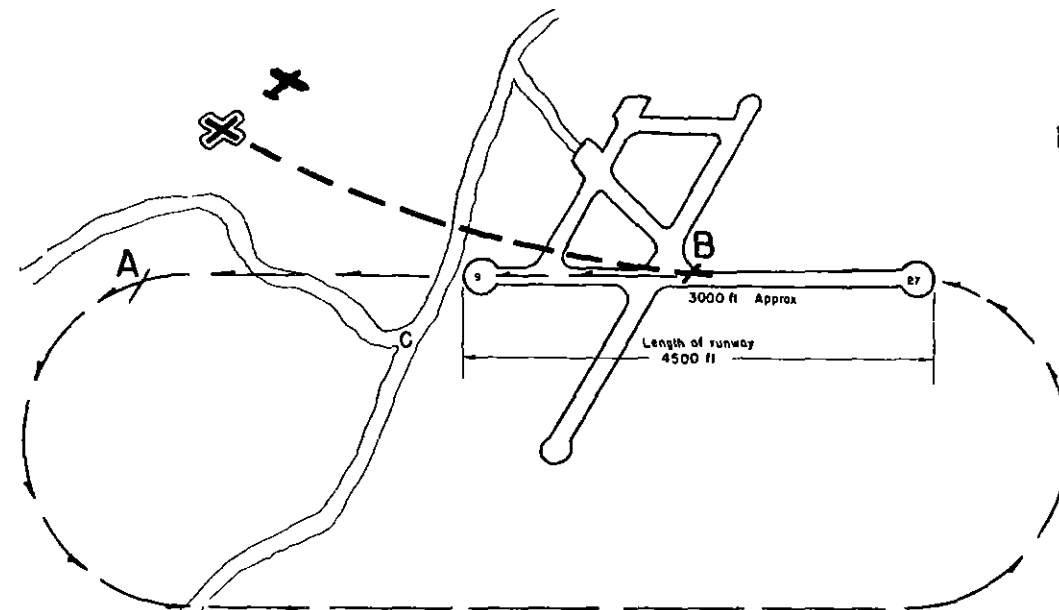
FLIGHT PATH OF NC 37468
TRI-CITY AIRPORT - BRISTOL, TENN.

The aircraft stopped in a field 4,250 feet from the west end of Runway 27 on a bearing of 38 degrees from the takeoff direction. Investigation revealed that the tail wheel of the aircraft touched the ground first. The right propeller and engine struck 105 feet further on. Nine feet beyond this point the left propeller and engine made contact. From this point a series of shallow propeller blade cuts approximately 15 inches apart were made by the left propeller in the turf. After contacting the ground, the aircraft skidded on its belly approximately 300 feet, turning 90 degrees to the right of its line of travel.

- ORIGINAL TAKE OFF PATH
- A APPROXIMATE POINT AT WHICH THE PILOT ADVISED THAT HE WAS RETURNING TO LAND
- B APPROXIMATE POINT AT WHICH IT WAS APPARENT THAT THE AIRCRAFT WAS GOING AROUND
- - - FLIGHT PATH OF ATTEMPTED GO-AROUND
- + POINT OF IMPACT - AFTER WHICH THE AIRCRAFT TURNED APPROXIMATELY 100 DEGREES TO THE RIGHT
- C ROAD
