ACCIDENT INVESTIGATION REPORT

CIVIL AERONAUTICS BOARD

PAN AMERICAN AIRWAYS, INC. AND CESSNA 140—PORT WASHINGTON, LONG ISLAND, NEW YORK, JANUARY 30, 1949

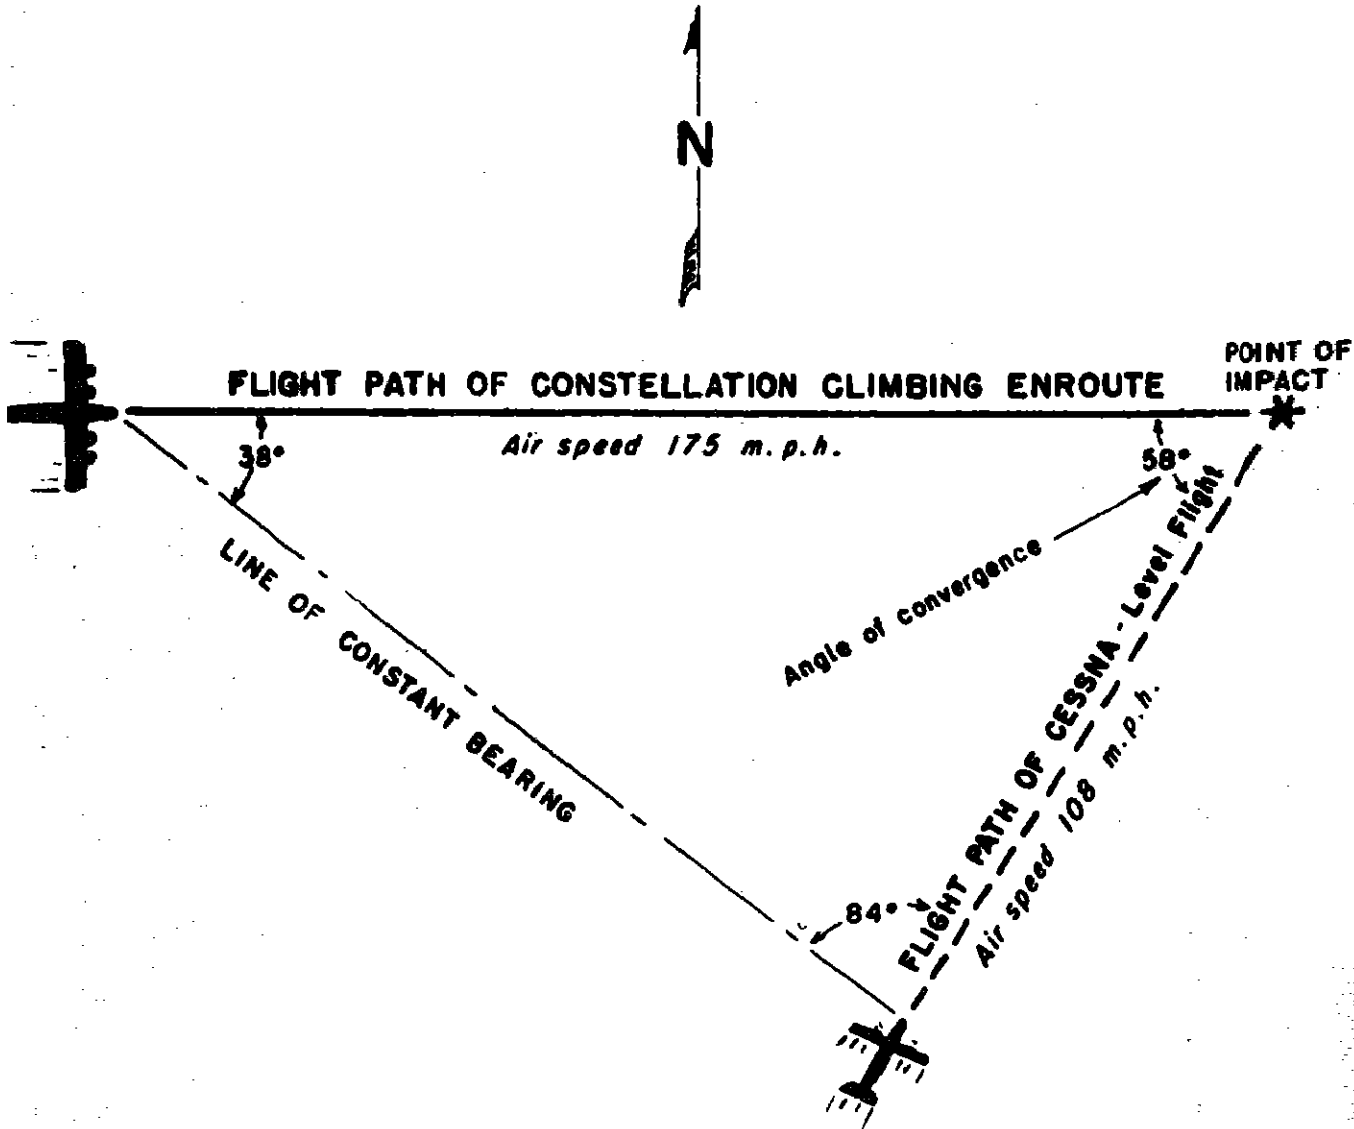
APPENDIX I

was 55 degrees, or approximately the same as the above computed convergence angle of 58 degrees. As the two airplanes converged the Cessna was at a relative bearing of 38 degrees right from the Constellation, and the Constellation was at a relative bearing of 84 degrees left from the Cessna.

5. The two airplanes converged at an angle of 58 degrees and collided at an altitude of 3,300 feet over Port Washington, New York, on Red Airway 23,
6. During the period of time that the airplanes were converging at an angle of 58 degrees, the Cessna maintained a constant relative bearing from the Constellation of 38 degrees and the Constellation maintained a constant relative bearing from the Cessna of 84 degrees.

RELATIVE BEARINGS OF 38° CESSNA FROM CONSTELLATION, AND 84° CONSTELLATION FROM CESSNA, REMAIN CONSTANT THROUGHOUT PERIOD THAT BOTH AIRCRAFT ARE ON COLLISION COURSES.
