CIVIL AERONAUTICS BOARD

ACCIDENT INVESTIGATION REPORT

AERONCA COLLISION, SHARON SPRINGS, KANS., APRIL 30, 1950**The Accident**

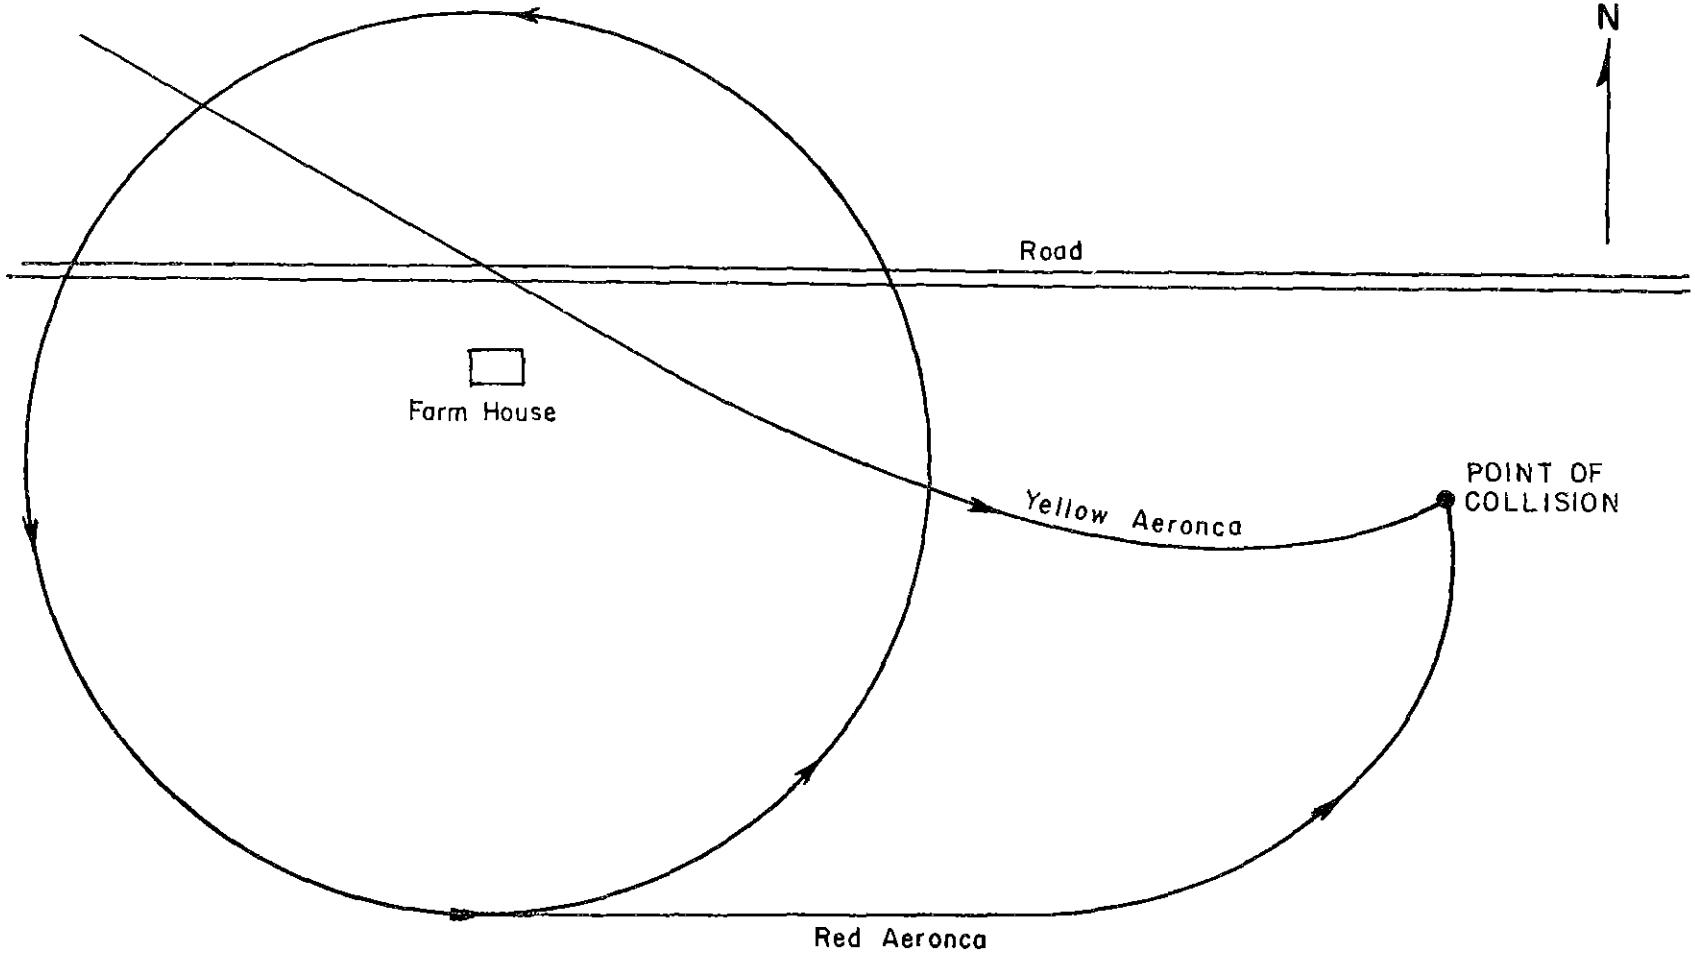
time toward the east. During the same period Scott practiced "S" turns at an altitude of 500 feet, progressing slowly to the east. Immediately before the collision both aircraft were observed flying an easterly heading. Rivers, in the red aircraft, seemed to be slightly below, ahead, and to the right of Scott. Then, both aircraft turned left, but Rivers' turn was considerably steeper than Scott's. As a result both aircraft collided. (See Chart, Appendix I.)

PROBABLE FLIGHT PATHS
AS INDICATED BY WITNESSES
