CIVIL AERONAUTICS BOARD

ACCIDENT INVESTIGATION REPORT

SOUTHWEST AIRWAYS COMPANY—14 MILES NORTHWEST OF SANTA BARBARA,
CALIFORNIA, APRIL 6, 1951

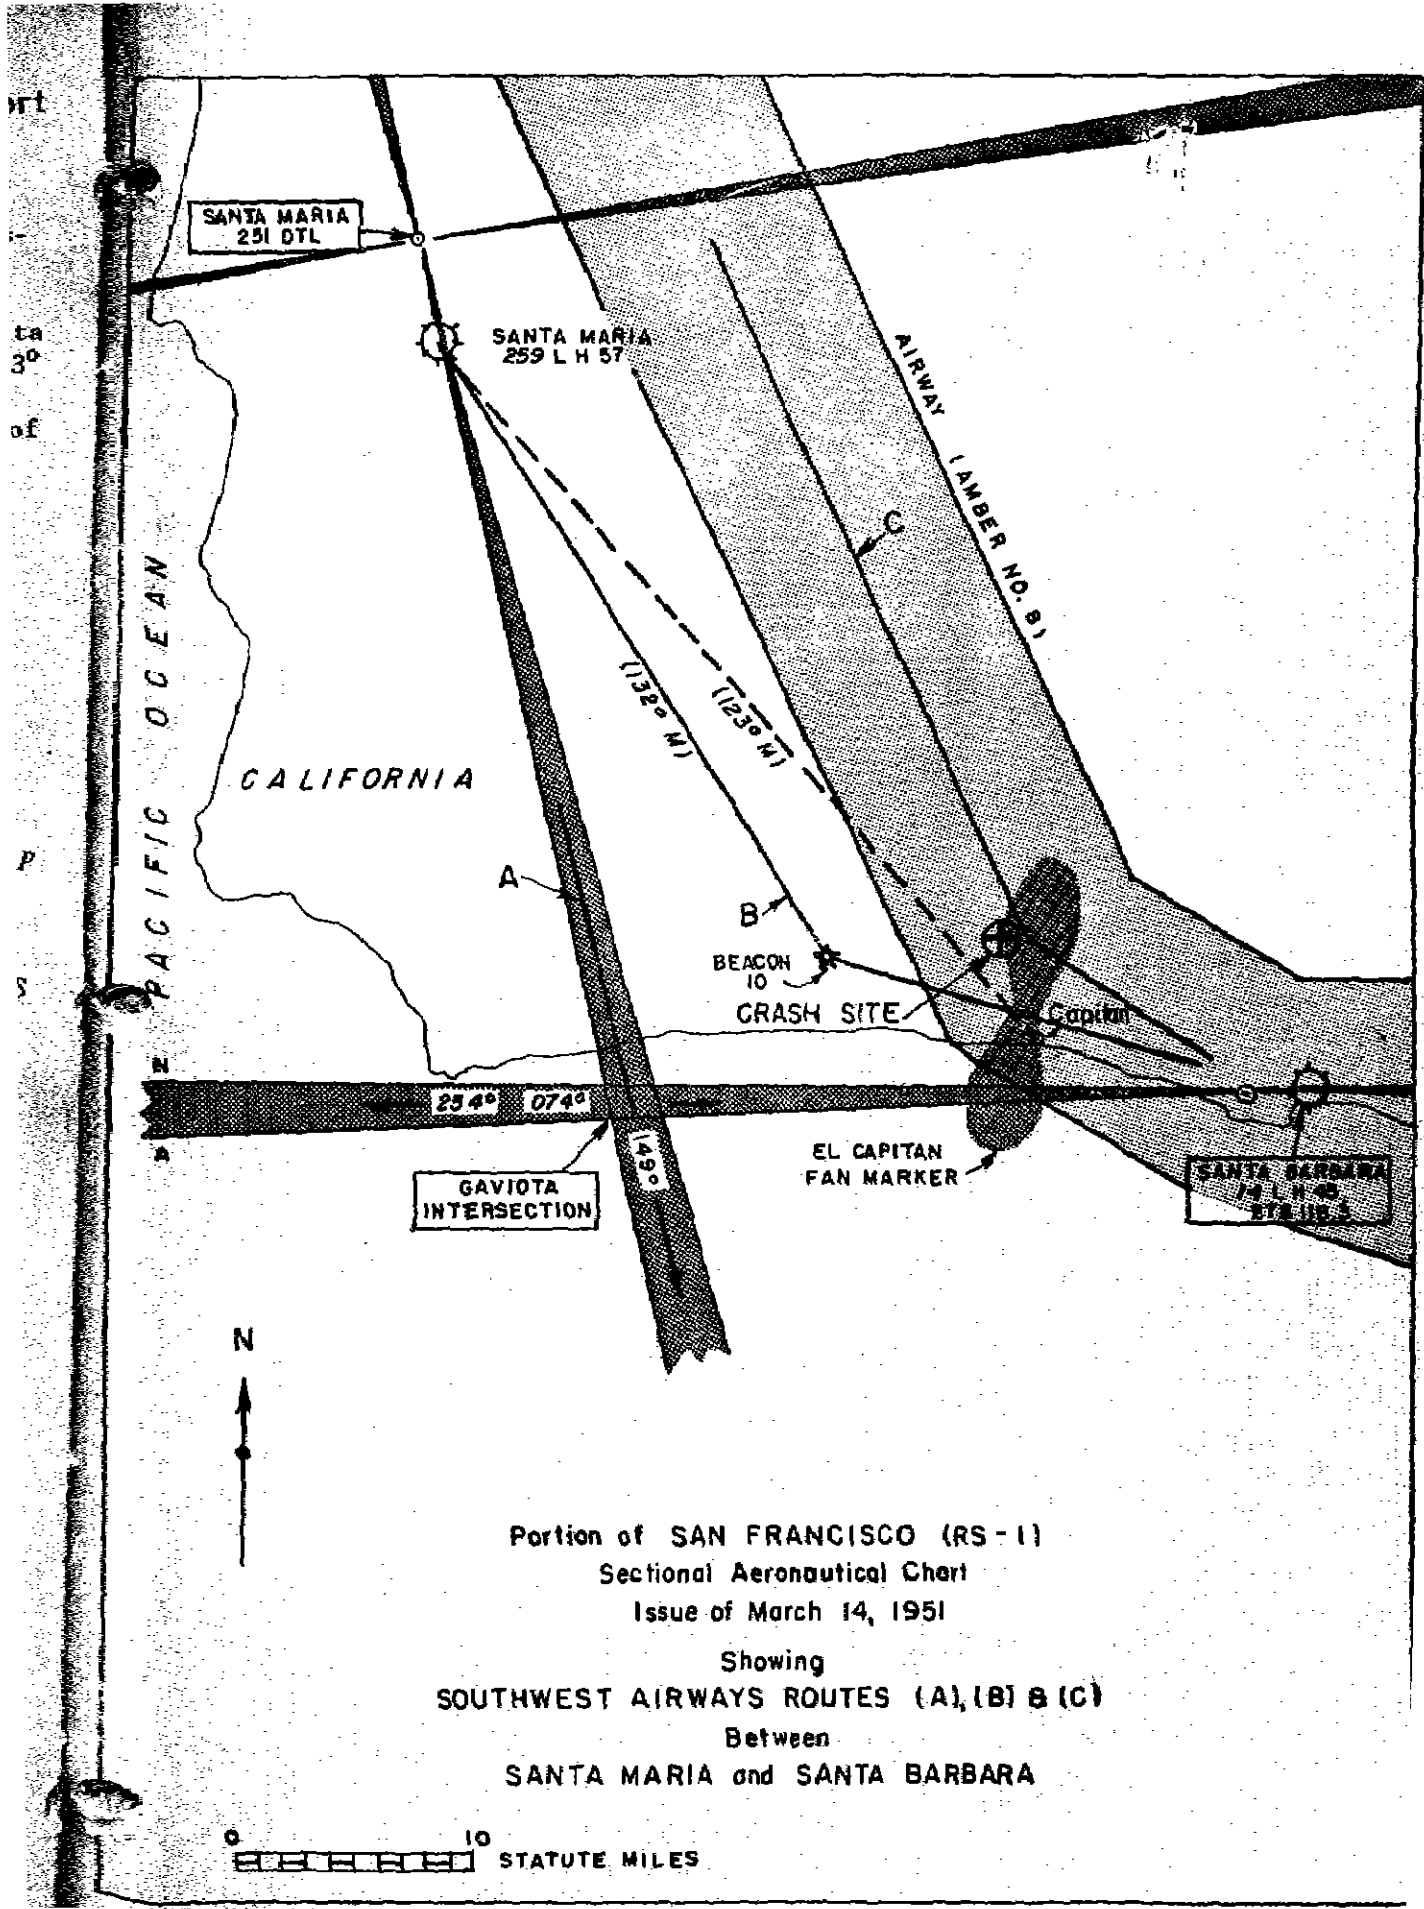
Portion of SAN FRANCISCO (RS-1)
 Sectional Aeronautical Chart
 Issue of March 14, 1951

In reference to routes between Santa Maria and Santa Barbara, the company's operations manual sets forth three routes, all approved by the Civil Aeronautics Administration. The three approved routes, used under different conditions of weather, are shown on the attachment and described as follows:

The course being flown, via the town of Capitan, is shown by a dotted line on the attachment. It was entered into the company's operational manual about three weeks before the accident, and was removed from the manual, by the carrier, immediately after the accident. However, this course was not in conflict with the pertinent provisions of the Civil Air Regulations inasmuch as it was within five miles of an approved route³—a route being defined as a strip 10 miles wide. Although the flight was confined to the limits of an approved route, the altitude at which the crash occurred, 2,740 feet, was markedly below the approved night minimums of 500 feet on top, and no lower than 4,000 feet, as prescribed in the company's operating specifications and approved by the Civil Aeronautics Administration. It appears that this was in conflict with the Civil Air Regulations.⁴

Showing
 SOUTHWEST AIRWAYS ROUTES (A), (B) & (C)
 Between
 SANTA MARIA and SANTA BARBARA
