## CIVIL AERONAUTICS BOARD

## ACCIDENT INVESTIGATION REPORT

## NATIONAL AIRLINES, INC.,—NEWARK, NEW JERSEY, MAY 21, 1951

Landing Accident, NAL DC-6, N-90896, Newark  
N.J. Airport, 0408 EST 5/21/51

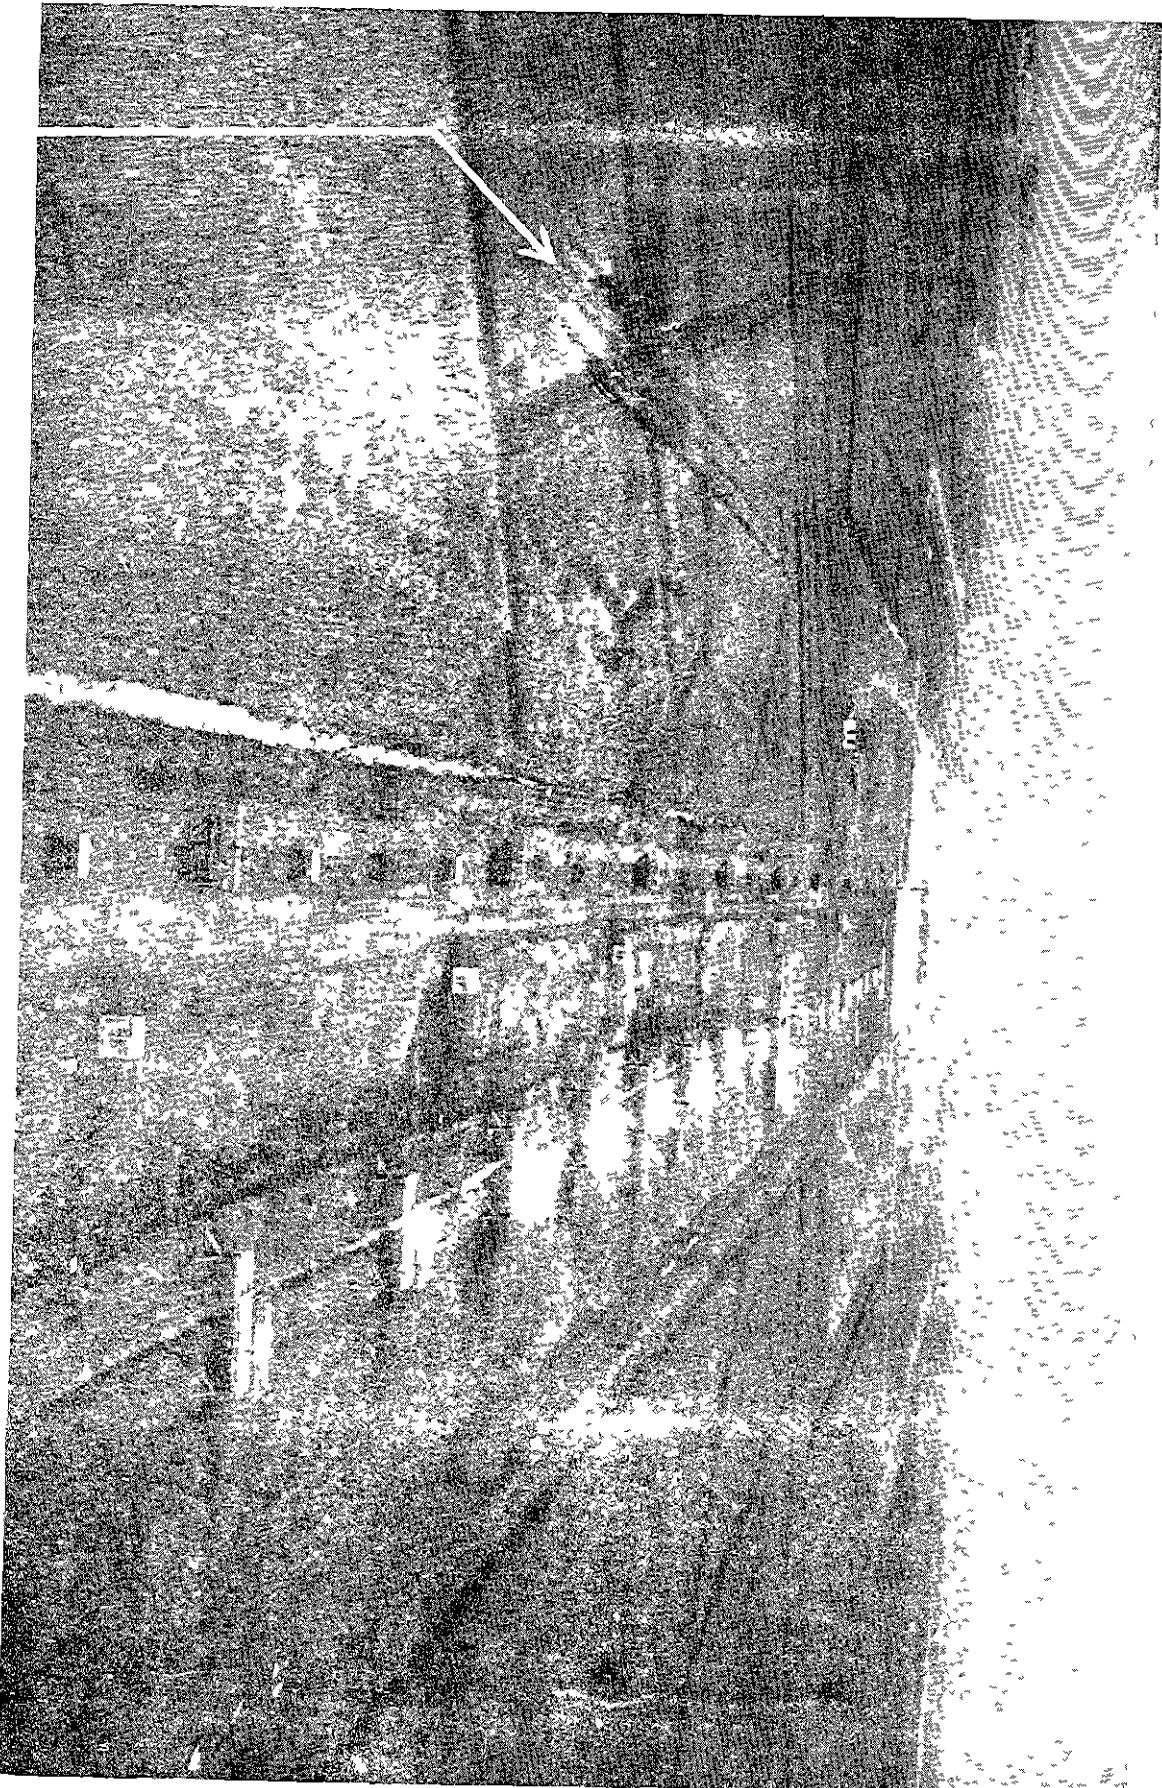
It was found that the touchdown in the swamp was made with the aircraft in approximately level flight attitude. Both main landing gear wheels and the nose wheel sank a maximum of 12 inches into the marsh, the wheel marks measured a maximum ground contact of 126 feet. This 126 feet refers to wheel marks in the swamp mud itself, and not to the first contact with the swamp grass. The first evidence of contact is shown in a swath cut in the swamp grass some 7 or 8 feet high, approximately 45 feet prior to touchdown in the mud, and at an angle about 10 degrees from the horizontal. Touchdown occurred 101 feet to the left of the centerline of the approach lights. These lights extend in a direct line for 3,000 feet from near the middle marker to the approach end of the runway. The landing was completed 1,215 feet from the approach end of the runway and 110 feet to the left of the runway edge. All four propellers were placed in reverse pitch during the landing run, and the aircraft was taxied onto Runway 6, 2,671 feet from point of second touchdown.

WHEEL MARKS IN SWAMP AREA TO LEFT OF  
CENTER LINE APPROACH LIGHTS.
