CIVIL AERONAUTICS BOARD

ACCIDENT INVESTIGATION REPORT

UNITED AIR LINES, INC., — FORT COLLINS, COLORADO, JUNE 30, 1951

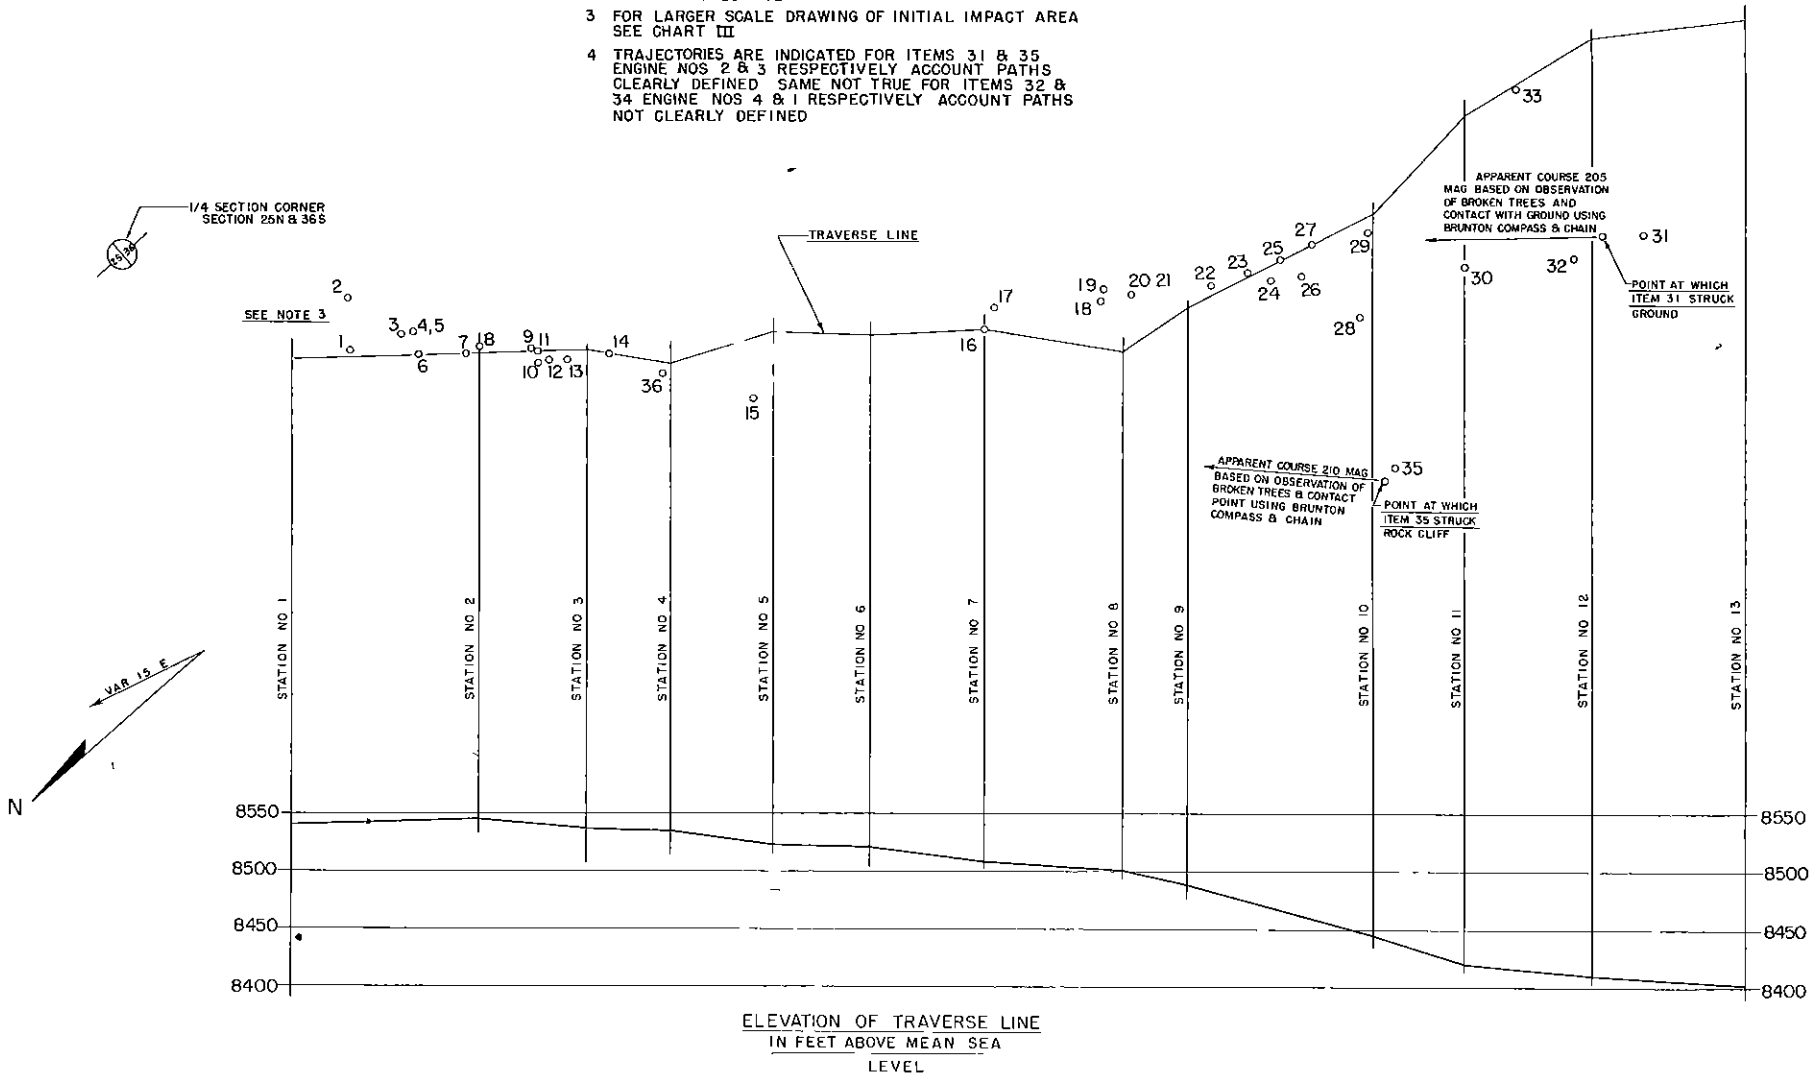
CHART II - DISTRIBUTION OF WRECKAGE
 UNITED AIR LINES ACCIDENT
 DC-6 N37543 AT CRYSTAL MOUNTAIN
 NEAR FORT COLLINS COLORADO JUNE 30 1951

traveled in a straight line 225 feet, then bounced into the air again, and came to rest 465 feet farther on. The aircraft was demolished, and aircraft parts and assemblies were strewn over a 1,400-foot area.⁵ Localized fires occurred after impact.

- 1 SCALE 1 40
- 2 SEE CODE CHART II FOR IDENTIFICATION OF ITEMS OF PLOTTED WRECKAGE
- 3 FOR LARGER SCALE DRAWING OF INITIAL IMPACT AREA SEE CHART III
- 4 TRAJECTORIES ARE INDICATED FOR ITEMS 31 & 35 ENGINE NOS 2 & 3 RESPECTIVELY ACCOUNT PATHS CLEARLY DEFINED SAME NOT TRUE FOR ITEMS 32 & 34 ENGINE NOS 4 & 1 RESPECTIVELY ACCOUNT PATHS NOT CLEARLY DEFINED

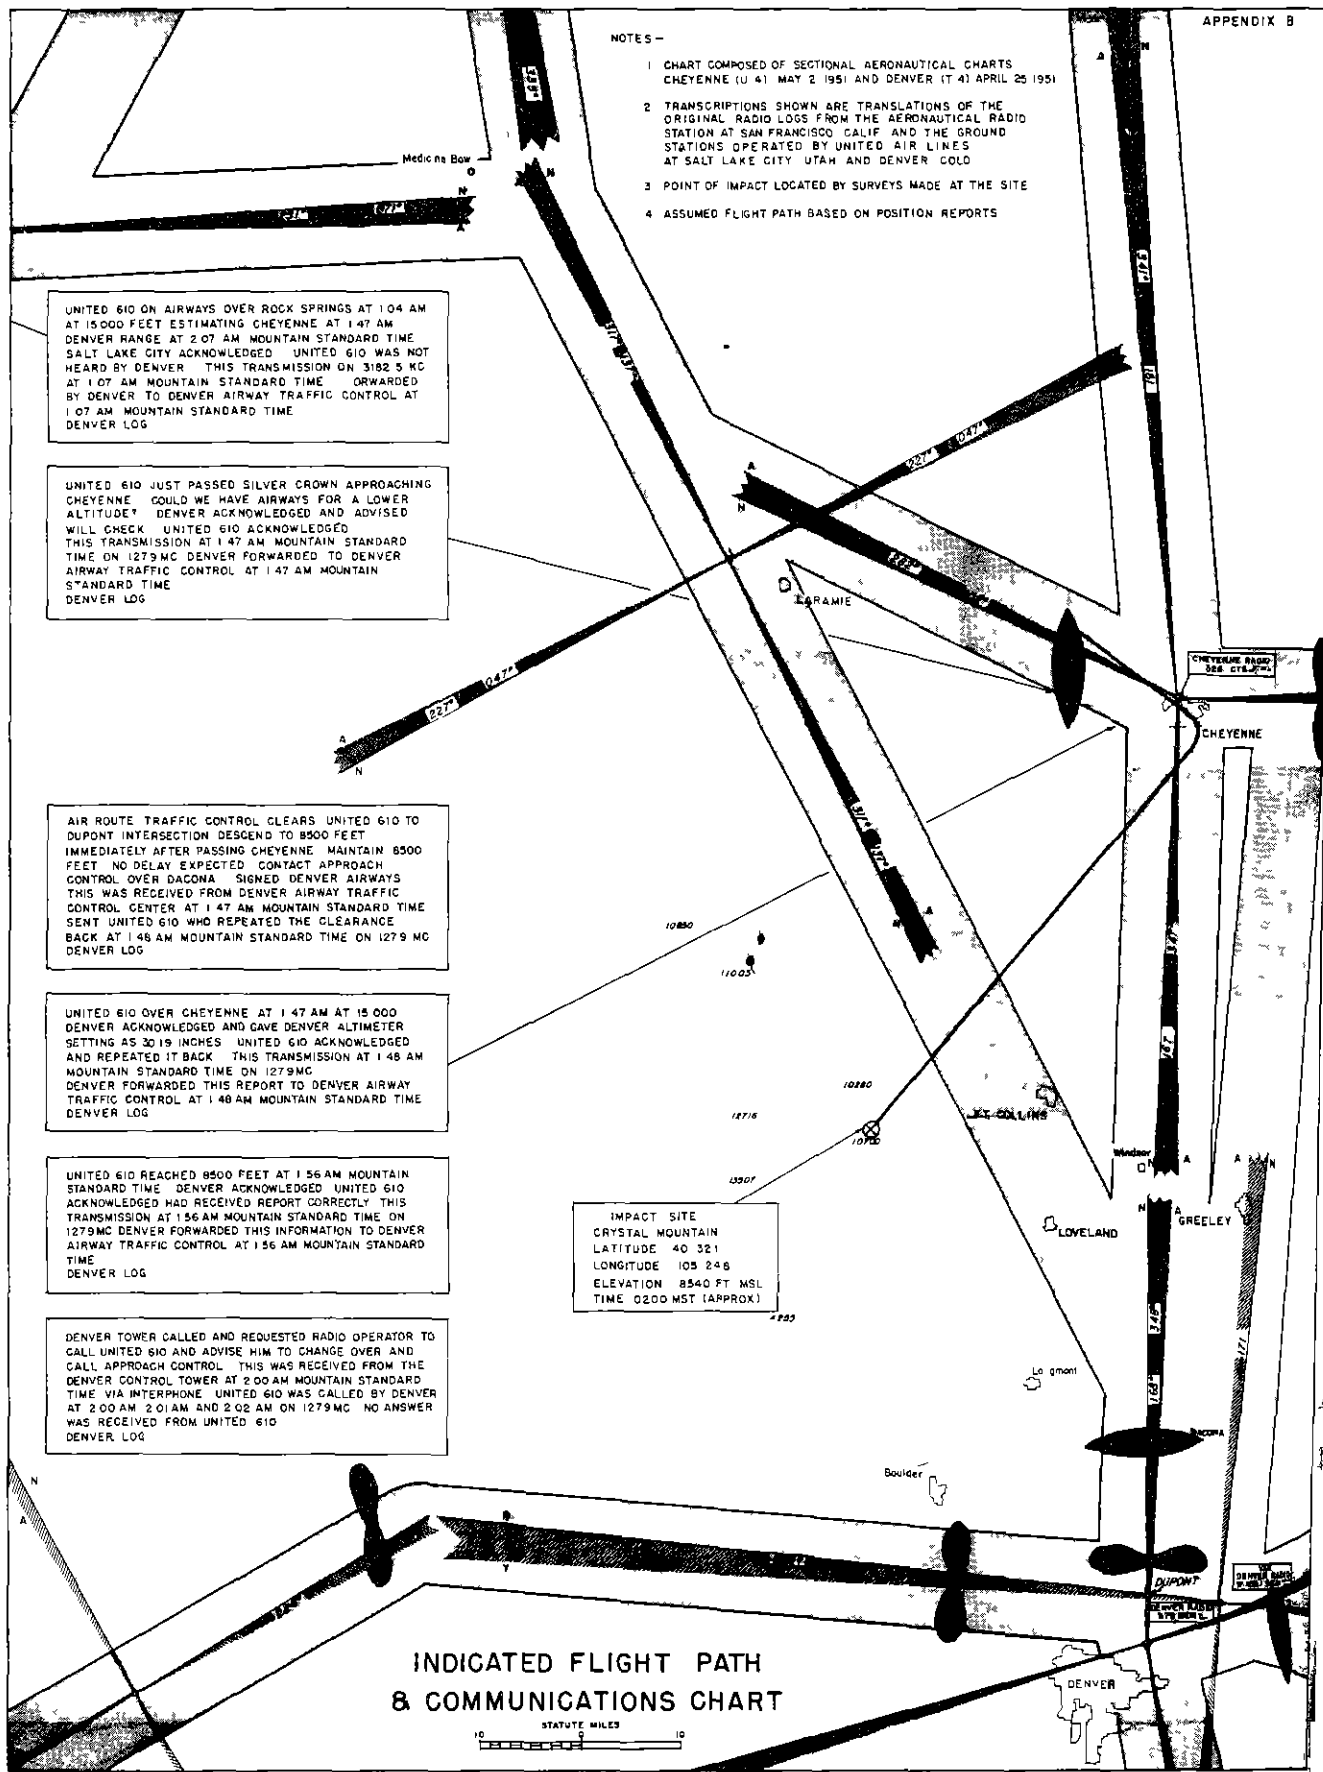
INDICATED FLIGHT PATH
& COMMUNICATIONS CHART

As a part of the investigation, an exploratory flight was made in a similar type aircraft to determine the credibility of the probable flight path of the subject aircraft between Cheyenne and the scene of the crash⁶. In an effort to duplicate the assumed track of Flight 610, the test flight crossed the Cheyenne range station from the northwest at 15,000 feet, and a shallow descending right turn was started toward a heading of 210 degrees magnetic. Two minutes were required to arrive at this heading. Continuing on this heading, a descent of 700 to 1,000 feet per minute was maintained at an indicated air speed of 245 miles per hour. Descent from 15,000 to 8,500 feet MSL required seven minutes. Four minutes later the flight arrived over the scene of the accident after climbing slightly to clear the ridge. Thirteen minutes were required to fly from Cheyenne to the scene of the accident. This time, added to the time the aircraft reported crossing Cheyenne, closely approximates the assumed time of the crash.

IMPACT SITE
CRYSTAL MOUNTAIN
LATITUDE 40 32.1
LONGITUDE 105 24.8
ELEVATION 8540 FT MSL
TIME 0200 MST (APPROX)
