CIVIL AERONAUTICS BOARD

ACCIDENT INVESTIGATION REPORT

EASTERN AIR LINES, INC.—NEAR RICHMOND, VIRGINIA, JULY 19, 1951

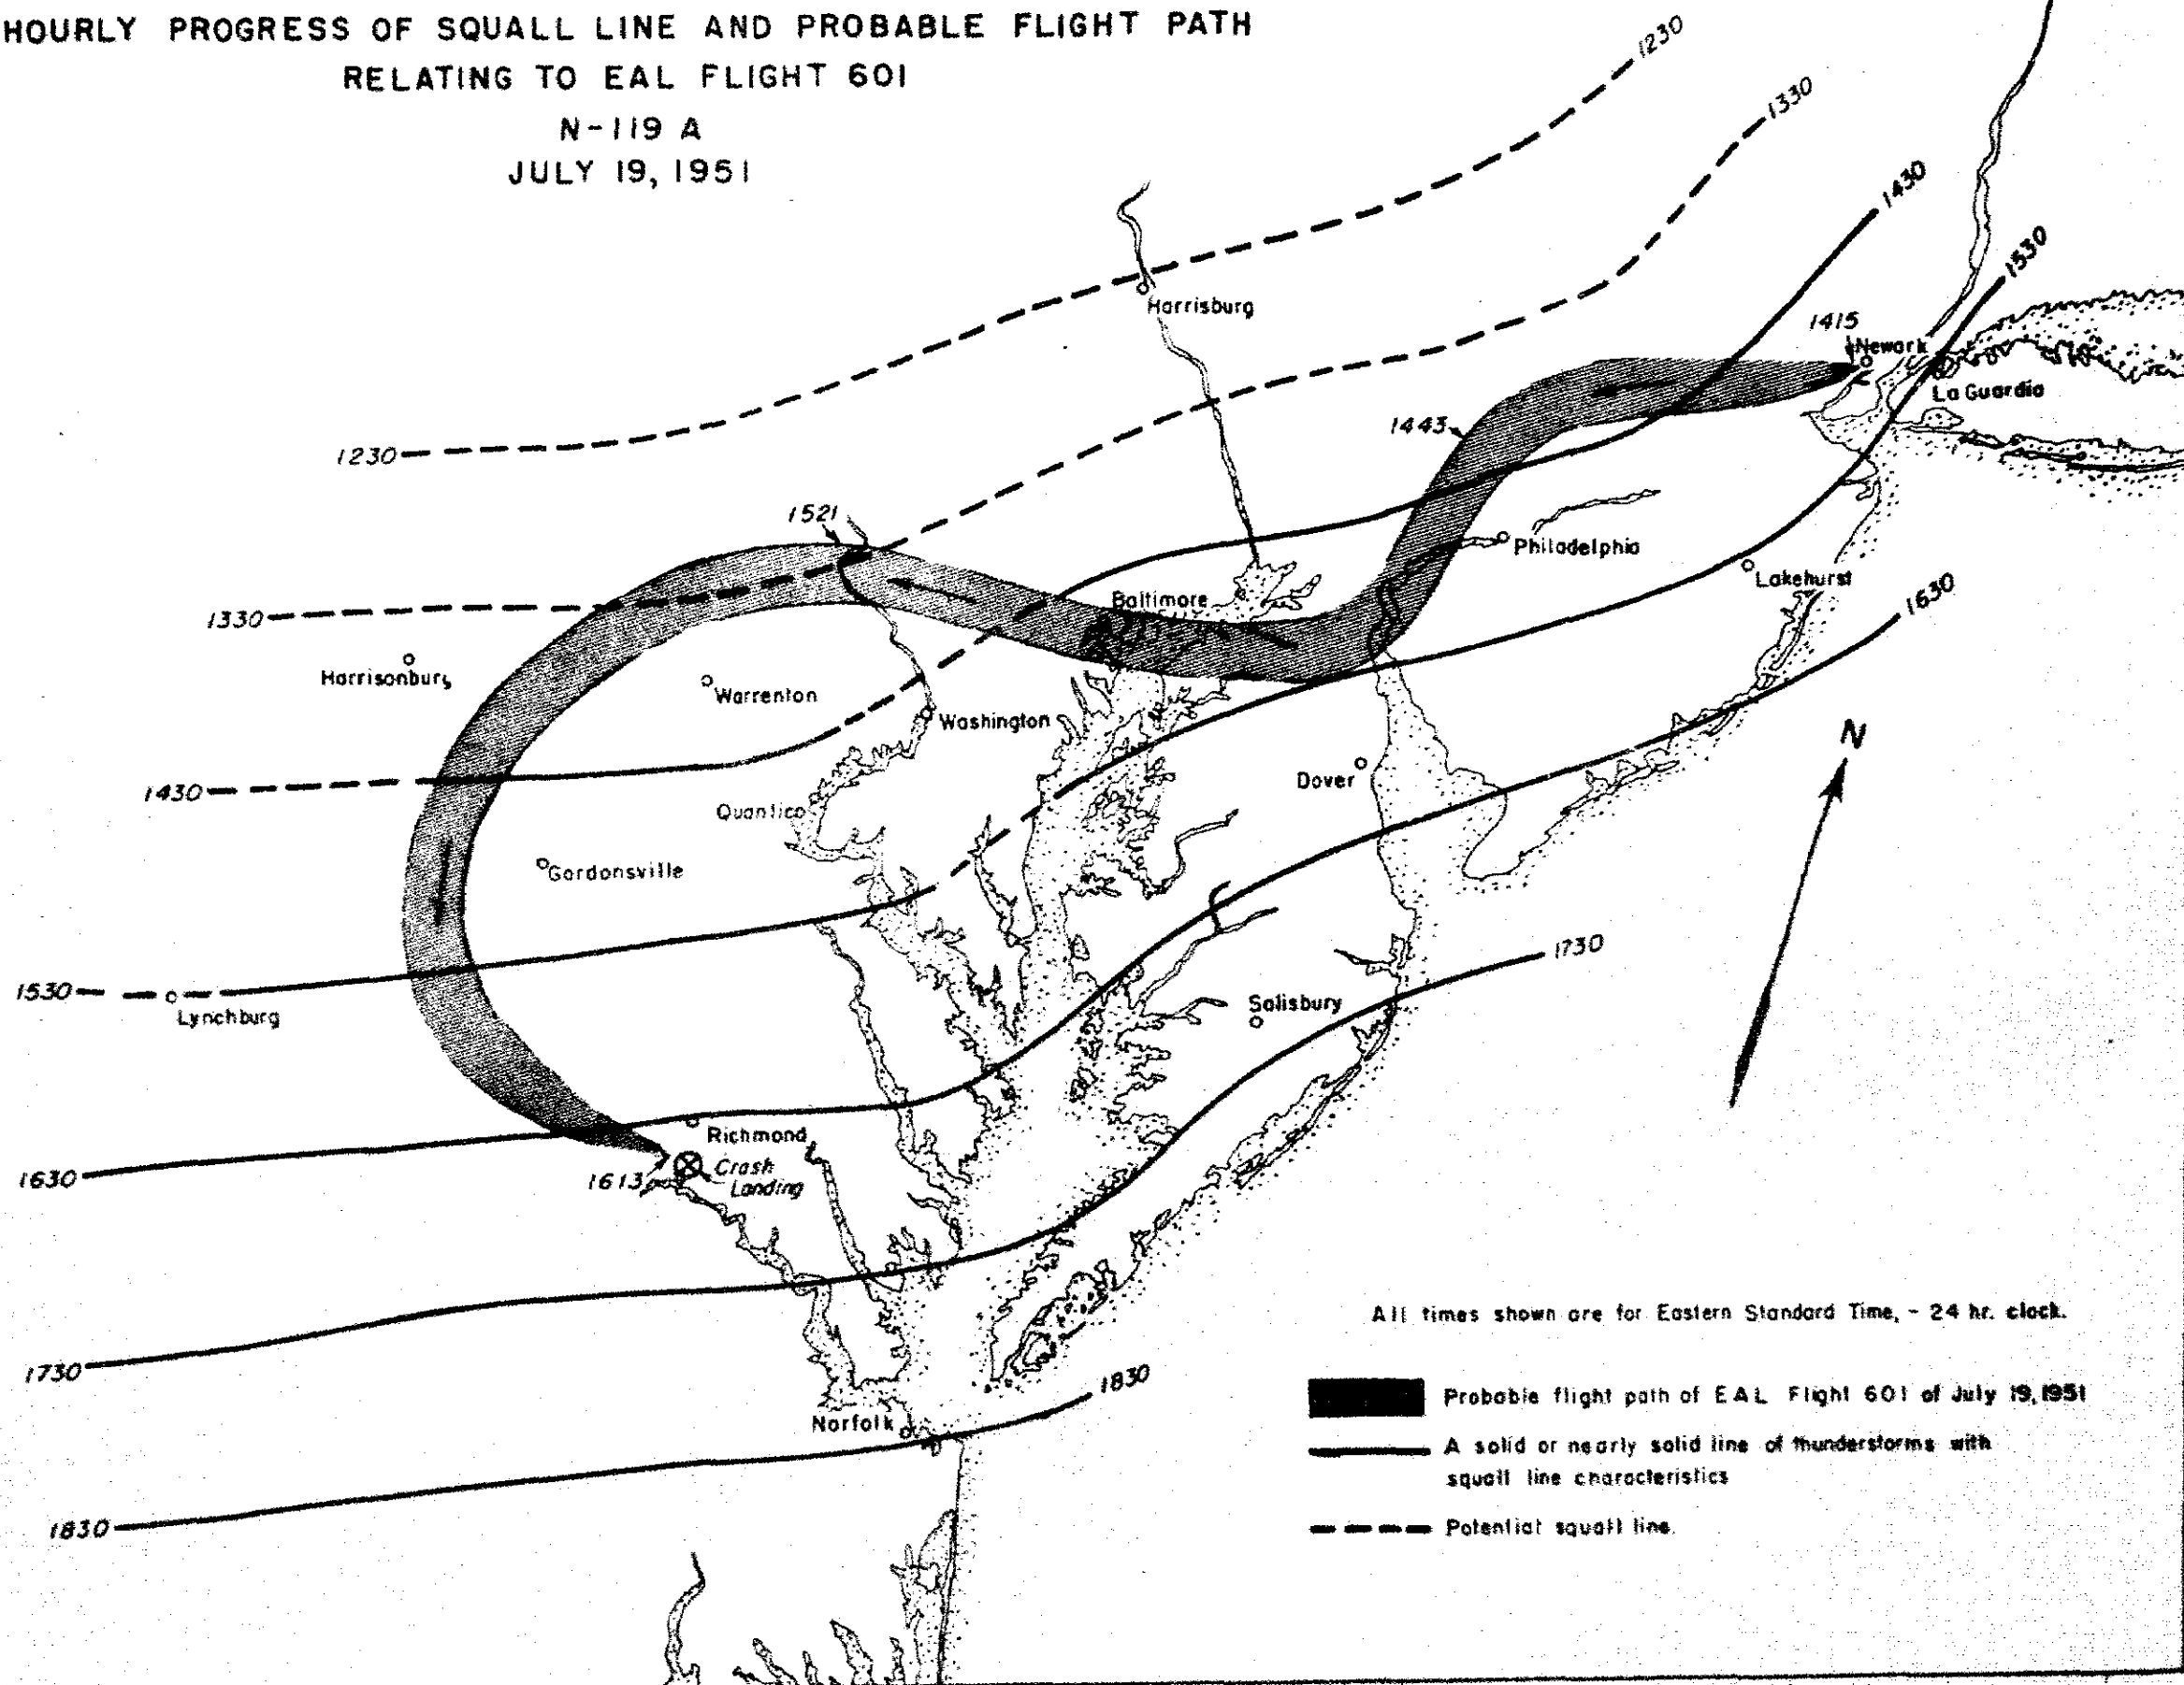
HOURLY PROGRESS OF SQUALL LINE AND PROBABLE FLIGHT PATH RELATING TO EAL FLIGHT 601

By the time the flight arrived near Philadelphia, such a portion of squall line was well-developed between Philadelphia and Baltimore. It was in the forward edge of the storm, in the area south and southwest of Philadelphia that the worst conditions were encountered—hail, severe turbulence, aircraft icing, and strong updrafts.

line Traversing this line, it broke out to the rear but re-entered the storm line a little later Analysis of weather showed that had the initial turn to the west not been made, the flight would have broken out of the first storm near Dover, Delaware, and would have had good weather for the remainder of the trip However, once the flight was in the clear area to the west and rear of the first squall line, it had to again cross the line of convergence as it continued to Norfolk and Miami A scattered thunderstorm condition had become a solid, or nearly solid, squall line from Quantico to Gordonsville and near Lynchburg at about 1500

After passing the Potomac River the flight described an approximate semicircle, curving from northwest of Washington, southwest to about Waynesboro, Virginia, and thence eastward to Richmond
