CIVIL AERONAUTICS BOARD

ACCIDENT INVESTIGATION REPORT

**PAN AMERICAN WORLD AIRWAYS, INC., KINGSTON, JAMAICA,
SEPTEMBER 2, 1951****THE ACCIDENT**

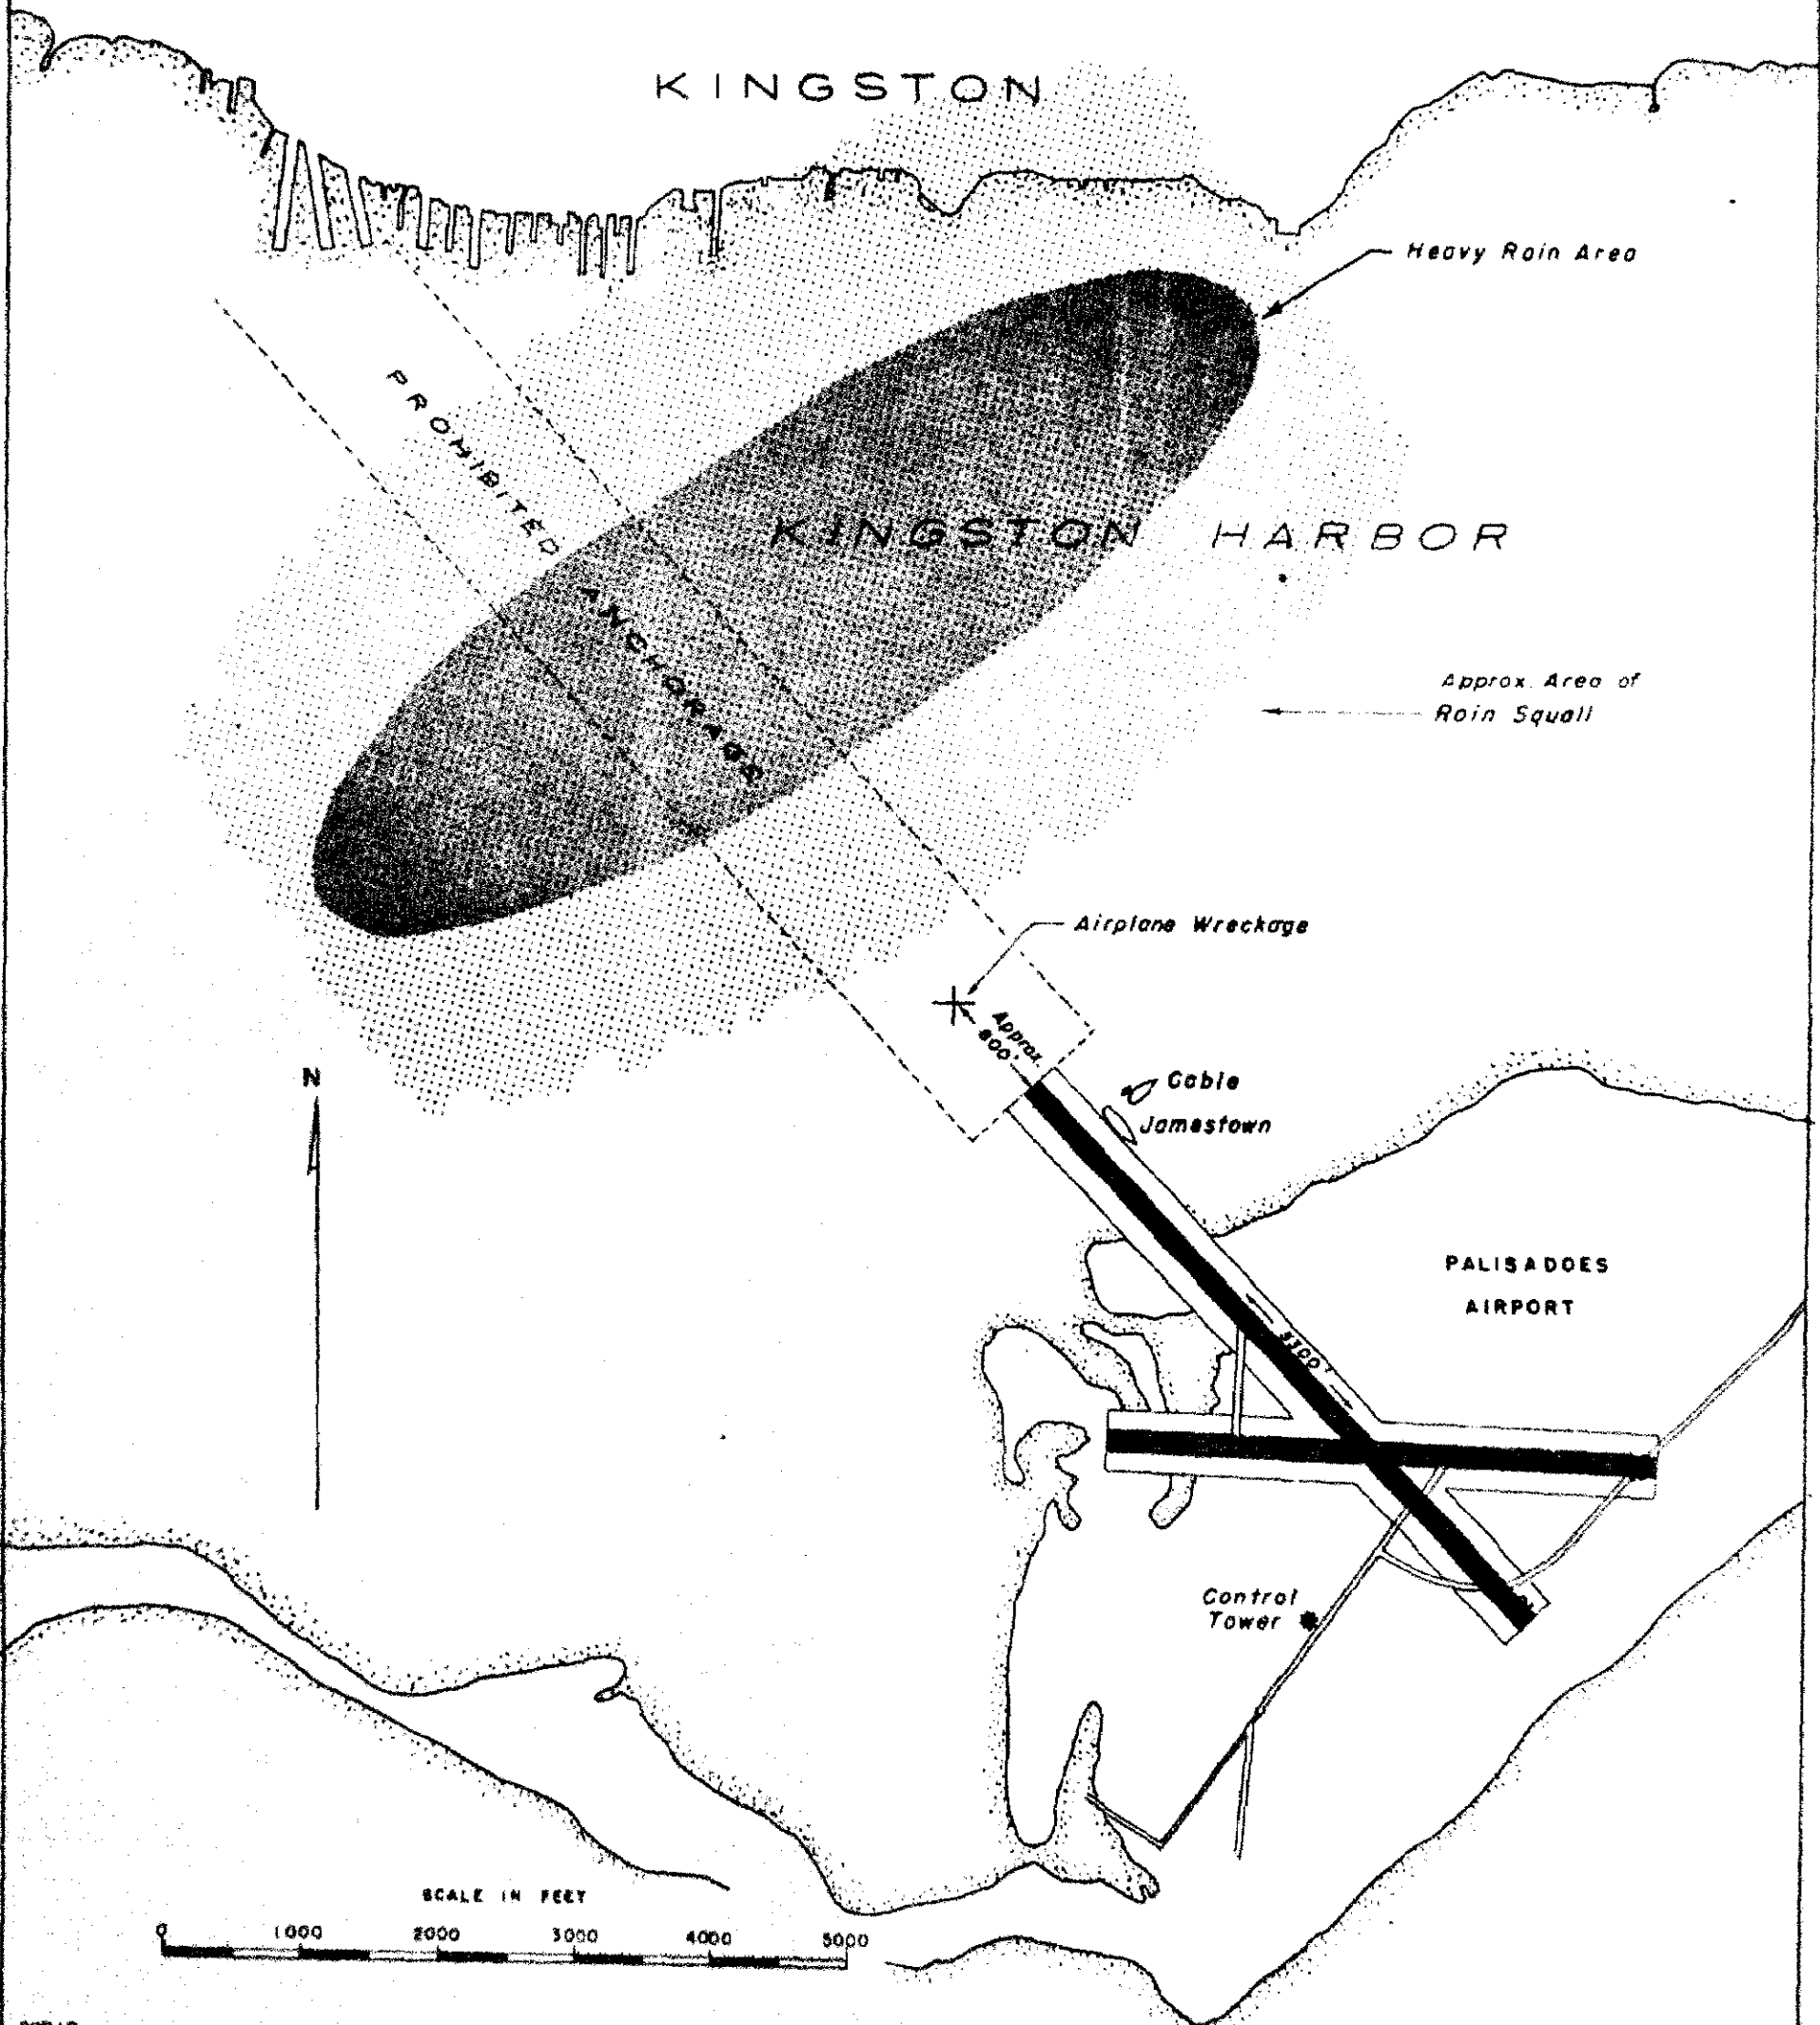
APPENDIX "A"
PAWA ACCIDENT AT KINGSTON, JAMAICA
SEPTEMBER 2, 1951

emerging from the heavy part of the squall, which was then over the approach end of Runway 14 and moving northwesterly. At this time the flight requested and received permission to circle the airport to the right. Witnesses located near the approach end of Runway 14 observed the aircraft flying in a southeasterly direction, paralleling the runway. At approximately the runway intersection,² the aircraft turned right and continued around the airport to a point northwest of the approach end of Runway 14 and over Kingston Harbor, here it was observed to descend into the water about 800 feet short of the runway. No one was seriously injured.

When asked the approximate angle of right bank at the moment of impact with the water, he replied, "45 to 50 degrees " When asked how far from the approach end of Runway 14 did he make his turn on to final, he replied, "1,500 feet " He further stated that no attempt was made to reduce power, which at the time was 2600 rpm and 28 inches of mercury, before striking the water The aircraft was closely aligned with the centerline of Runway 14 extended and a survey showed that when it sank, the nearest part of the aircraft was 798 feet from the end of the runway

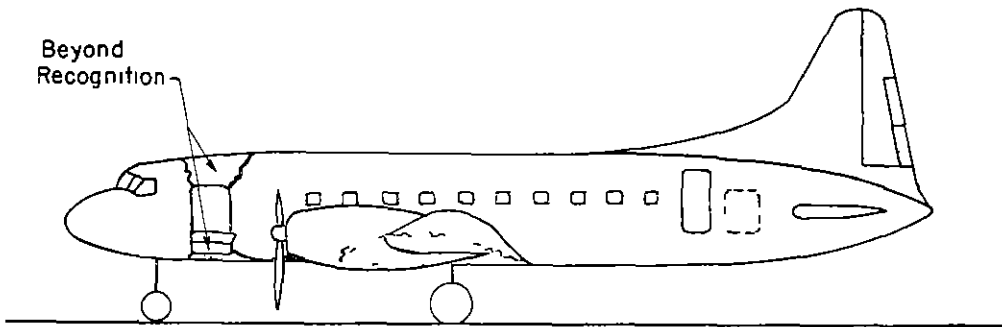
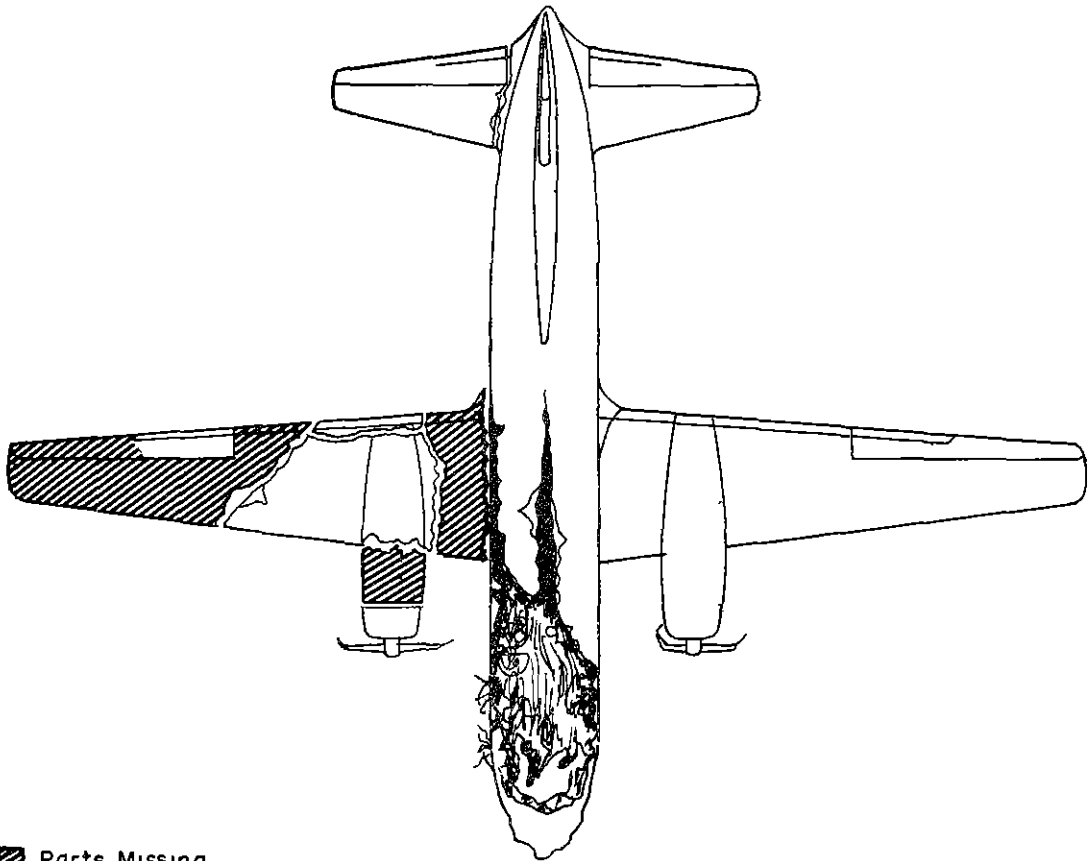
APPENDIX "B"
DAMAGE CHART
PAWA CONVAIR N90662
KINGSTON, JAMAICA
SEPTEMBER 2, 1951

Initial contact with the water resulted in the right wing being torn from the fuselage at the wing root, and the nose section and cockpit structure breaking off at the front entrance door frame located on the right side of the fuselage. This nose section went to the bottom in 20-odd feet of water, the captain and the copilot were able to extricate themselves, however, and reached the surface without injury. Before the fuselage became fully submerged, all passengers either made their way forward into the water through the opening created by the missing nose section, or back and out through the emergency rear door. One life raft had been inflated and several passengers placed aboard before the arrival of the

The wrecked aircraft sank to the muddy bottom of Kingston Harbor in about 24 feet of water with the outboard half of the left wing, the left stabilizer and elevator, the rudder, and the upper portion of the vertical stabilizer remaining above the surface of the water

Salvage equipment at Kingston was extremely limited. Also, due to the ravages of a severe hurricane which had passed through Kingston on August 17, 1951, there was no telephone service available, and other communications, electrical power, and transportation were greatly restricted. This not only delayed the preparations for salvage operations, but made such operations very difficult. However, the major portion of the wreckage was eventually raised, placed on a barge, and towed to the airport dock, where it was thoroughly examined. Meanwhile, a vessel equipped with grappling hooks dragged the area in an attempt to locate missing parts of the aircraft. Dredging operations were suspended temporarily to permit the murky water to clear, after which two professional divers with special equipment were flown in from Miami and their services were utilized October 4 through October 8. The combined salvage operations resulted in recovery of the major portion of the aircraft. Those parts not recovered consisted of the right engine, much of the right nacelle, approximately two-thirds of the right wing including a section between the fuselage and the nacelle, approximately one-half of the right flap, and approximately one-half of the right aileron.³
