CIVIL AERONAUTICS BOARD

ACCIDENT INVESTIGATION REPORT

CALIFORNIA EASTERN AIRWAYS, INC. AND OVERSEAS NATIONAL AIRWAYS,
AIR COLLISION - NEAR OAKLAND MUNICIPAL AIRPORT,
OAKLAND, CALIFORNIA, NOVEMBER 17, 1951

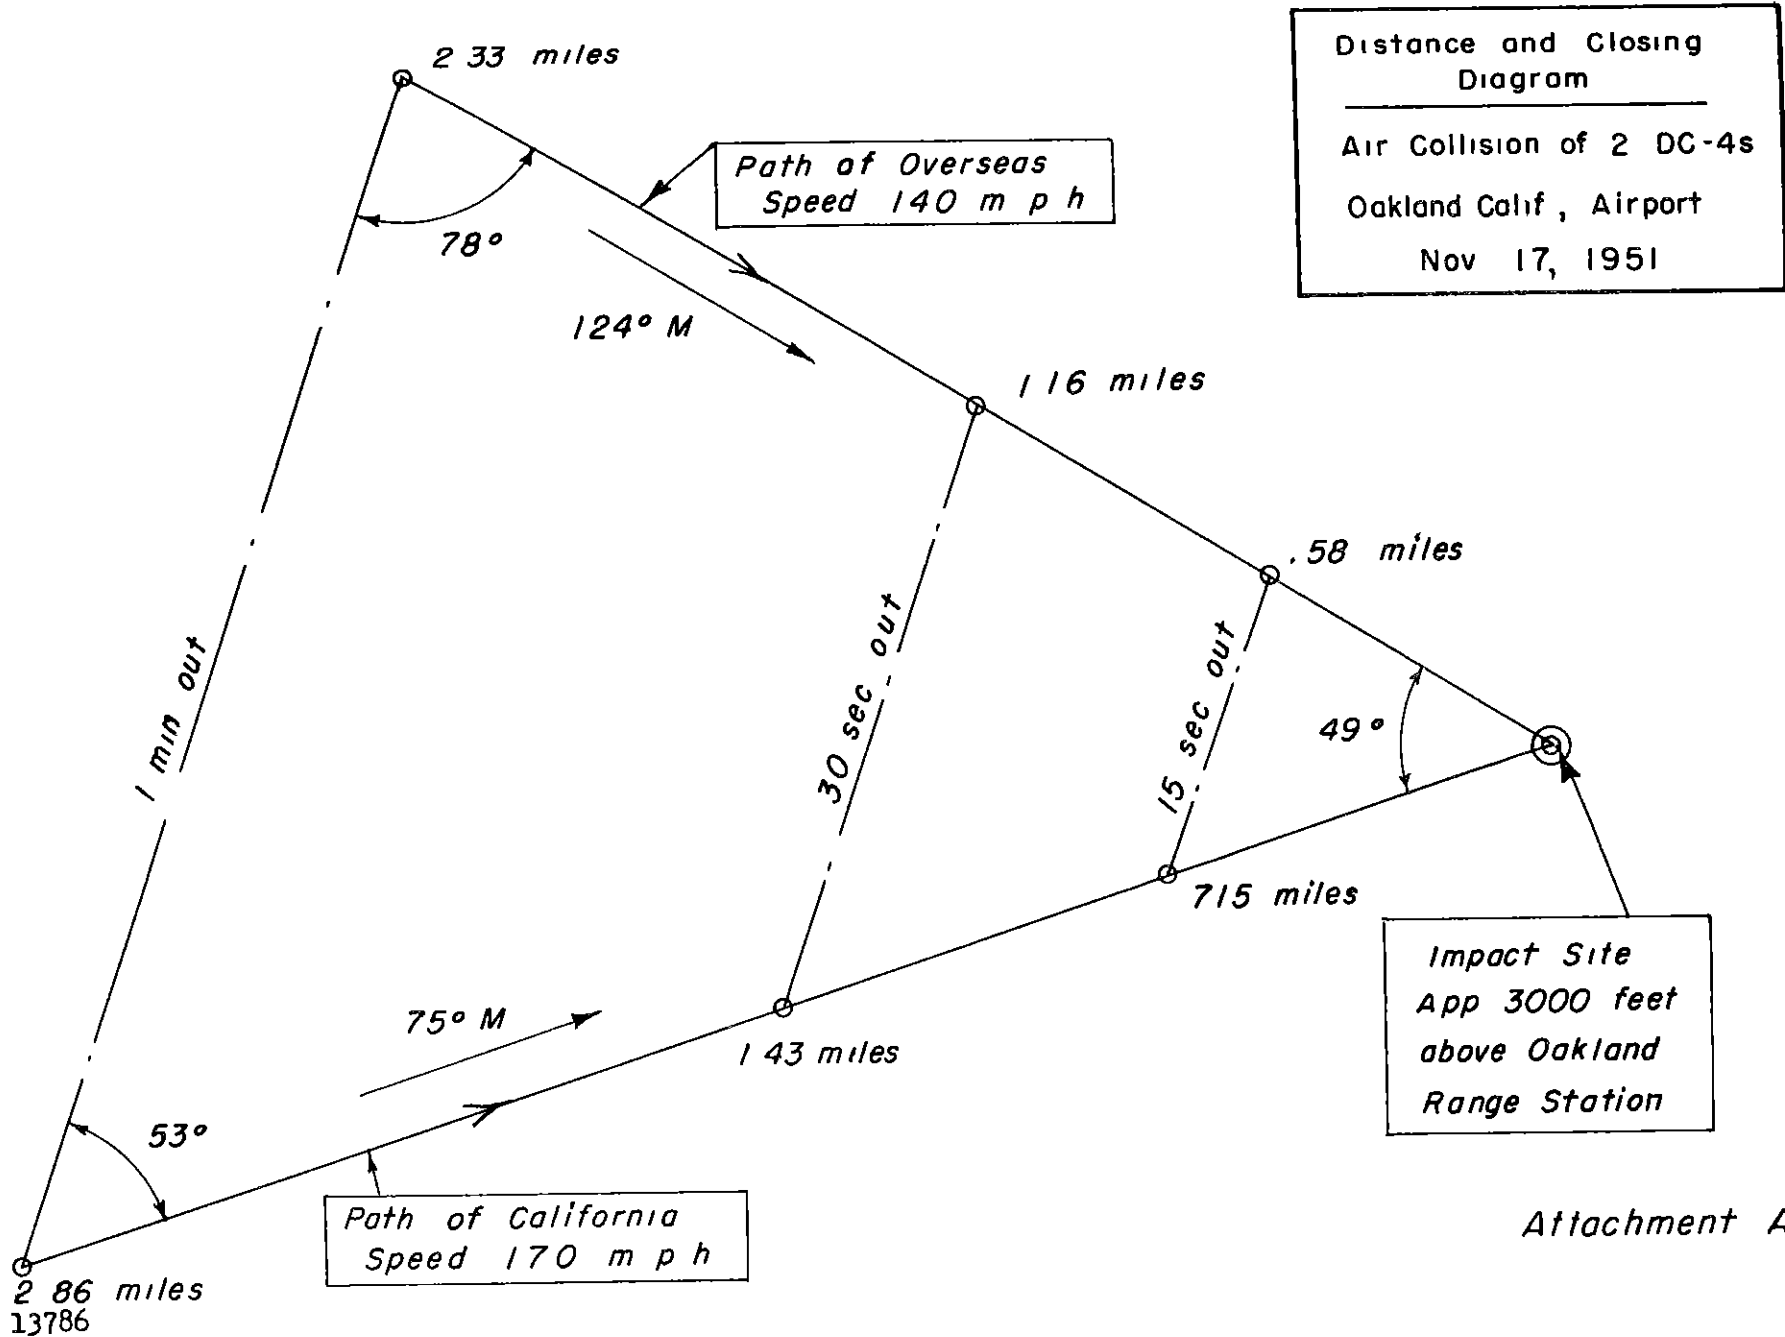
Shortly before 1013, the approximate time of the accident, both aircraft approached the Oakland low frequency radio range station, which is 0.2 mile northeast from the approach end of Runway 15 of the Oakland Airport. Overseas was on a magnetic heading of approximately 124 degrees inbound on the NW leg of the range; and California was homing on the range on a heading of 75 degrees M.^{4/} Both aircraft were at an altitude of 3,000 feet.

However, reference to Attachment A shows that Overseas, during the final stages of flight, was at a relative bearing of 53 degrees to the left of California, preventing its safety pilot from seeing Overseas.

As previously stated, California was on a heading of 75 degrees magnetic, which placed the aircraft to the right of Overseas. Thus, the safety pilot of California on the right side of the cockpit could not see more than 45 degrees to his left. As there was no observer stationed in the cabin, it is apparent that this flight could not see Overseas as both aircraft converged on the range station.^{8/} The fact that a mechanic working in the cabin of California did observe the other aircraft, but too late to alert the crew, is significant. Had an observer been on duty, the accident could have been averted. In fact, during the final stages of convergence both aircraft could have been plainly visible one from the other had safety requirements of adequate lookout from both aircraft been adhered to. Furthermore, had both flights followed their company practices of reporting to the tower immediately prior to arrival over the range station, the tower operator might well have prevented the collision.

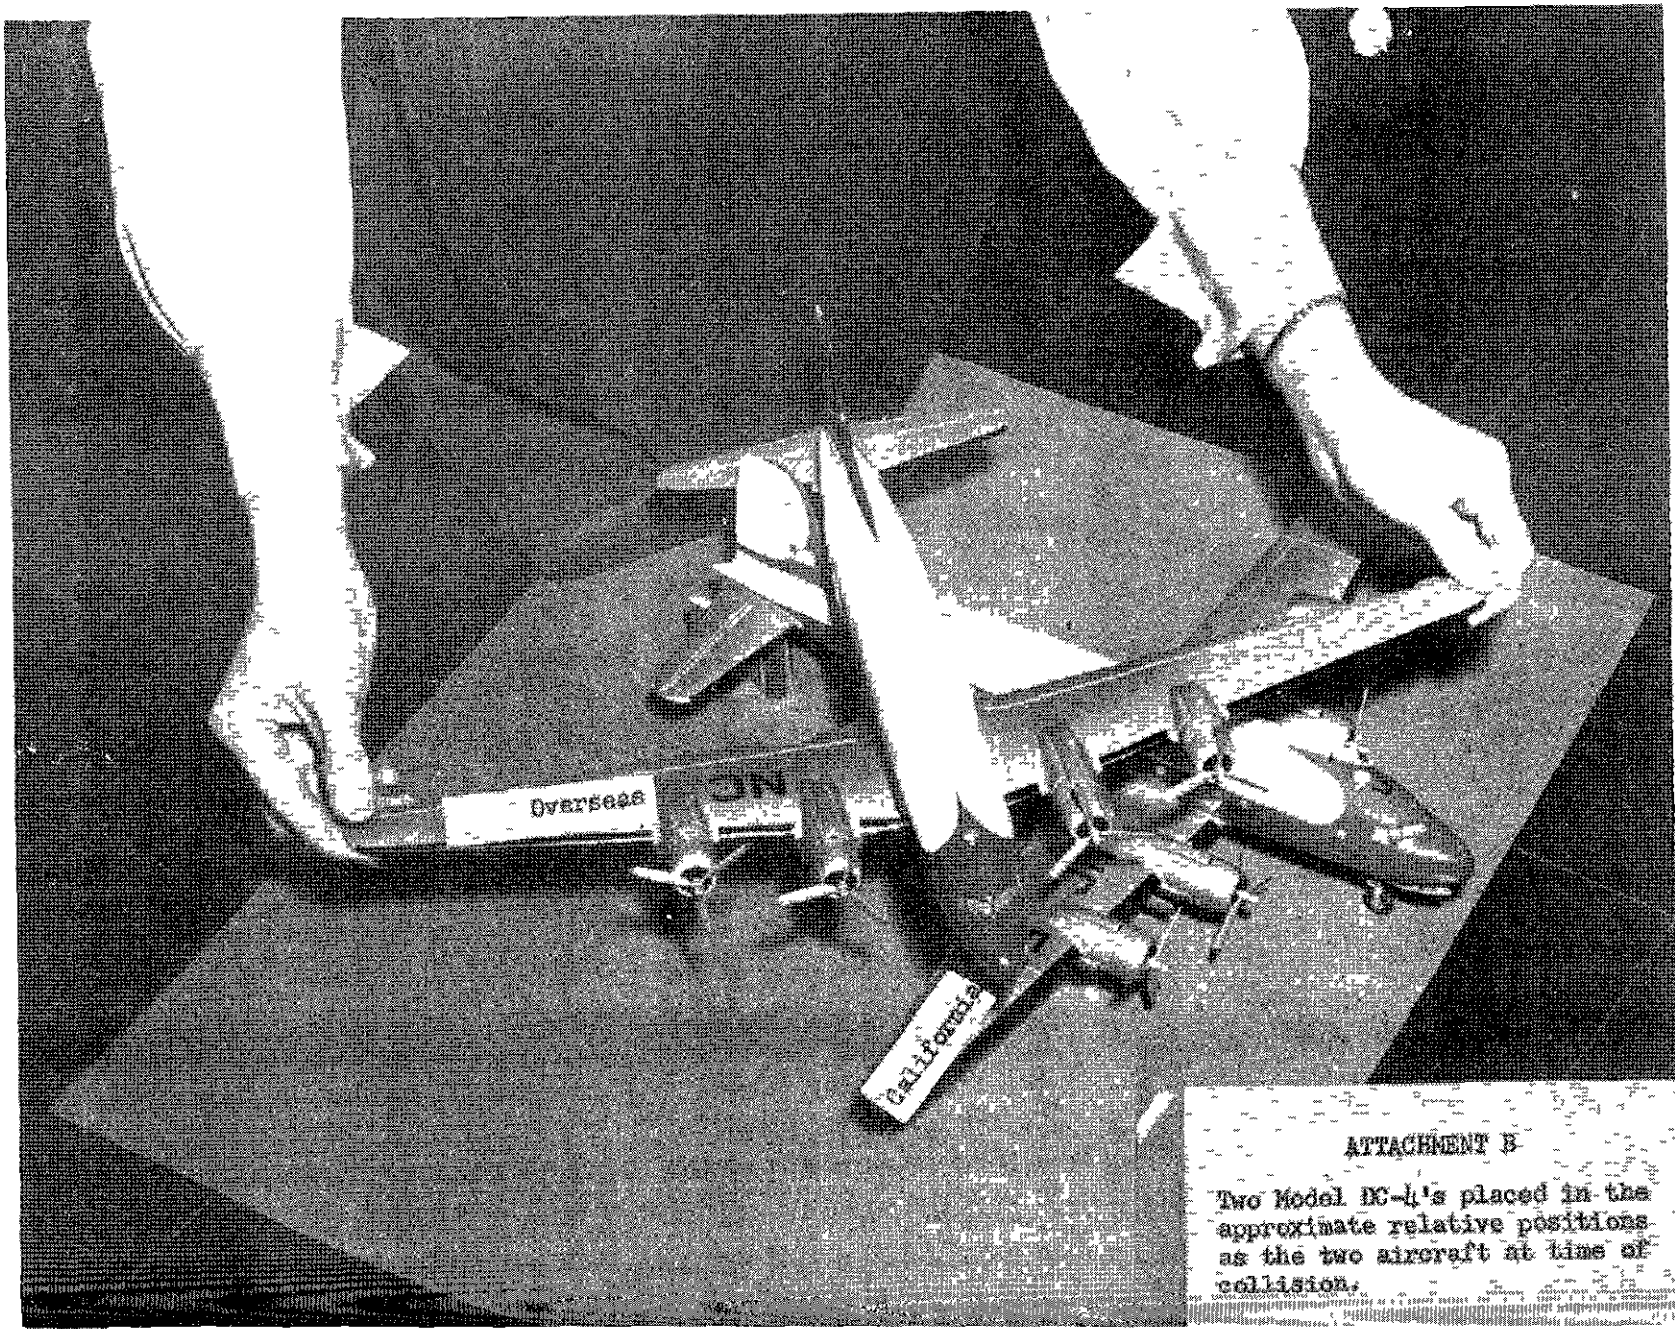
ATTACHMENT B

California was at a slightly lower altitude than Overseas, and contact was made between the leading edge of the vertical stabilizer of California and the right side of the fuselage of Overseas just forward of the horizontal stabilizer. Shortly after the collision, Overseas crashed out of control on Doolittle Drive, the highway paralleling the north side of Oakland Airport. Its three pilots were killed at the time of impact with the ground. A number of persons driving on the highway close to the impact site received burns of varying degrees, and several automobiles were destroyed by fire.

Inspection of Overseas' empennage, which had separated from the fuselage at a point just forward of the horizontal stabilizer's leading edge, disclosed aluminum paint marks running in the horizontal direction on the rubber de-icer boot of the right horizontal stabilizer, starting about eleven feet in from the tip and continuing inboard to where the de-icer boot was torn free near the inboard end. The inboard portion of the leading edge of the right horizontal stabilizer was flattened. The fuselage had been struck on the right side about on a line with the leading edge of the horizontal stabilizer. Blue paint marks were found on the fuselage in this area.

Further examination of Overseas' rear fuselage disclosed a twenty foot length of antenna wire lodged in a tear in the side-skin at station No. 920. This wire was of a stranded type and was positively identified as having come from the top antenna of California. All control cables which passed through the damaged rear fuselage area were severed by impact forces or by subsequent tearing forces damaged as the tail unit left the aircraft.^{5/}

Two Model DC-4's placed in the approximate relative positions as the two aircraft at time of collision.
