CIVIL AERONAUTICS BOARD

ACCIDENT INVESTIGATION REPORT

MIAMI AIRLINE, INC.—ELIZABETH, NEW JERSEY, DECEMBER 16, 1951**THE ACCIDENT**

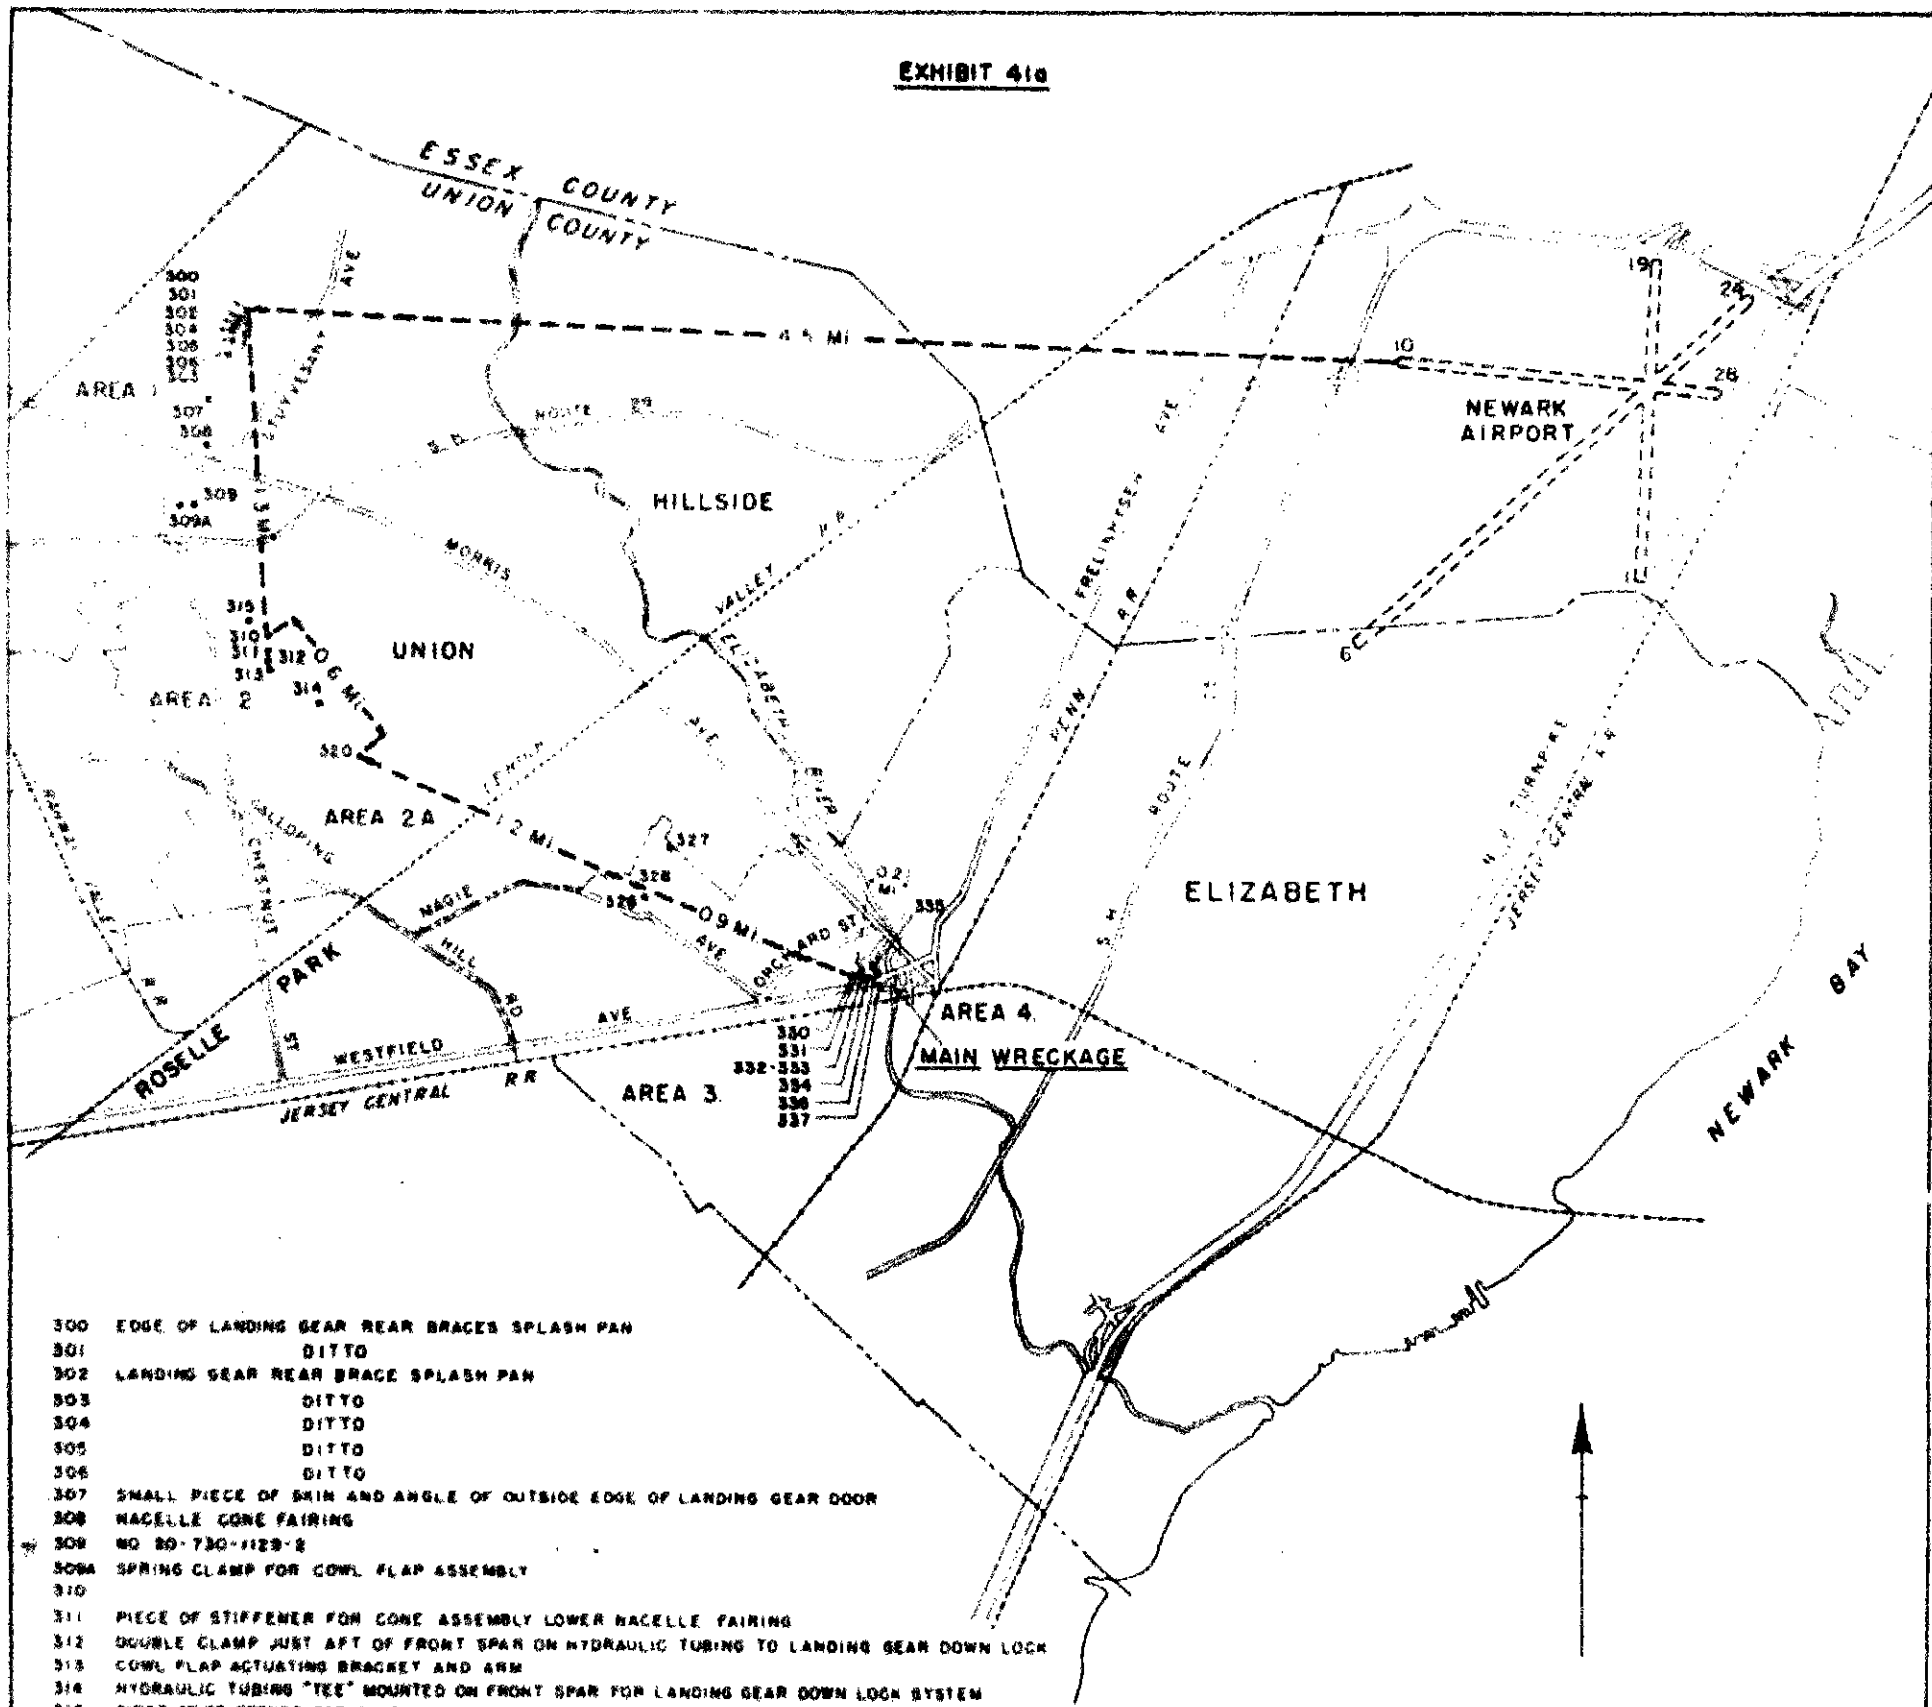
EXHIBIT 41a

- 300 EDGE OF LANDING GEAR REAR BRACES SPLASH PAN
- 301 DITTO
- 302 LANDING GEAR REAR BRACE SPLASH PAN
- 303 DITTO
- 304 DITTO
- 305 DITTO
- 306 DITTO
- 307 SMALL PIECE OF SKIN AND ANGLE OF OUTSIDE EDGE OF LANDING GEAR DOOR
- 308 NACELLE CONE FAIRING
- 309 NO 80-730-1128-2
- 309A SPRING CLAMP FOR GOWL FLAP ASSEMBLY
- 310
- 311 PIECE OF STIFFENER FOR CONE ASSEMBLY LOWER NACELLE FAIRING
- 312 DOUBLE CLAMP JUST AFT OF FRONT SPAR ON HYDRAULIC TUBING TO LANDING GEAR DOWN LOCK
- 313 COWL FLAP ACTUATING BRACKET AND ARM
- 314 HYDRAULIC TUBING "TEE" MOUNTED ON FRONT SPAR FOR LANDING GEAR DOWN LOCK SYSTEM
- 315 PIECE OF STIFFENER FOR CONE ASSEMBLY LOWER NACELLE FAIRING

- 320 REAR LEFT SIDE OF RIGHT NACELLE SKIN AT CORNER OF WHEEL DOOR

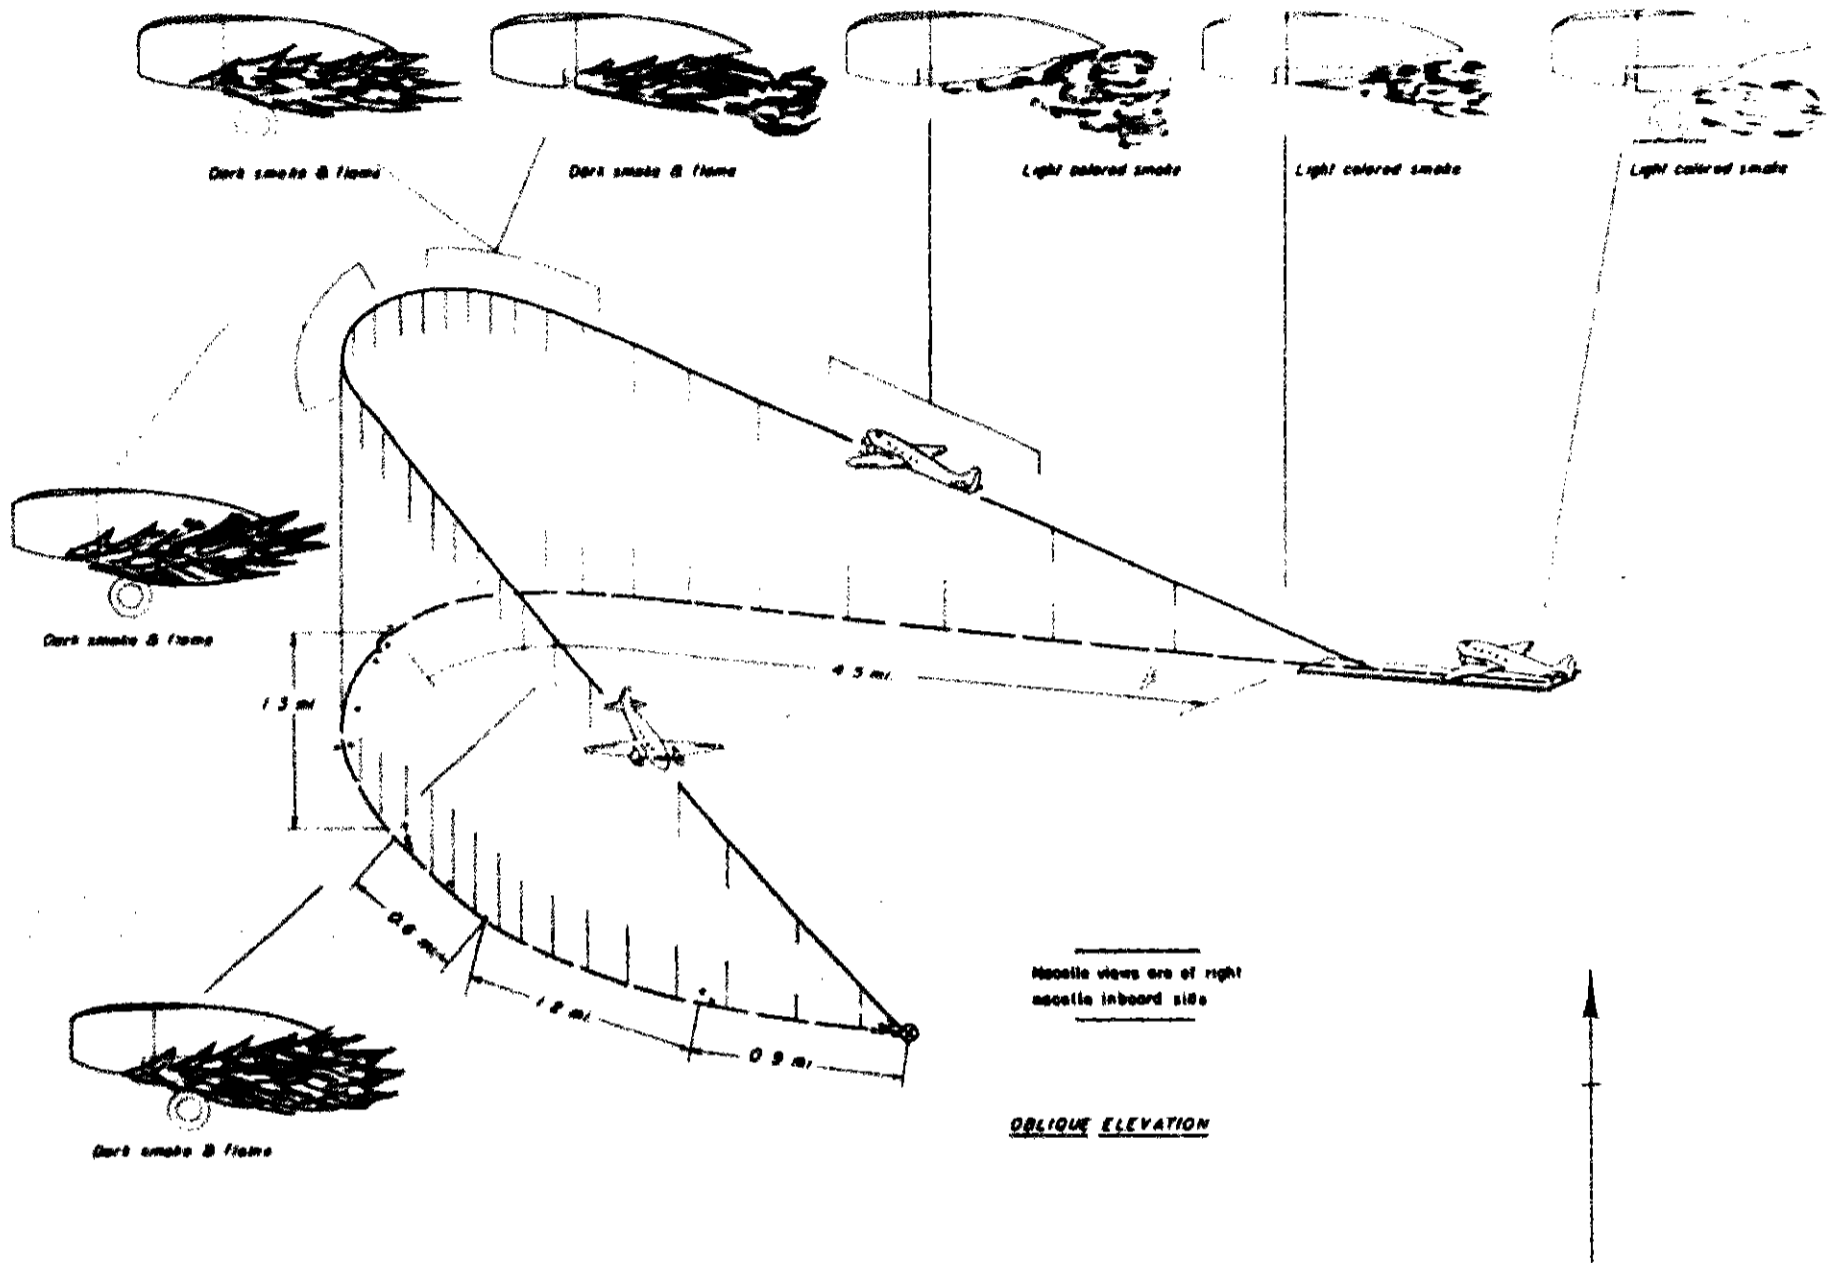
PROBABLE FLIGHT PATH BASED ON DISTRIBUTION OF WRECKAGE
AND OBSERVATIONS OF WITNESSES

Obs. aft approx 1000' on left descending turn, gear on obs. intense flame rt eng. Obs. flame go out, immediate recognition of increased volume and intensity

Obs. aft almost overhead - stream gray smoke rt eng gear up - then obs. bright orange flame rt eng

Obs. aft overhead - flame rt eng - as aft passed over rt wing 'folded up' - aft. dropped - fell direct down out of sight
