CIVIL AERONAUTICS BOARD

ACCIDENT INVESTIGATION REPORT

ROBIN AIRLINES, INC. - COBOURG, ONTARIO, CANADA, DECEMBER 20, 1951

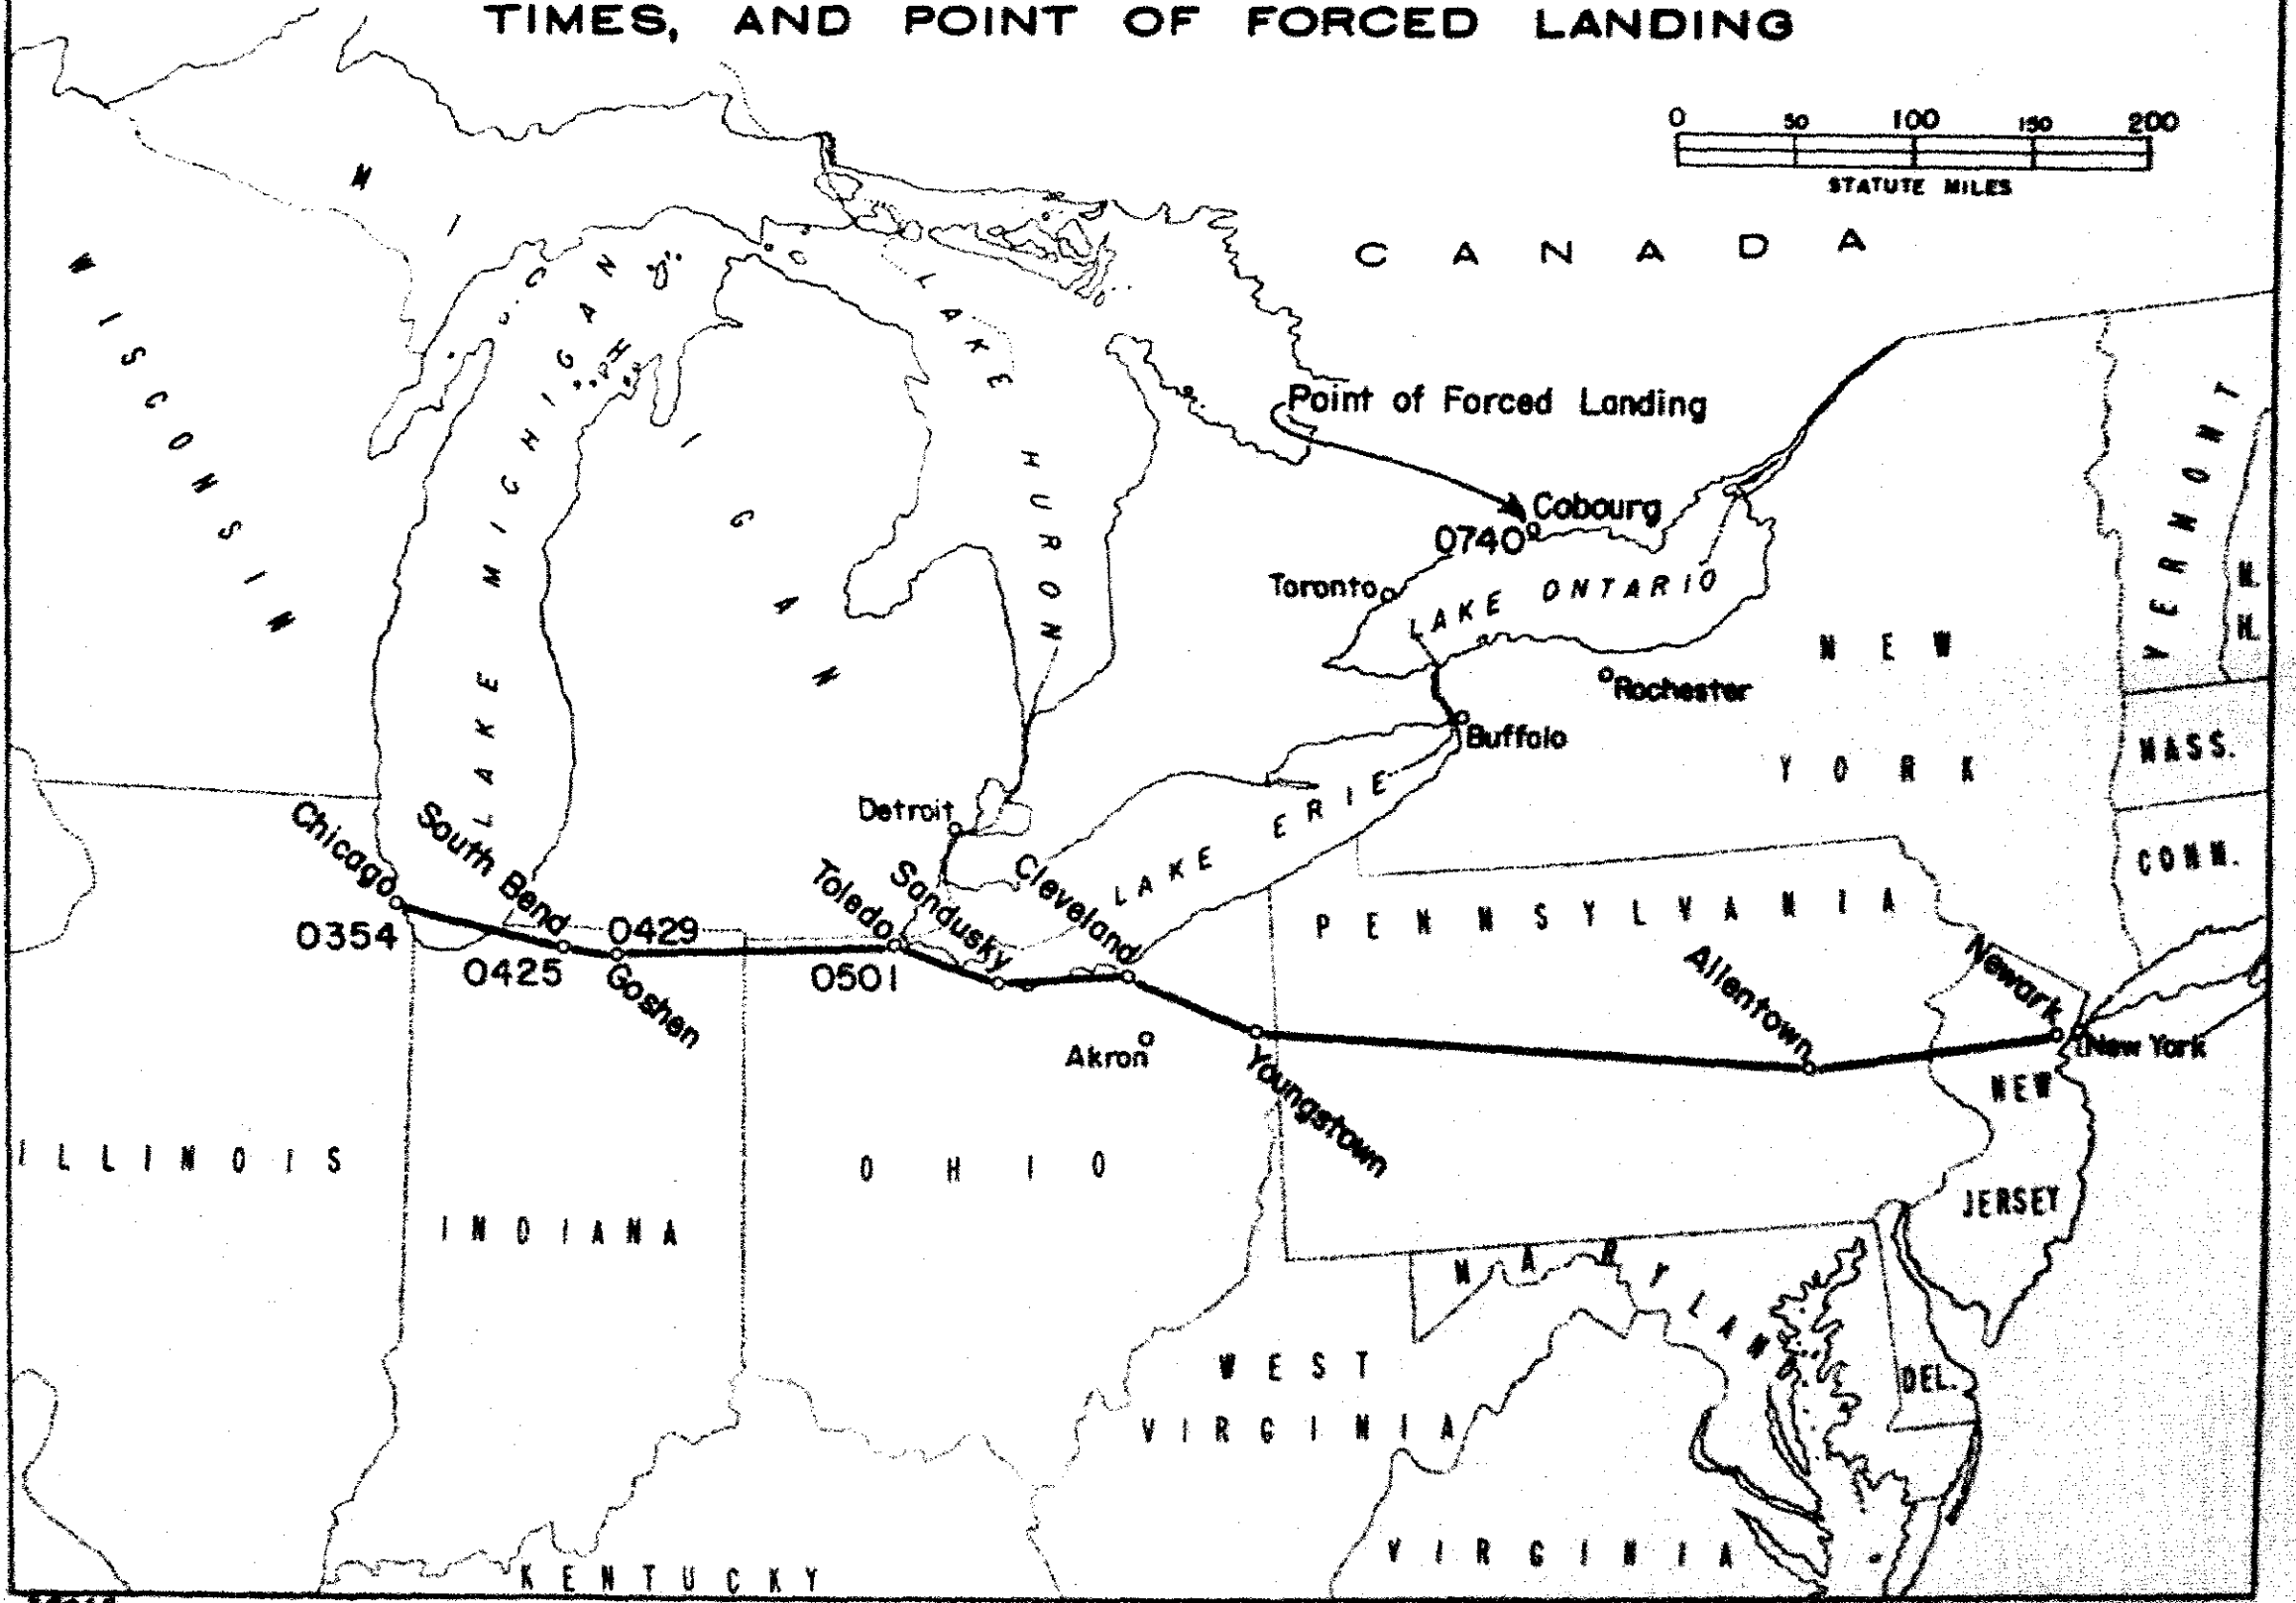
APPENDIX "A"

At 0750, Rochester communications station advised that the pilot of N-59487 had telephoned to report that the flight had made a forced landing near Cobourg, Ontario, Canada, with no injuries to the crew or the passengers. (See Appendix "A".)

MAP SHOWING INTENDED ROUTE, REPORTED TIMES, AND POINT OF FORCED LANDING
