## CIVIL AERONAUTICS BOARD

**ACCIDENT INVESTIGATION REPORT**

TRANSOCEAN AIR LINES - NEAR FAIRBANKS, ALASKA, DECEMBER 30, 1951

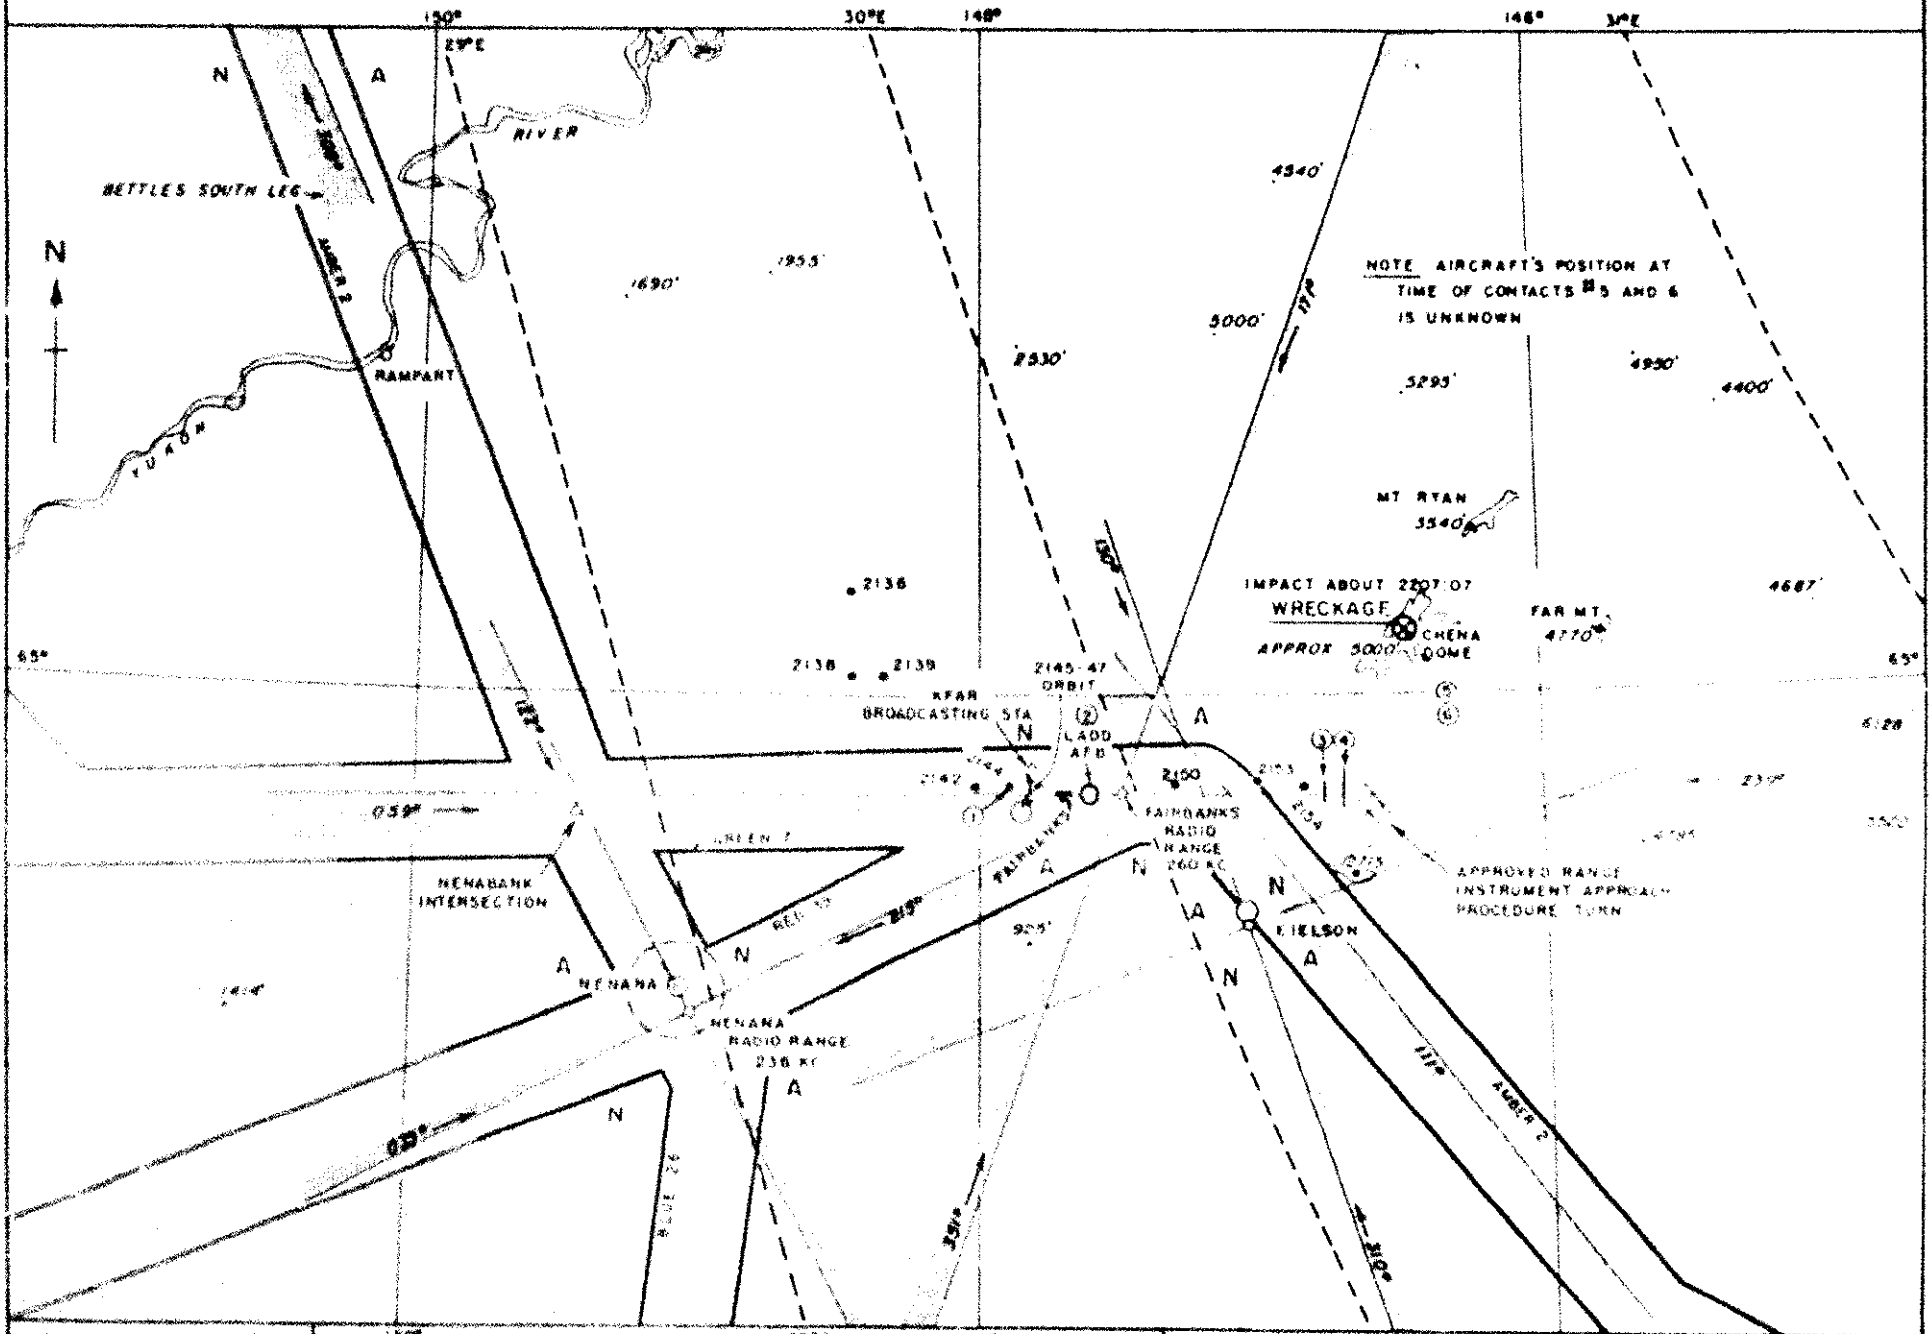
**ATTACHMENT I**  
**SHOWING AIRCRAFT RADIO CONTACTS AND RADAR PLOTS**  
**RELATIVE TO ACCIDENT**  
**TRANSOCEAN AIR LINES C-46F; N68963 NEAR FAIRBANKS, ALASKA - DEC. 30, 1951**

Radar plots were obtained of Flight 501 South in the Fairbanks area.<sup>3/</sup> The first plot placed the aircraft in the N quadrant approximately 35 miles northwest of the Fairbanks radio range station. Upon intercepting the west leg of the range at 2142, the flight was plotted on or near the east and west legs for 12 minutes; the aircraft circled near the commercial broadcasting station KFAR, located five miles west-northwest of Fairbanks, between 2145 and 2147, and passed over the Fairbanks radio range station between 2148 and 2149. At 2157 the target faded from the radar scope. Examination of this flight path indicates that the aircraft turned to the left into the mountainous area. There was no instrument procedure specified for the Fairbanks range which authorized such a left turn, nor has the procedure been modified since the accident.

According to the radar plots, at 2144 the flight was only 12 miles west of Fairbanks, or about 60 miles southeast of the 2144 estimated position. It is apparent that the pilot was estimating his position when he reported at 2144 that he was 25 miles northwest of Nenabank intersection. At 2136, radar plotted the flight's position approximately 38 miles east of the 2144 reported position.

5. The flight was considerably off course when initially positioned by radar, and was shortly thereafter plotted on the west and east legs of the Fairbanks range for 12 minutes.
