## CIVIL AERONAUTICS BOARD

**ACCIDENT INVESTIGATION REPORT**

NORTHWEST AIRLINES, INC., - SANDSPIT, BRITISH COLUMBIA,  
JANUARY 19, 1952

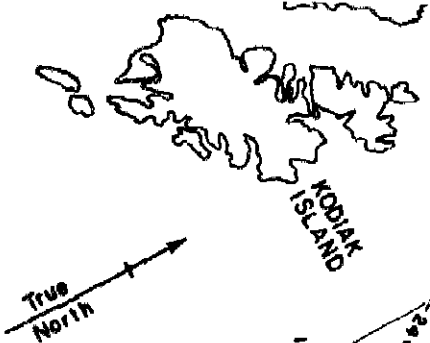
ATTACHMENT I

RADIO CONTACTS, FLIGHT 324

- 9- Southwest leg Gustavus range 2330, 8,000', estimating southwest leg of Sitka range at 2357 (2335)
- 10- No. 1 propeller feathered, proceeding to Sandspit (0003, 1-19-52)

- 13- Oil cooler No. 1 engine broken Proceeding to Sandspit (0029)
- 14- NWA Flight Control, through CAA communications relay, asked Flight 324 if it was proceeding to Sandspit and advised that Seattle weather was satisfactory Message not delivered to flight. (0040)

- 19- Flight 324 contacted Sandspit radio during initial approach. Last radio contact with the flight Crashed at approximately 0138

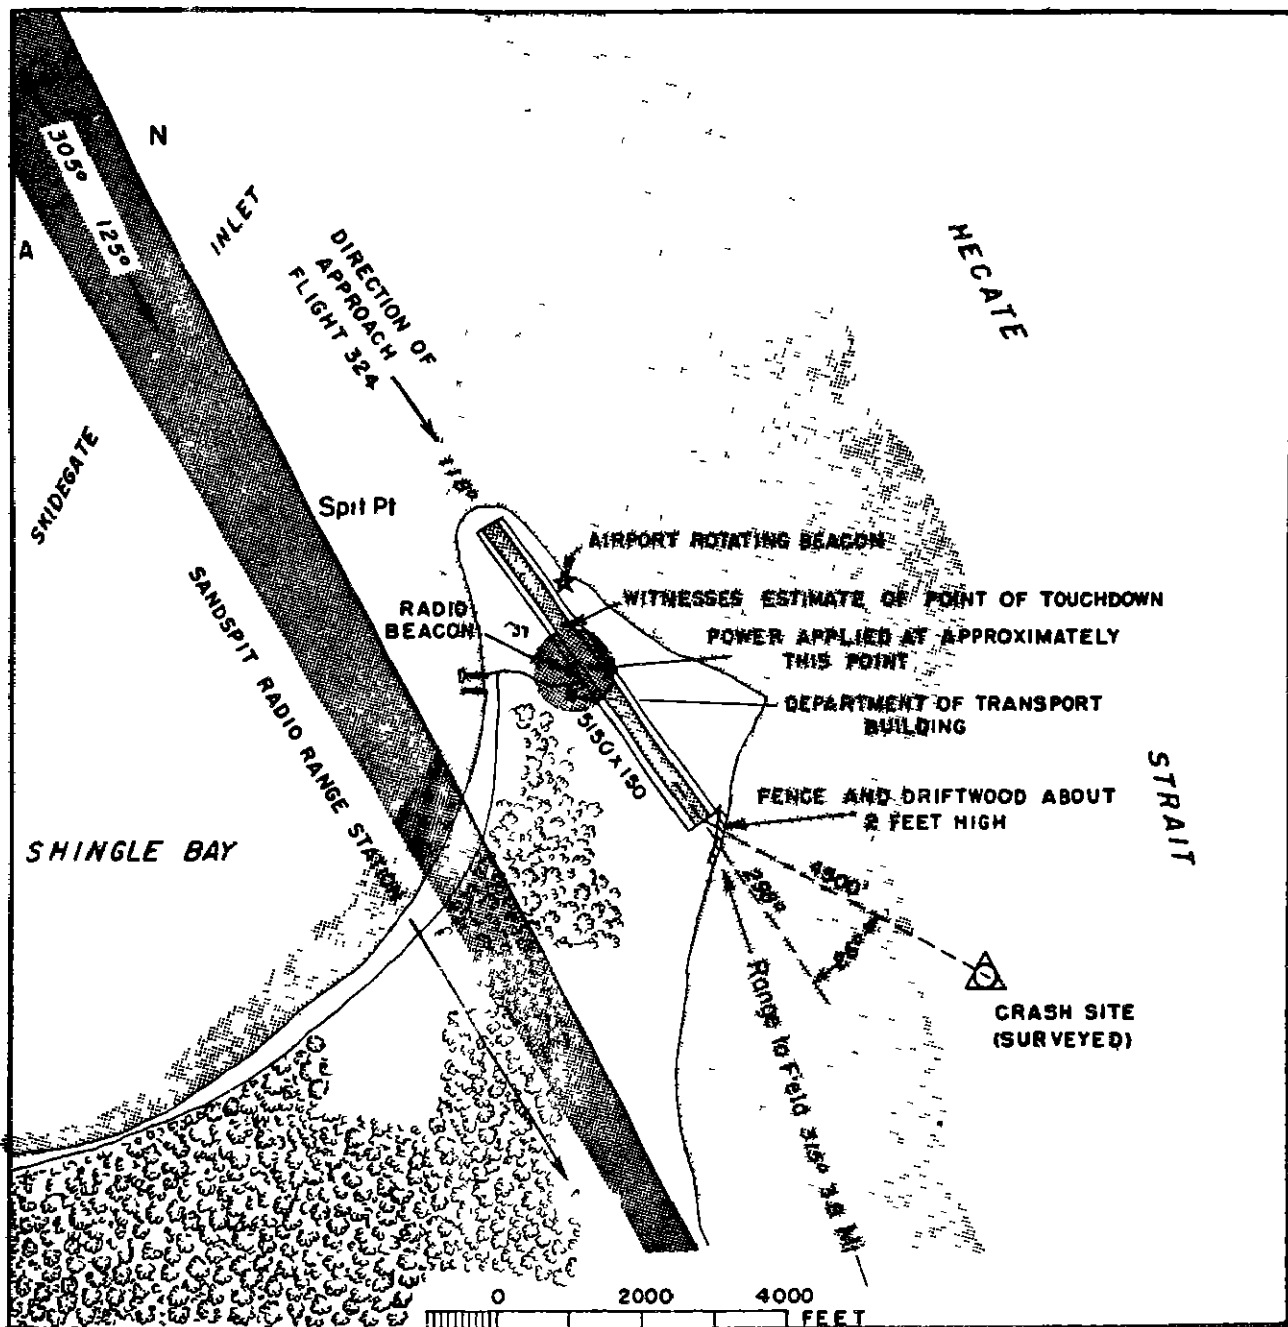
ATTACHMENT II

6. During the attempted climbout, the aircraft settled into the water, bounced, and came to rest 26 degrees to the left and approximately 4,500 feet from the end of the runway.

**NORTHWEST AIRLINES, INC , ACCIDENT SANDSPIT, B. C.  
 JANUARY 19, 1952  
 SANDSPIT FLIGHT STRIP**
