CIVIL AERONAUTICS BOARD

ACCIDENT INVESTIGATION REPORT

BRANIFF AIRWAYS, INC., NEAR HUGOTON, KANSAS, MARCH 26, 1952

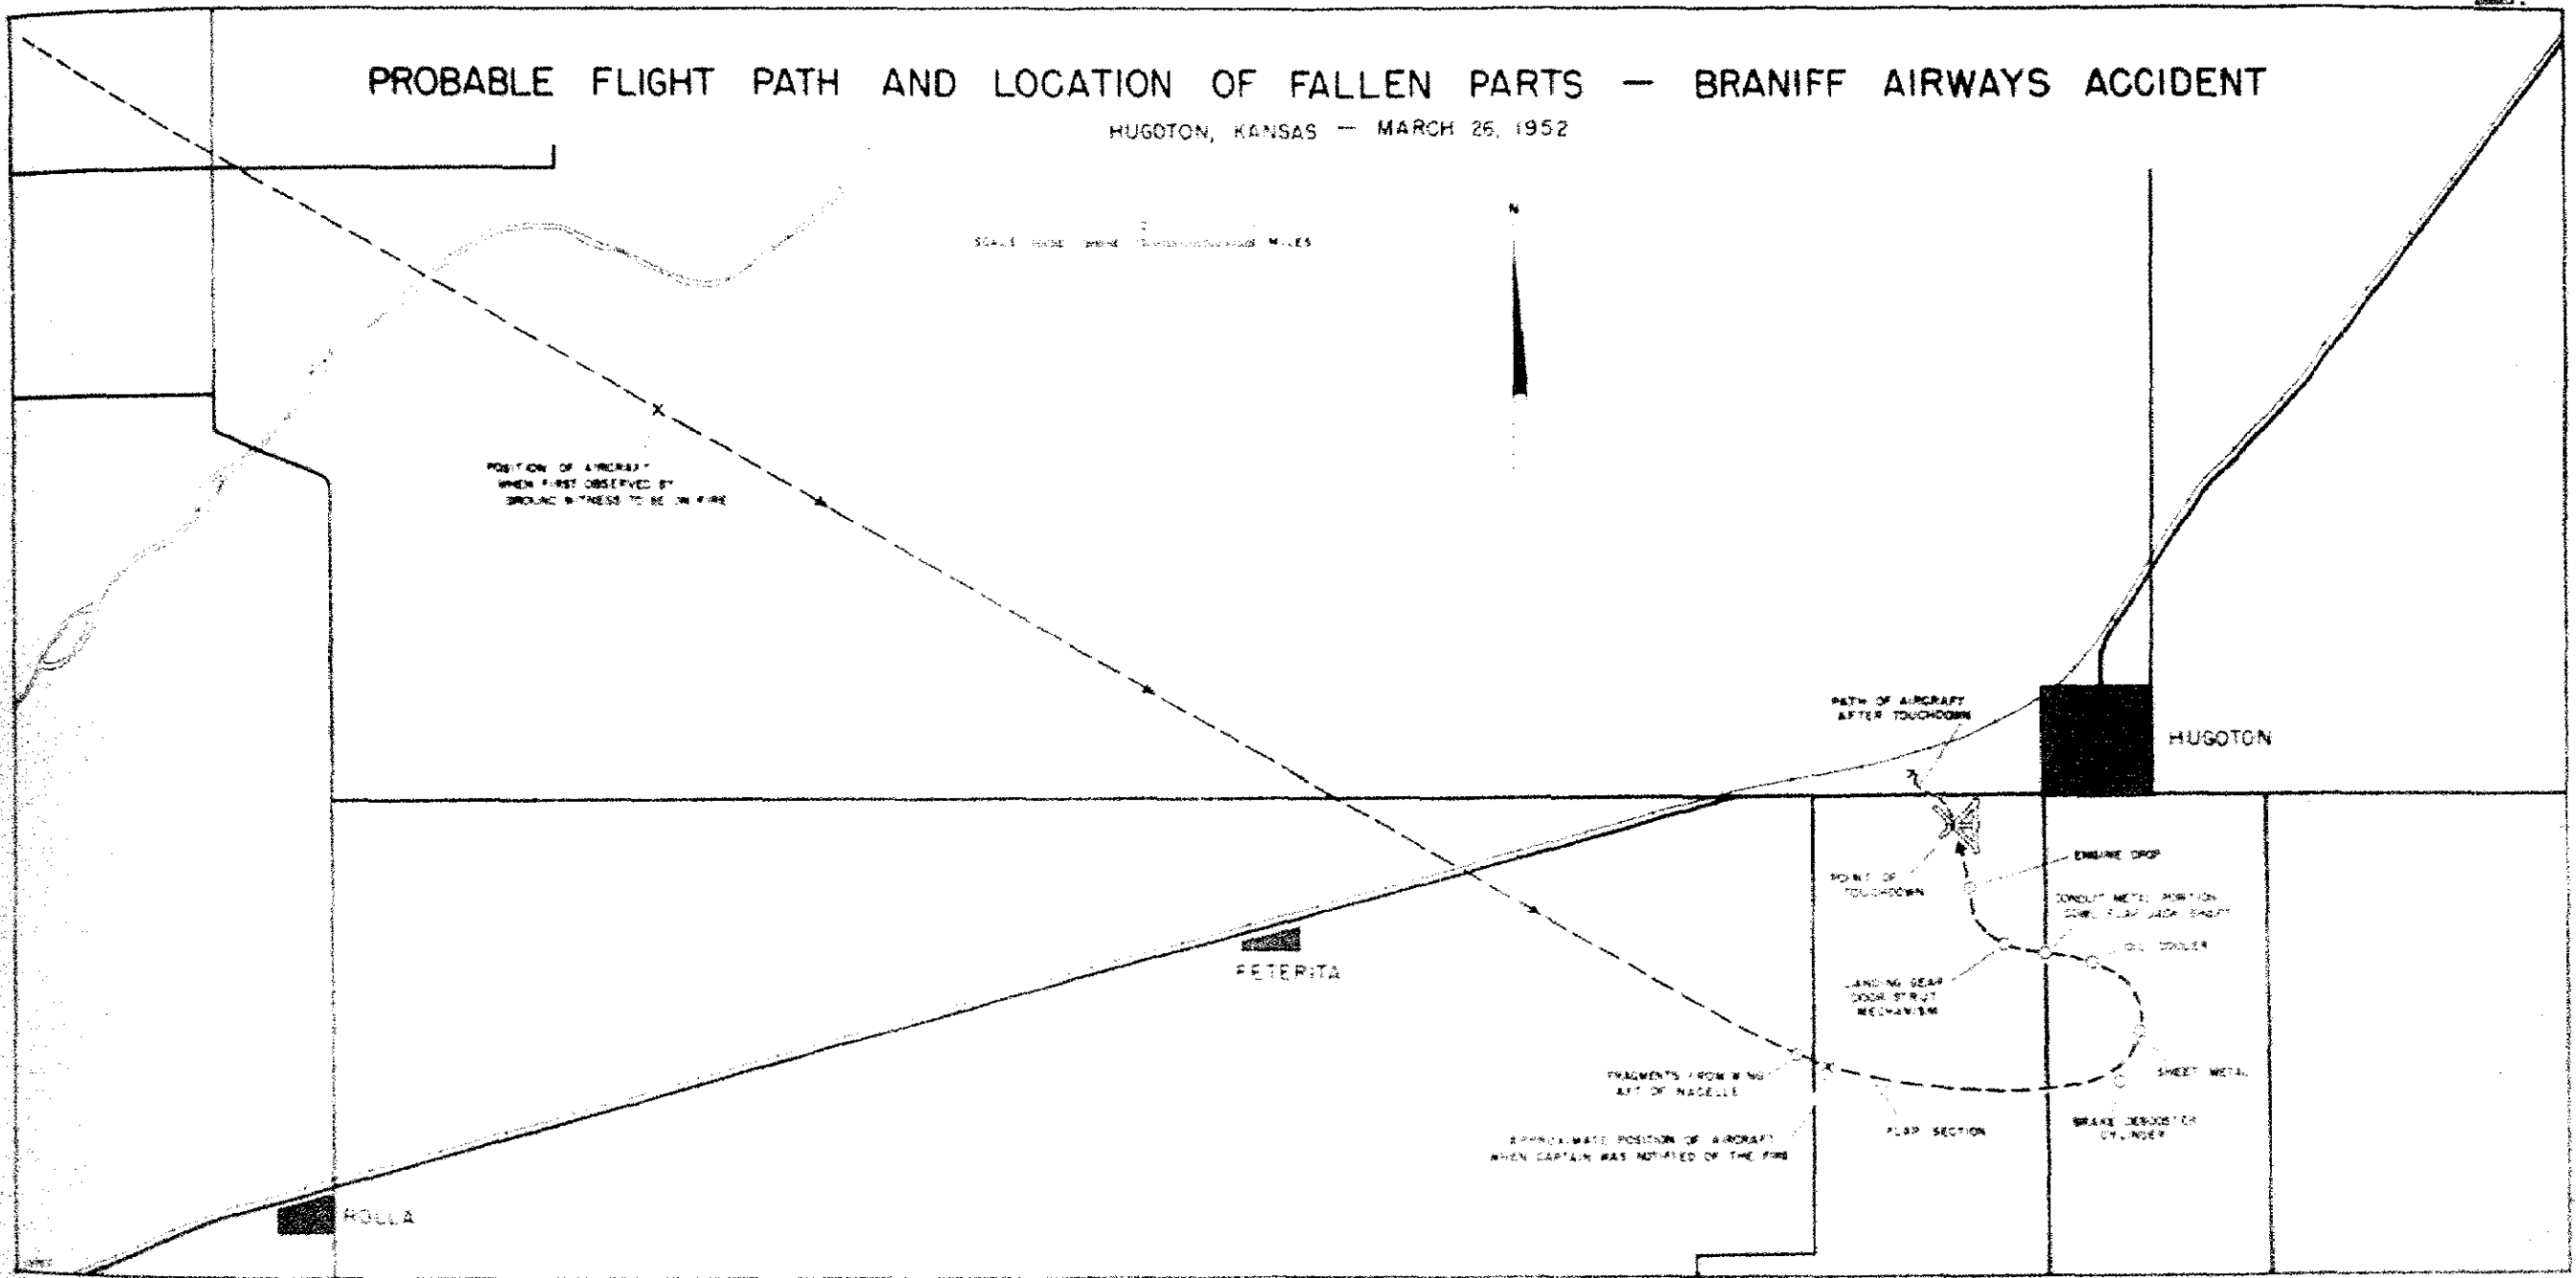
PROBABLE FLIGHT PATH AND LOCATION OF FALLEN PARTS — BRANIFF AIRWAYS ACCIDENT

Other witnesses said that when the aircraft was approaching the airport at an altitude estimated to be about 300 feet above the ground, they saw the burning No. 3 engine fall from the aircraft. This engine was found approximately one mile southeast of the airport. Related parts to this engine, its nacelle, and a portion of the skin on the underside of the right flap were also found back along the flight path for a distance of $2\frac{1}{2}$ miles.^{2/}
