CIVIL AERONAUTICS BOARD

ACCIDENT INVESTIGATION REPORT

ACCIDENT INVOLVING CESSNA 140, N 72505 - PHILIP BILLARD AIRPORT
TOPEKA, KANSAS, MAY 12, 1952

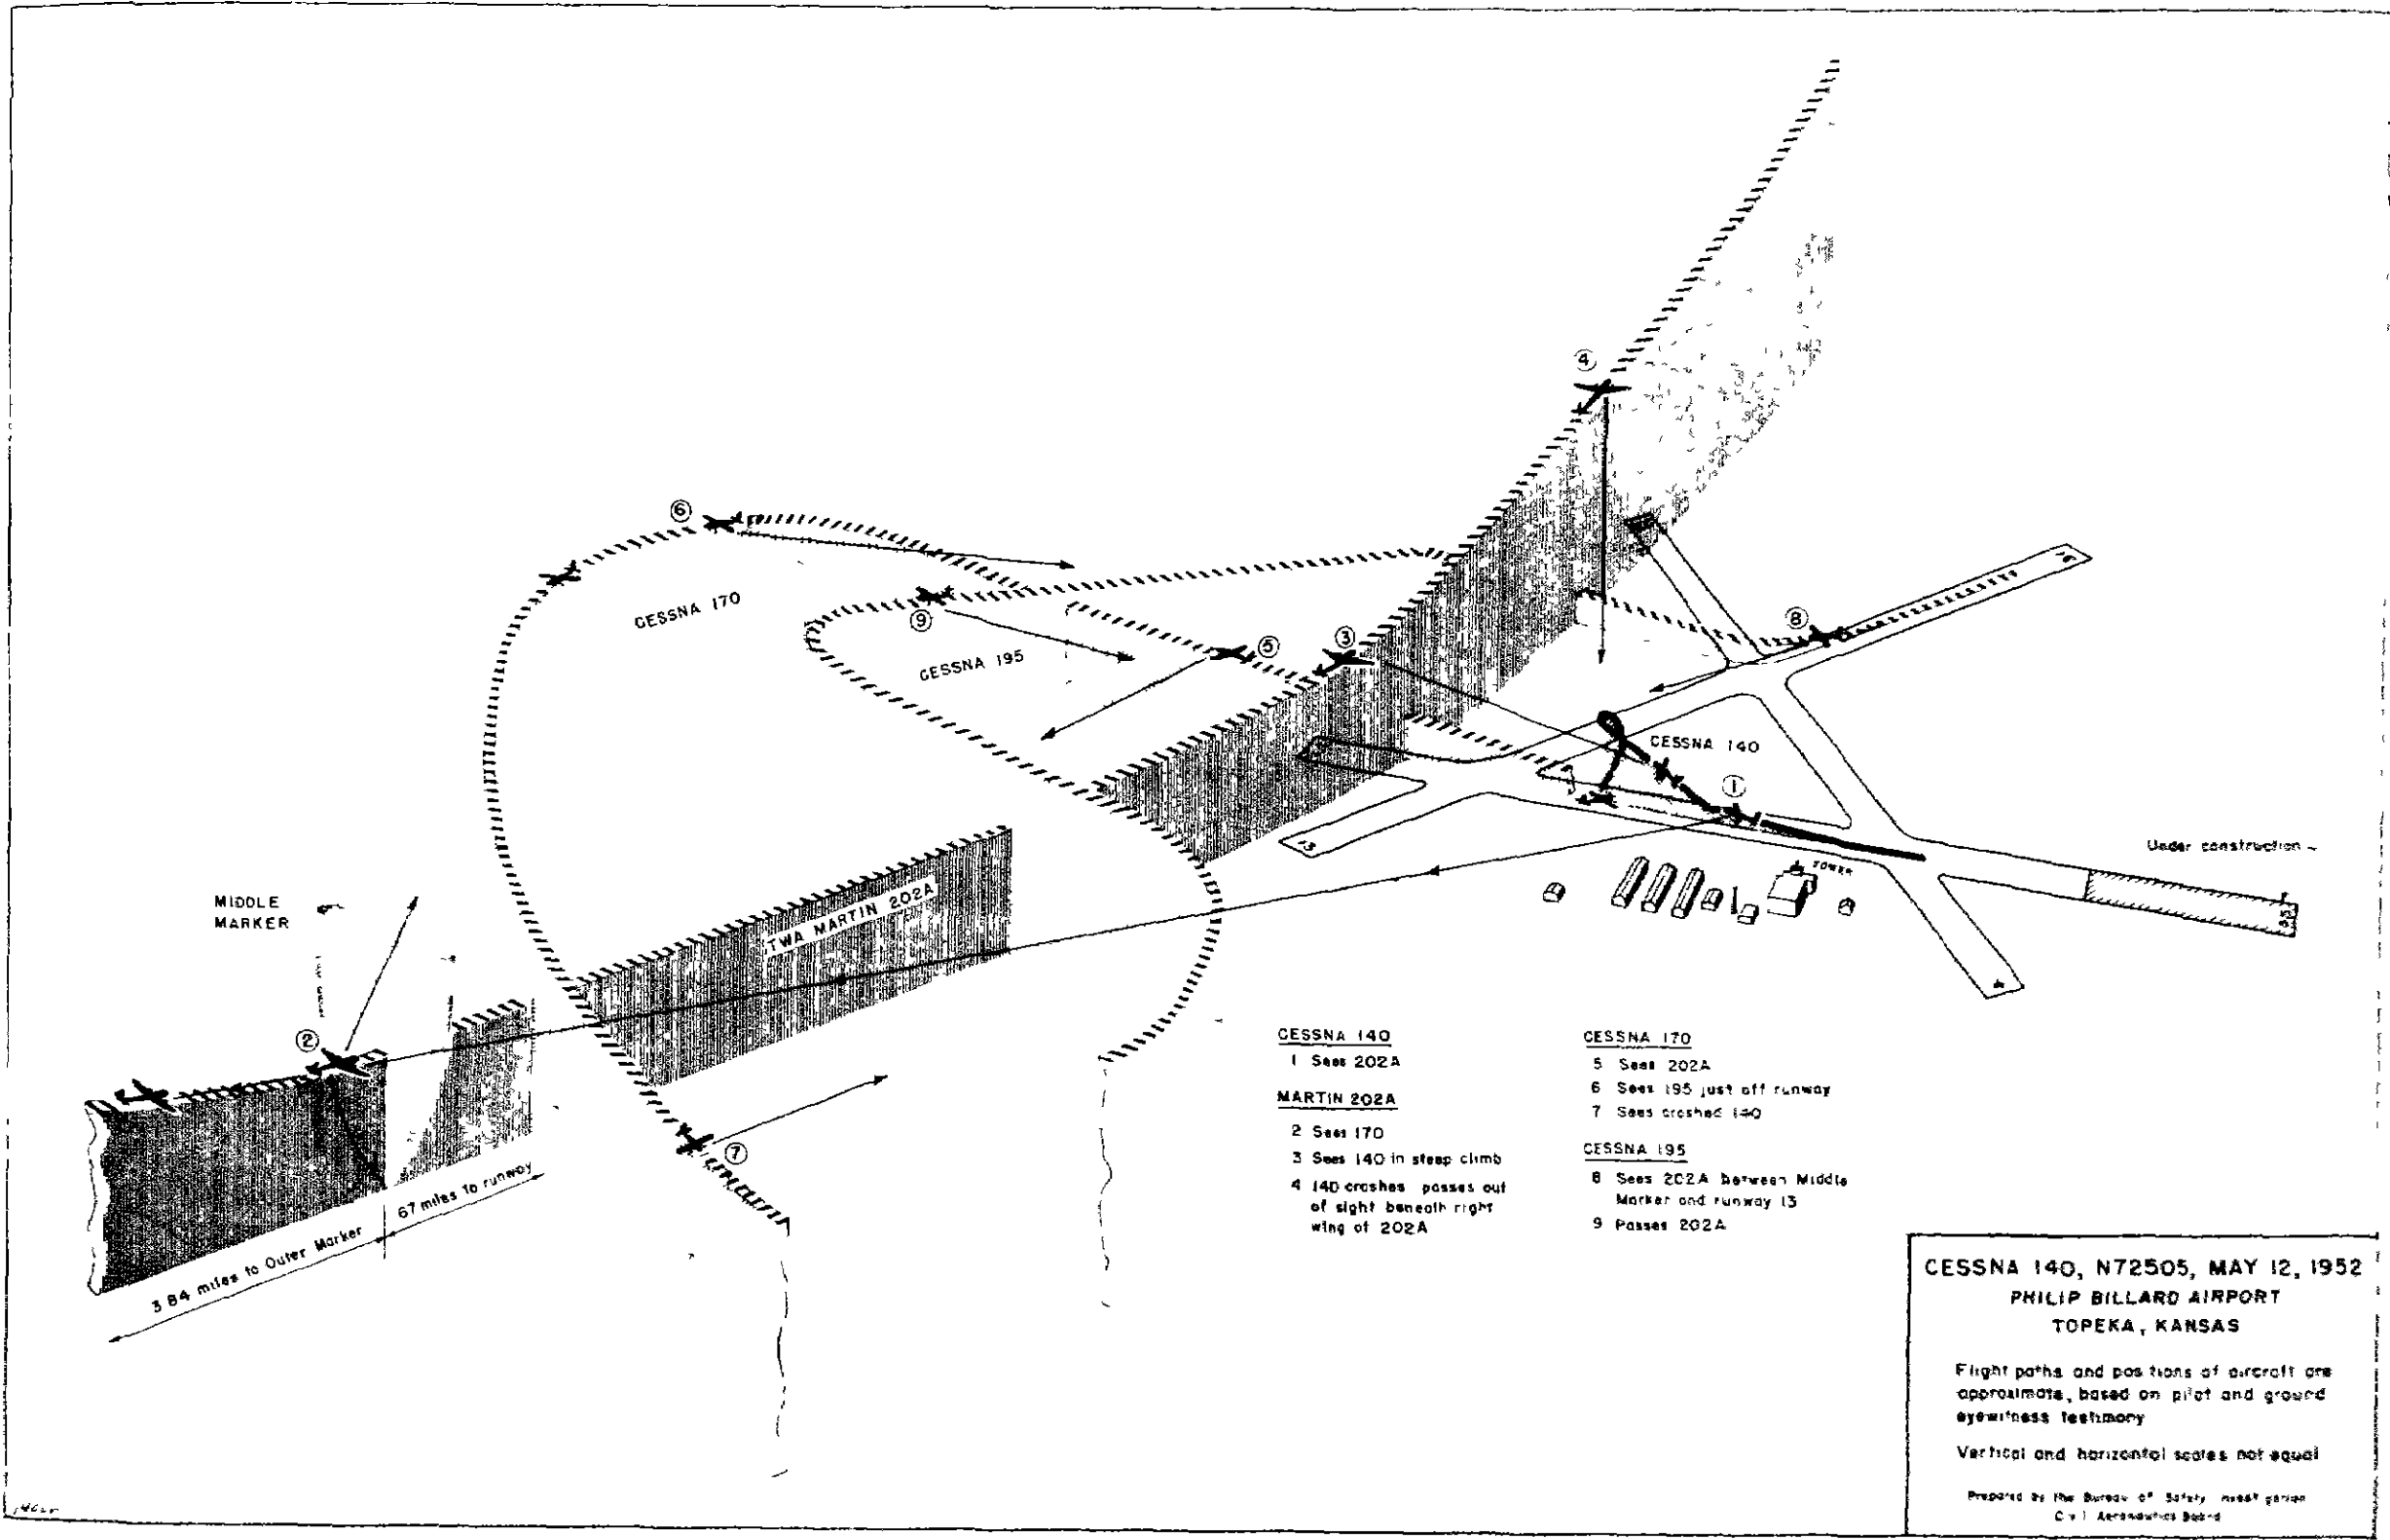
CESSNA 140, N72505, MAY 12, 1952
PHILIP BILLARD AIRPORT
TOPEKA, KANSAS

- 2 Sees 170
- 3 Sees 140 in steep climb
- 4 140 crashes passes out of sight beneath right wing of 202A

- 5 Sees 202A
- 6 Sees 195 just off runway
- 7 Sees crashed 140

- 8 Sees 202A between Middle Marker and runway 13
- 9 Passes 202A

Flight paths and positions of aircraft are approximate, based on pilot and ground eyewitness testimony
