CIVIL AERONAUTICS BOARD
ACCIDENT INVESTIGATION REPORT

Adopted: October 29, 1952

PAN AMERICAN WORLD AIRWAYS, INC. - NEAR RIO DE JANEIRO, BRAZIL,
JULY 27, 1952

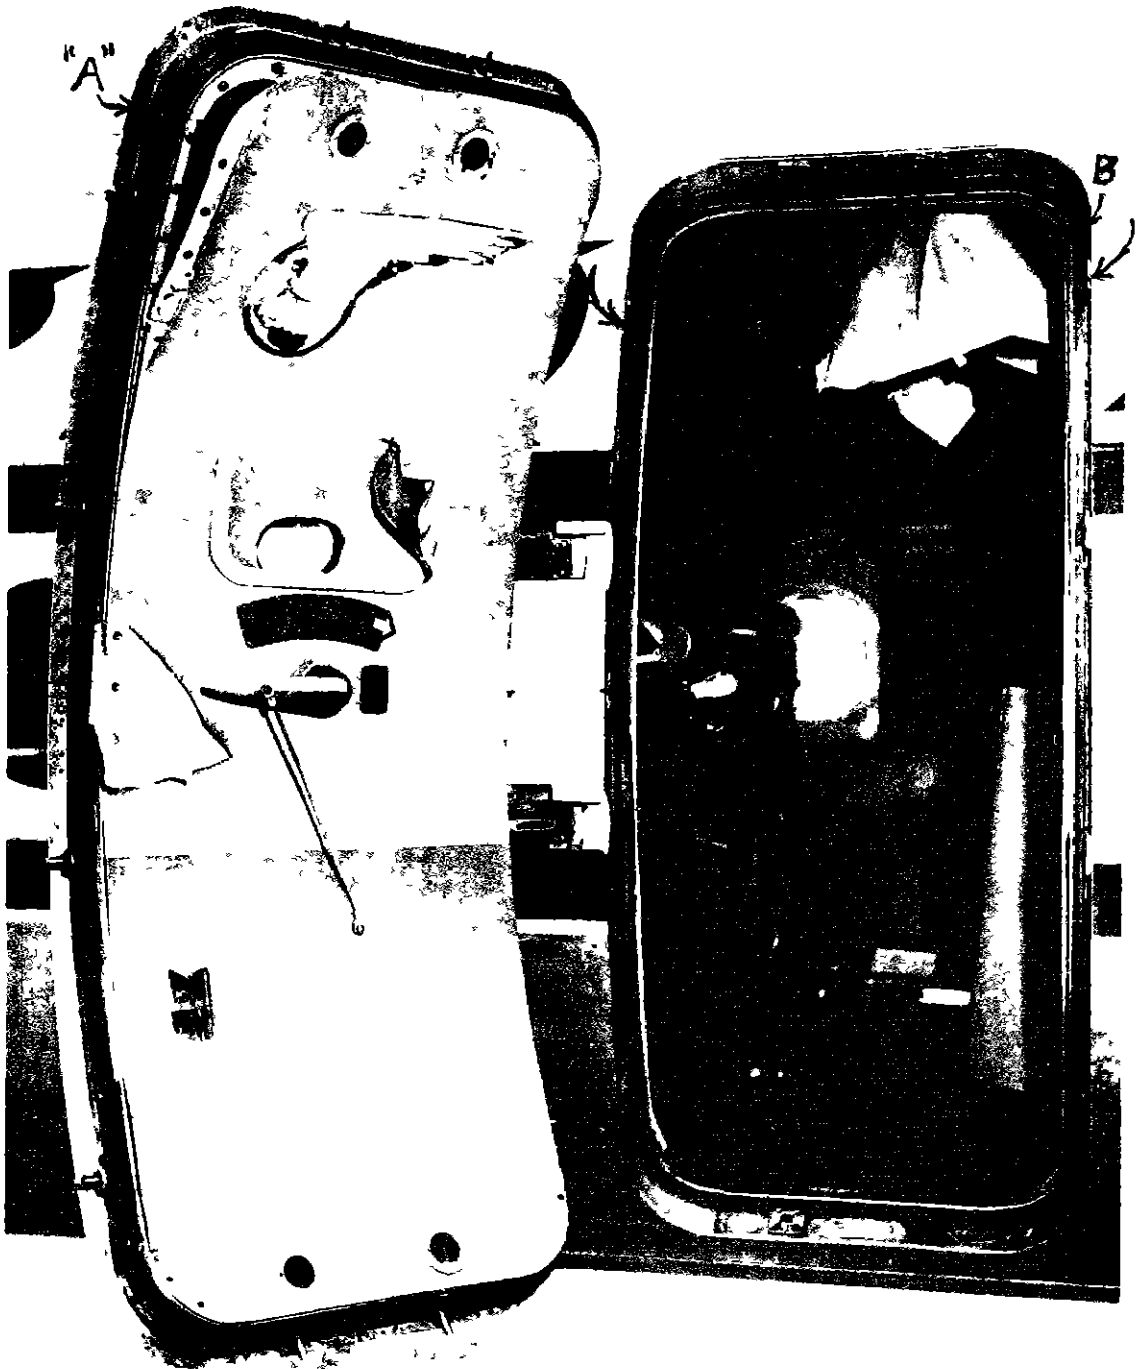
ATTACHMENT "A" - Exhibit 4B-1

Examination of the cabin main entrance door was made at Rio de Janeiro. Damage to the door was confined to downward distortion of both hinges, a cracked lower hinge and three rivets missing from the lower hinge. The forward

edge of the aluminum metal window frame in the door was distorted rearward, and a small section of upholstering fabric at the center rear edge was missing. A deep indentation and slight displacement of the rubber door seal near the door's upper rear corner was found and there was a small indentation of the rubber seal near the door's lower rear corner.

Damage to the door frame was confined to a slight depression of the frame metal near the upper rear corner. The rubber seal across the top of the frame was missing. The remainder of the frame's rubber seal appeared to be somewhat deteriorated.

The mating indentations in the door and its frame were of such size and nature that they were obviously caused by the loosened and wedged door frame seal.^{3/}

The deep indentation in the door's upper rear corner and slight displacement of the adjacent portion of the door's seal mated exactly with the slight depression in the door frame. In other words, when the door was closed, the two depressions abutted as if they had both been caused by the wedging of the same object.

These two depressions are marked on Attachment A. Their positions relative to the missing portion of the door seal suggested strongly that it was a loosened and sagging door frame seal that had jammed at that point.

The most probable reason for the door opening during flight is as follows. The door frame seal became loosened along the top of the frame during the flight from Port of Spain to Rio de Janeiro. But, as the door remained closed, it was held in its proper position. It sagged when the door was opened, and this sagging remained unnoticed while the aircraft was made ready for the next leg of the flight. Upon closing the door the sagging seal jammed, creating the marks shown on Attachment A, and preventing the door from being fully closed. Although there is a marked difference of opinion between the flight engineer and purser as to how far the door handle was turned, it is self evident that it was turned only far enough to engage the tapered ends of the bolts in their receptacles. Cabin pressure exerted an increasing force on the door. This force reached a magnitude sufficient, under normal vibration conditions in flight, to expel the tapered ends of the bolts from their receptacles and back into the door edge, whereupon the door opened violently under the impetus of a force of several tons. Outgoing air carried away the sagging portion of the frame seal also as shown on Attachment A.

Showing door as found (except upholstery along top of door which was pulled loose by investigators). NOTE: Indentation of door and door seal at "A". Frame seal missing between arrows. Slight indentation of frame at "B".
