CIVIL AVIATION BOARD  
ACCIDENT INVESTIGATION REPORT

CURTISS C-46, N 79096 - MIAMI INTERNATIONAL AIRPORT,  
MIAMI, FLORIDA, AUGUST 4, 1952

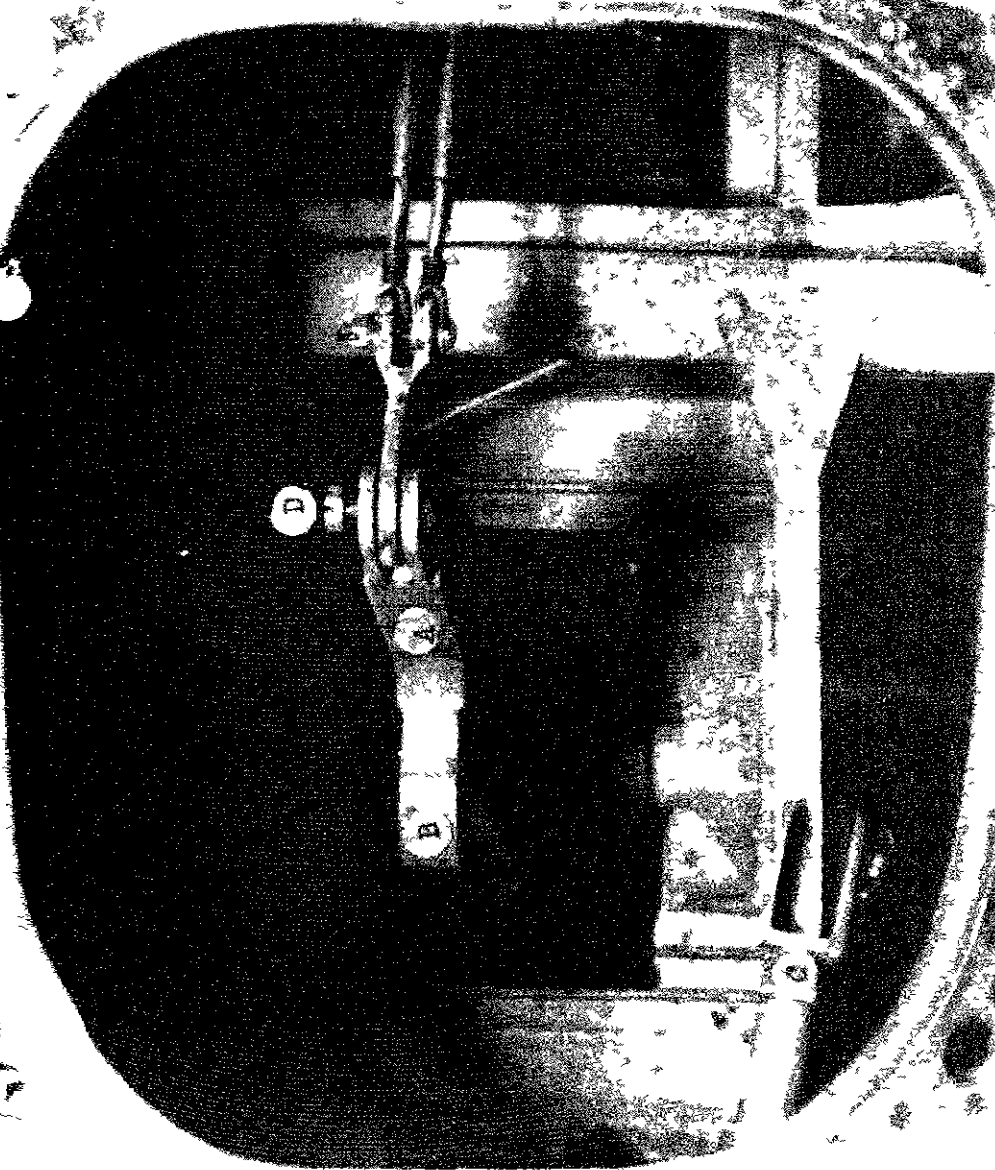
Appendix A

It was found that the forked end of the push-pull tube was disconnected from its point of attachment on the elevator bellcrank and the connecting bolt was missing, thereby rendering the elevator control completely inoperative. (See Appendix A.) It is of particular significance that a 5/16-inch bolt, washer, and nut of the same specifications as required in the assembly of this connection were found lying separate and loose in the tail of the aircraft.

It was also found that the bolt attaching the down elevator dual control cables to the bottom end of the elevator bellcrank not only was not safetied but the castellated shear nut was found with only a few threads remaining engaged. No evidence was found to indicate that either this bolt or the missing one in the elevator push-pull tube connection had

There is no reason to doubt that the 5/16-inch bolt, nut, and washer found loose in the tail of the aircraft following the accident were the ones originally installed in the push-pull tube to bellcrank connection. Furthermore, no evidence was found to indicate that they had been safetied following assembly. This determination is further supported by the fact that the bolt and nut attaching the down elevator cable to the bottom end of the bellcrank also was not safetied when assembled, as will be noted by referring to Appendix A.

- B - Attach point of elevator push-pull tube to bellcrank.
- C - Forked end of elevator push-pull tube.
- D - Bolt connecting down elevator cable to bellcrank.

Miami, Fla., 8/11/52, E-46, 87906 - View through inspection opening bottom of package (inverted), showing disconnected elevator push-pull tube, with elevator cable, in lower half elevator bellcrank.
