CIVIL AERONAUTICS BOARD

ACCIDENT INVESTIGATION REPORT

LAKE CENTRAL AIRLINES, INC., - INDIANAPOLIS, INDIANA,
AUGUST 21, 1952

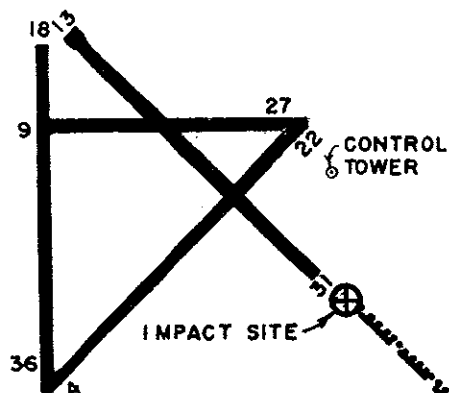
LAKE CENTRAL AIRLINES, INC.,
BEECH BONANZA N8765A,
INDIANAPOLIS, INDIANA
AUGUST 21, 1952

APPROXIMATE POSITION WHEN EAL 109
TURNED OFF RUNWAY 31; STARTED
DESCENT FROM 500'

ESTIMATED ALTITUDE 300';
ADDED FLAP.
