## CIVIL AERONAUTICS BOARD

**ACCIDENT INVESTIGATION REPORT**

LAKE CENTRAL AIRLINES, INC., DC-3 and CESSNA 170 - RICHMOND, INDIANA,  
DECEMBER 15, 1952

# AIR-COLLISION

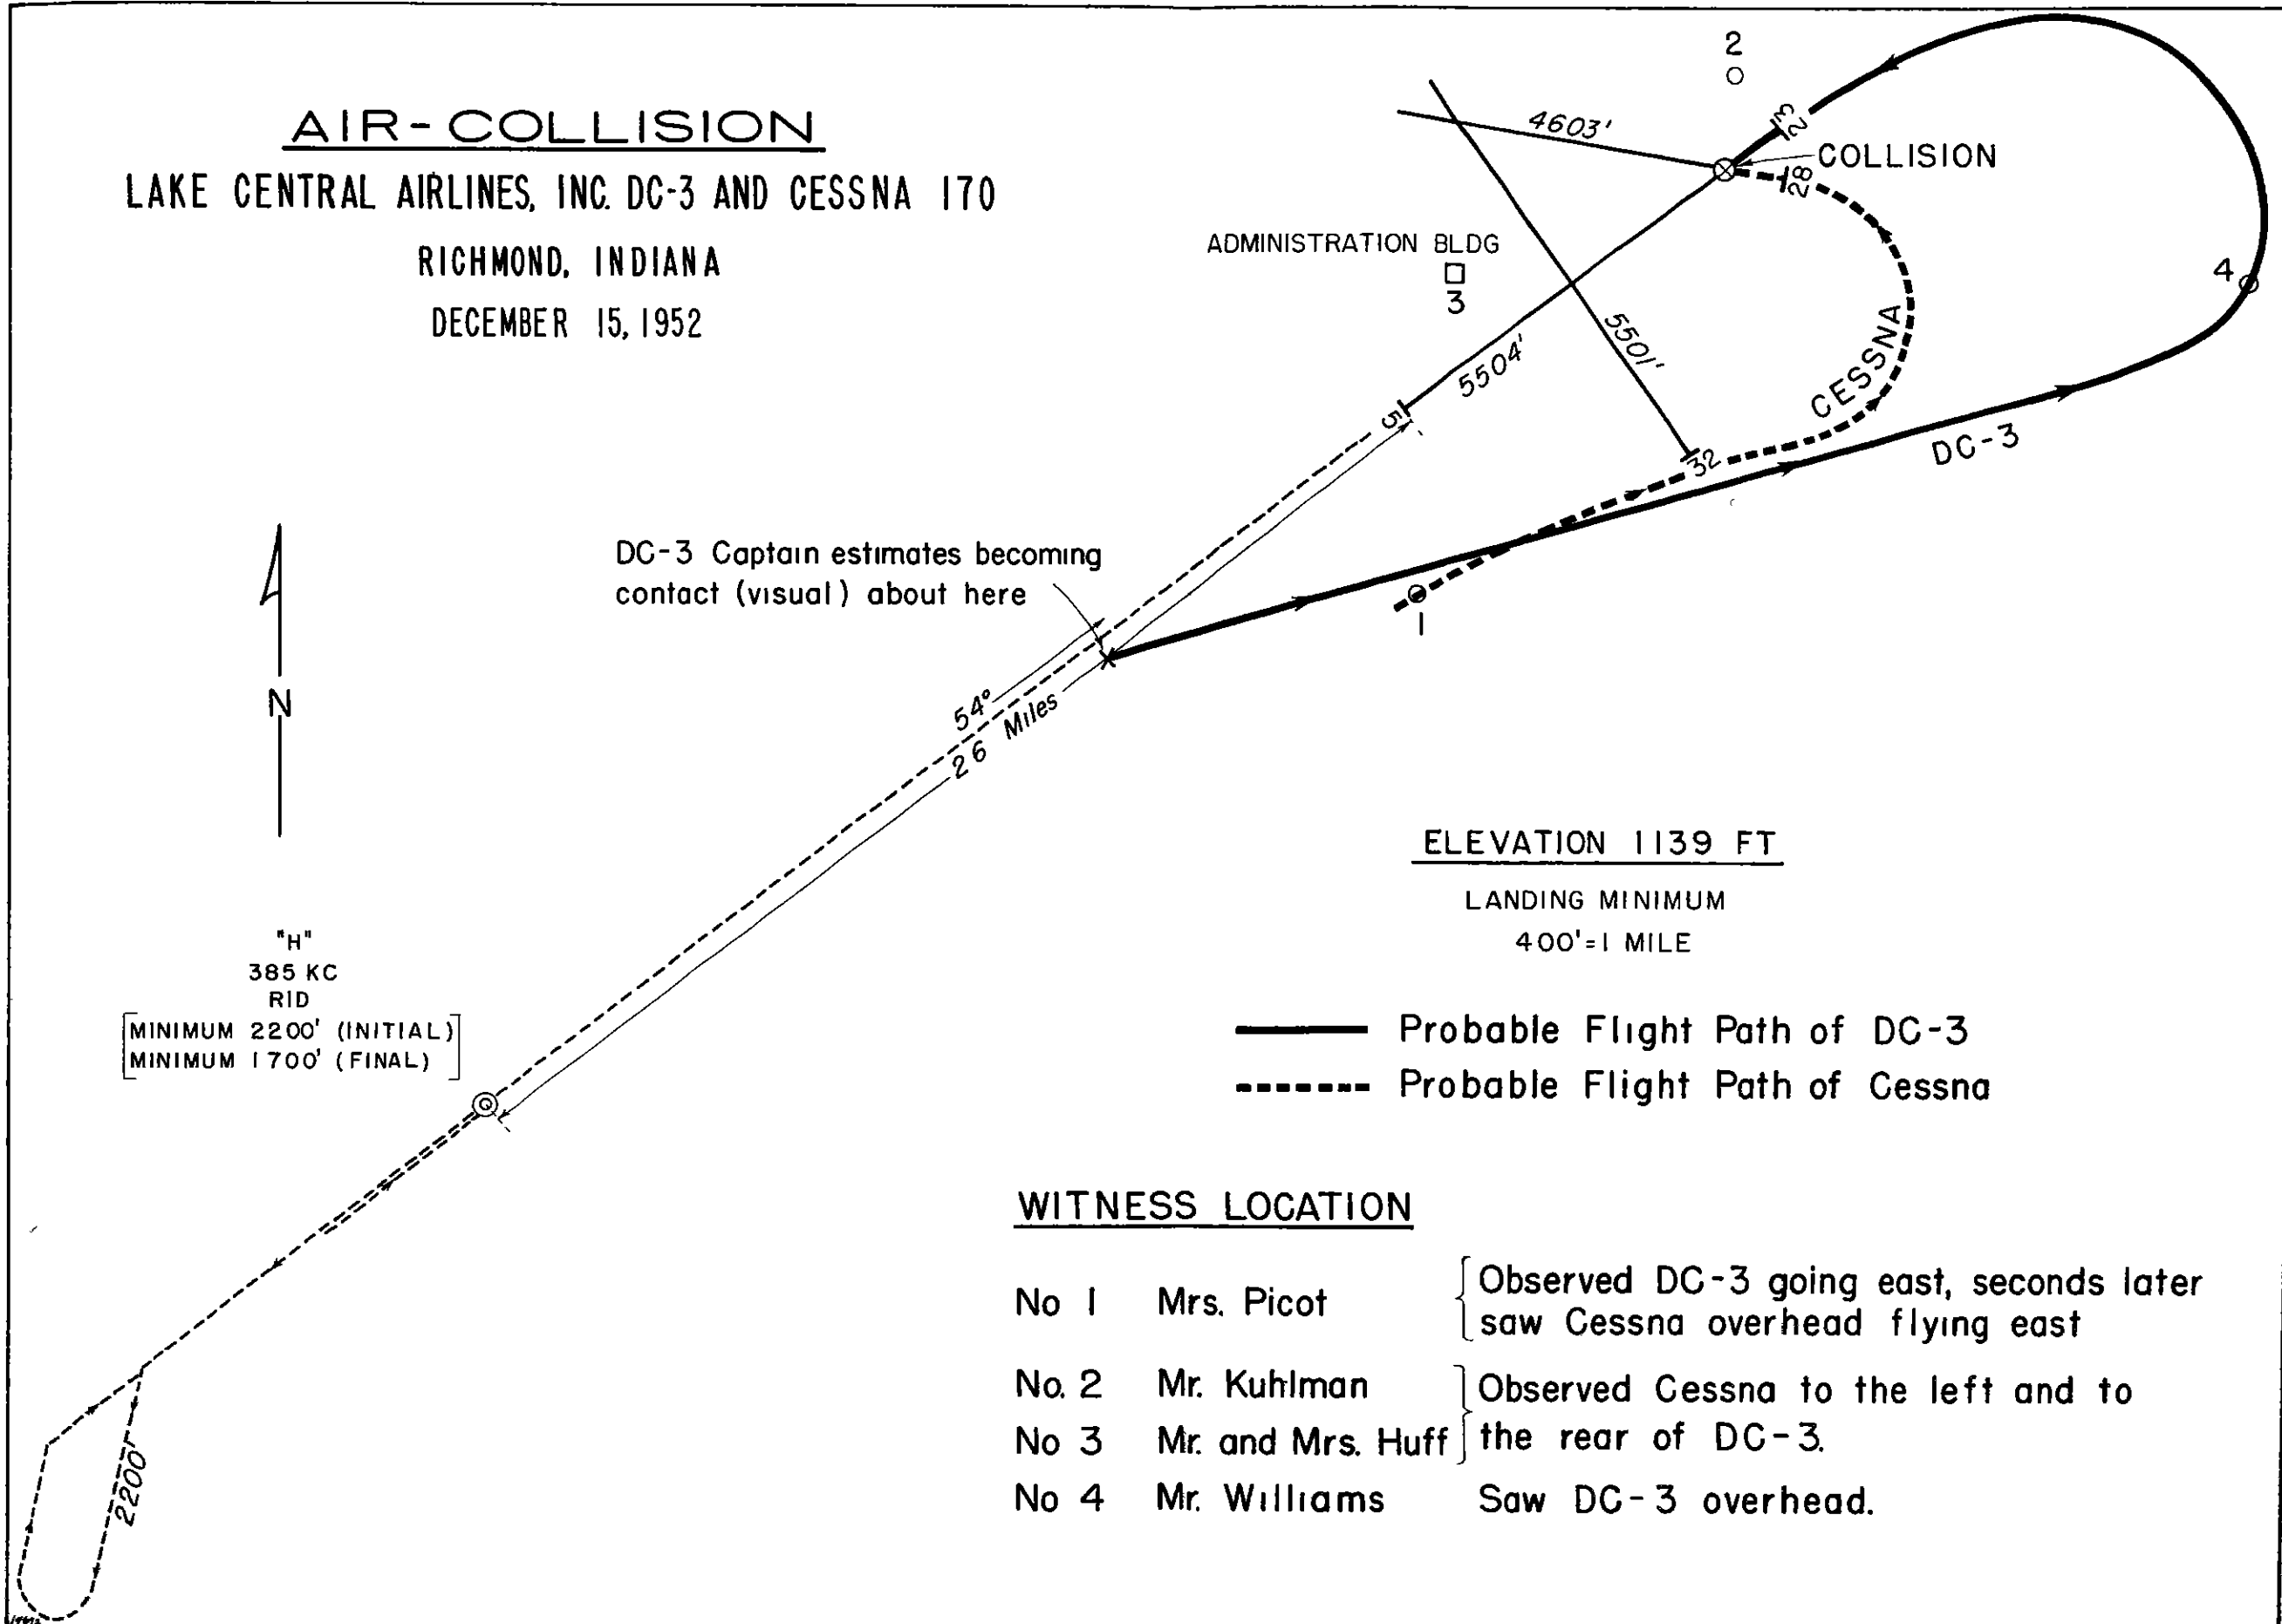
DC-3 Captain estimates becoming contact (visual) about here

———— Probable Flight Path of DC-3  
 - - - - - Probable Flight Path of Cessna

| No 1 | Mrs. Picot | } Observed DC-3 going east, seconds later saw Cessna overhead flying east |
| No 3 | Mr. and Mrs. Huff | } Observed Cessna to the left and to the rear of DC-3. |
| | | } Saw DC-3 overhead. |
