C I V I L A E R O N A U T I C S B O A R D
ACCIDENT INVESTIGATION REPORT

Adopted: October 9, 1953

METEOR AIR TRANSPORT, INC., LAMBERT FIELD, ST. LOUIS, MISSOURI
MAY 24, 1953

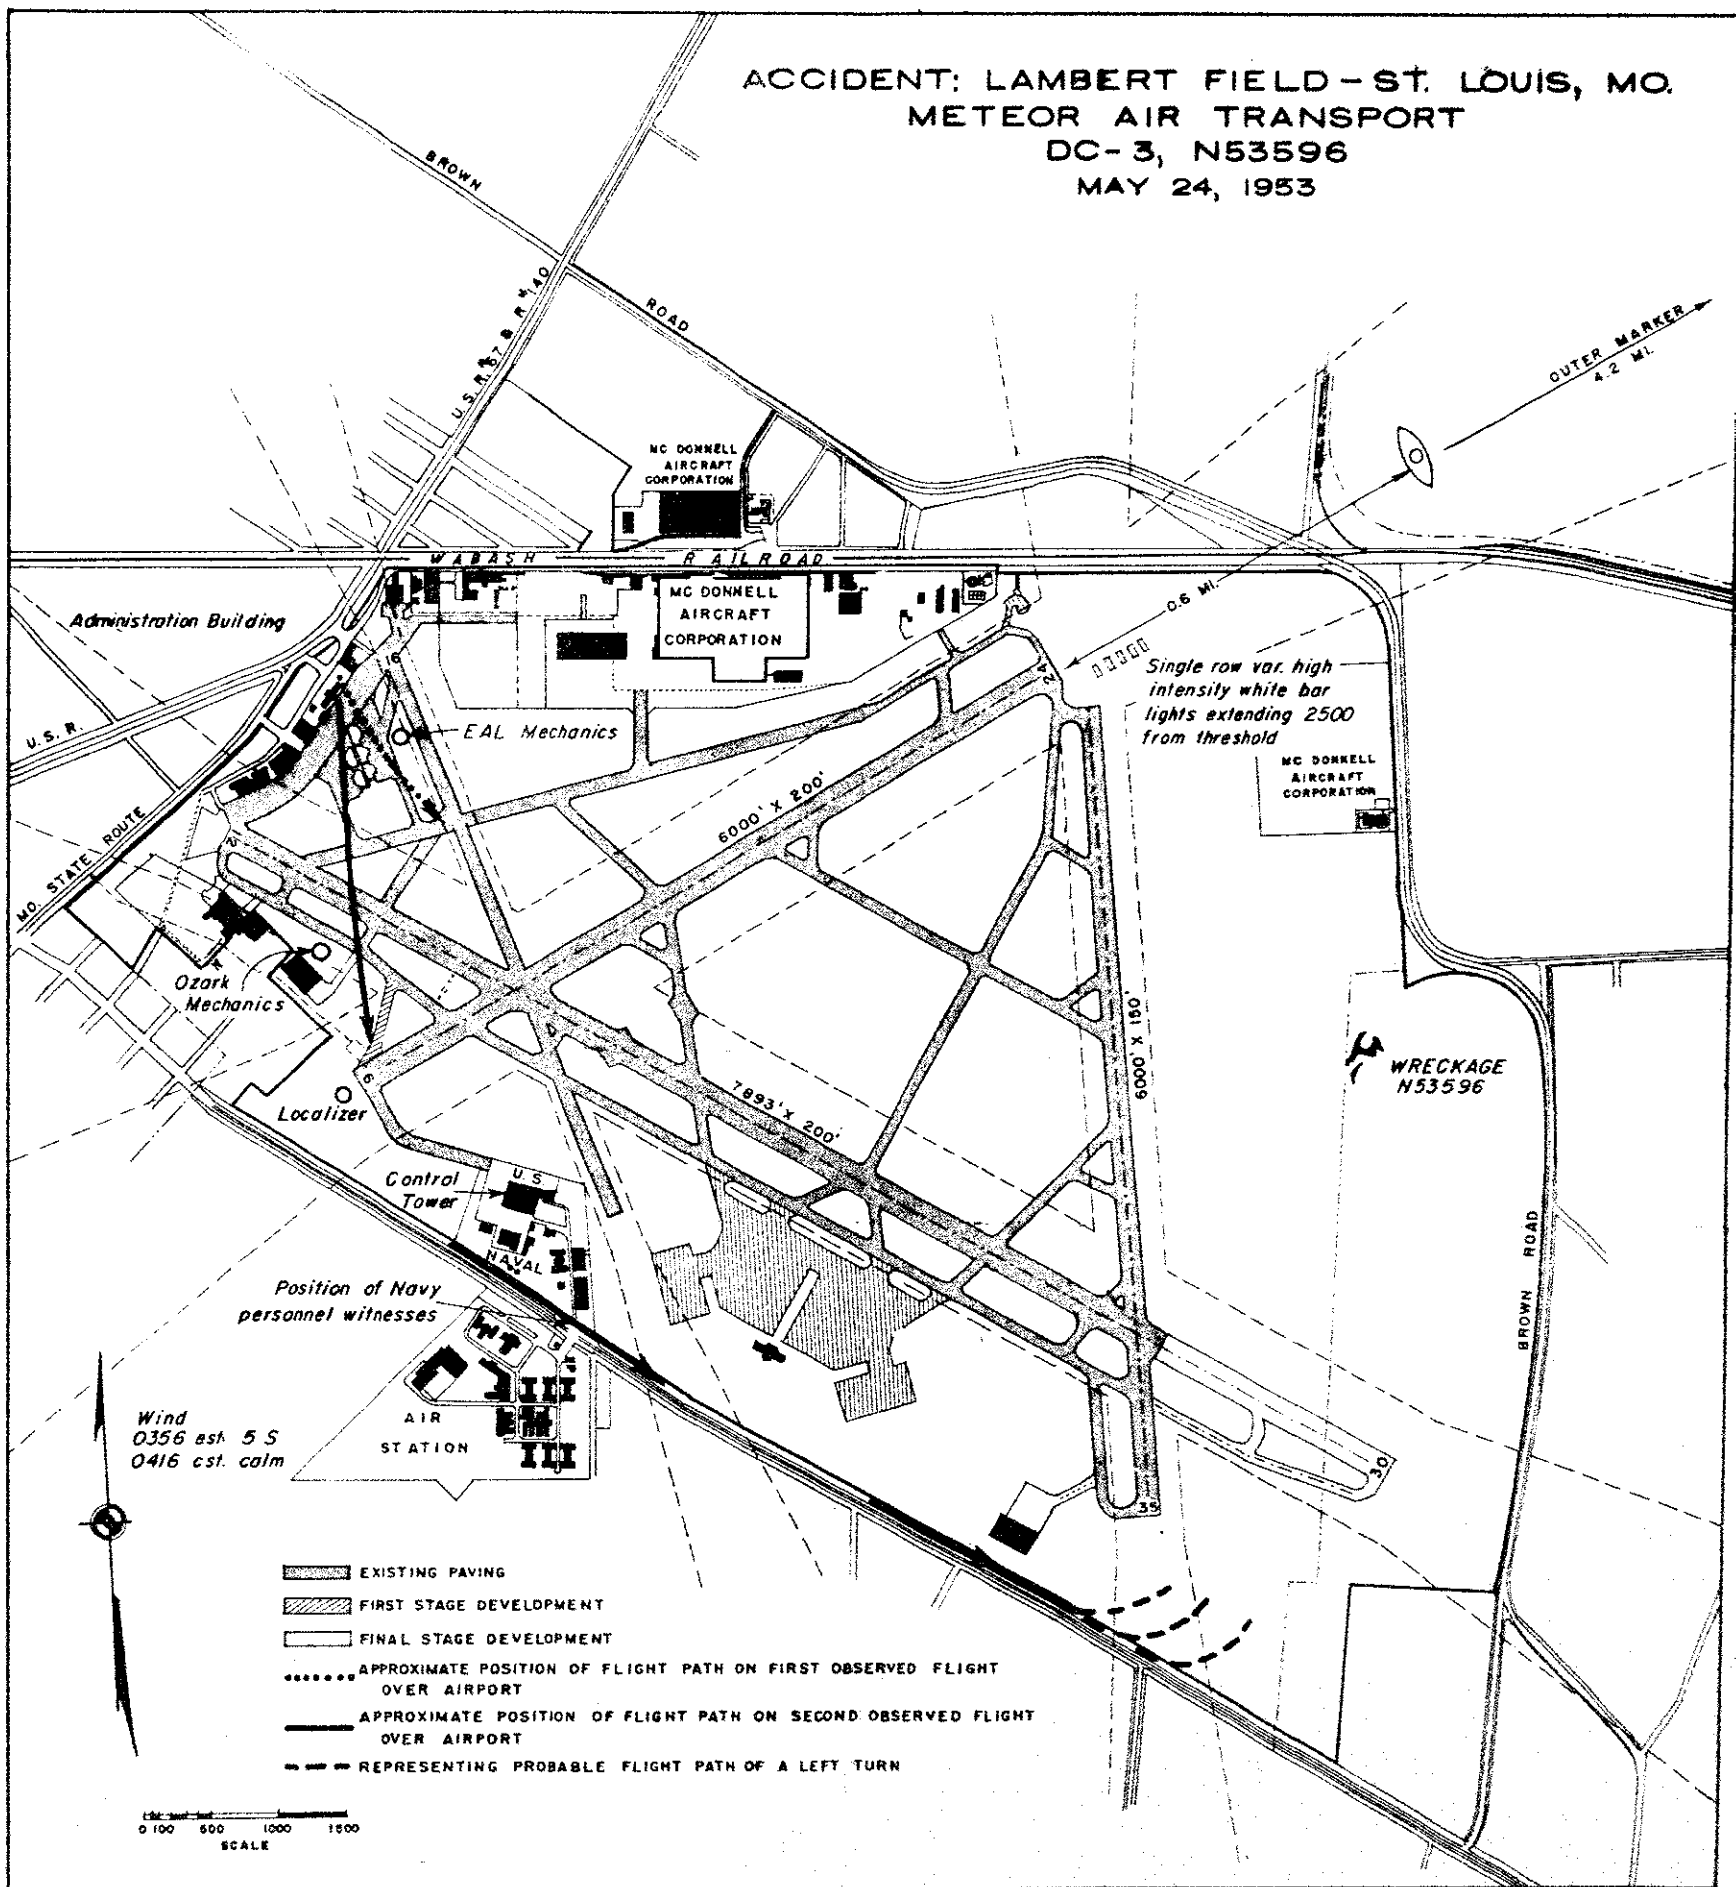
ACCIDENT: LAMBERT FIELD - ST. LOUIS, MO.
 METEOR AIR TRANSPORT
 DC-3, N53596
 MAY 24, 1953

It was determined that the aircraft struck the ground on an undeveloped portion of the airport approximately 1,950 feet east of the mid-point of the north-south runway which is itself located on the eastern side of the airport proper.^{4/} The tip of the right wing made initial contact with the ground with the aircraft on a northerly heading. After going straight for a distance of 65 feet with the right wing tip making a deep gouge in the earth, the aircraft cartwheeled to the right, changing its heading through approximately 270 degrees where, after sliding rearward about 10 feet, it came to rest right side up. The forward section of the fuselage comprising the pilot's compartment was crushed beyond any semblance of form, both engines were torn from the wings, and the R-2800 engine being carried in the passenger compartment was thrown through the cabin roof and came to rest approximately 40 feet beyond and east of the main wreckage.
