CIVIL AERONAUTICS BOARD
ACCIDENT INVESTIGATION REPORT

Adopted: June 24, 1954

ZANTOP FLYING SERVICE, NEAR KANSAS CITY,
MISSOURI, JANUARY 20, 1954The Accident

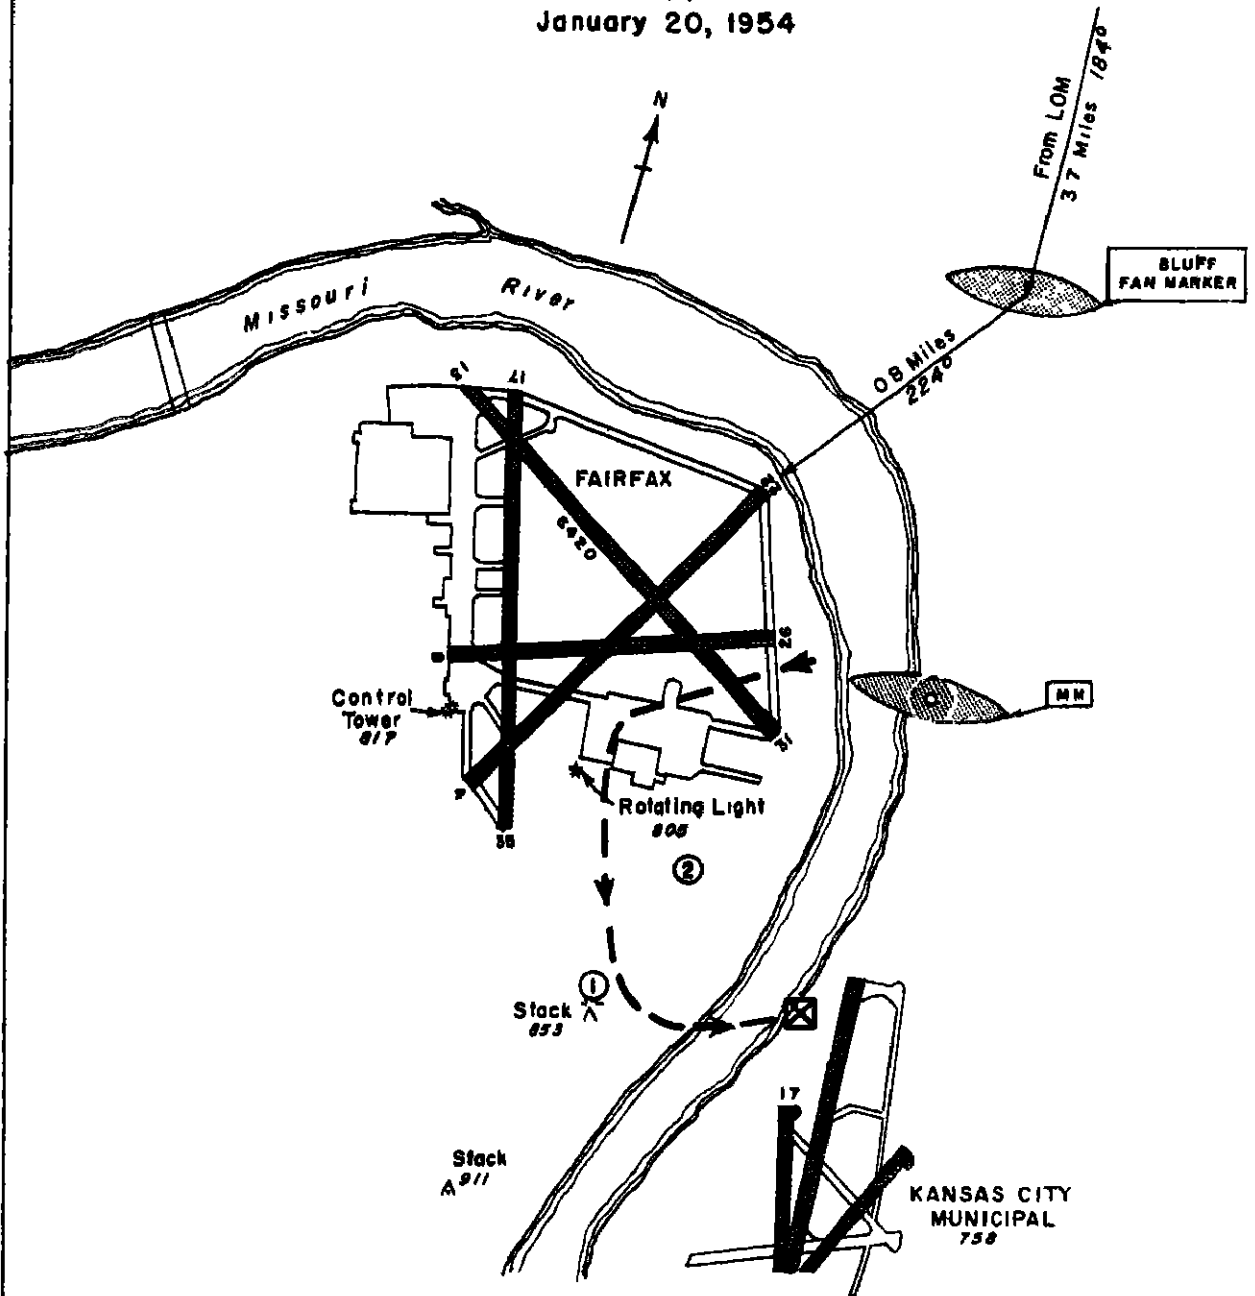
PROBABLE FLIGHT PATH AND LOCATION OF WRECKAGE

At approximately 0755 the wreckage was located by the Kansas City Municipal Airport patrol 400 feet north and 156 feet west of the approach end of Runway 17 of that airport.^{2/}

Two ground witnesses south of Fairfax Airport observed the aircraft flying overhead at an estimated altitude of 100-200 feet above the ground. These witnesses observed the aircraft making a left-hand pattern rolling violently from side to side while descending. They described the motion of the aircraft as wallowing. One witness, an aircraft mechanic, stated the aircraft appeared to be out of control.
