## CIVIL AERONAUTICS BOARD

**ACCIDENT INVESTIGATION REPORT**

WESTERN AIR LINES, INC. - NEAR WRIGHT, WYOMING,  
FEBRUARY 26, 1954

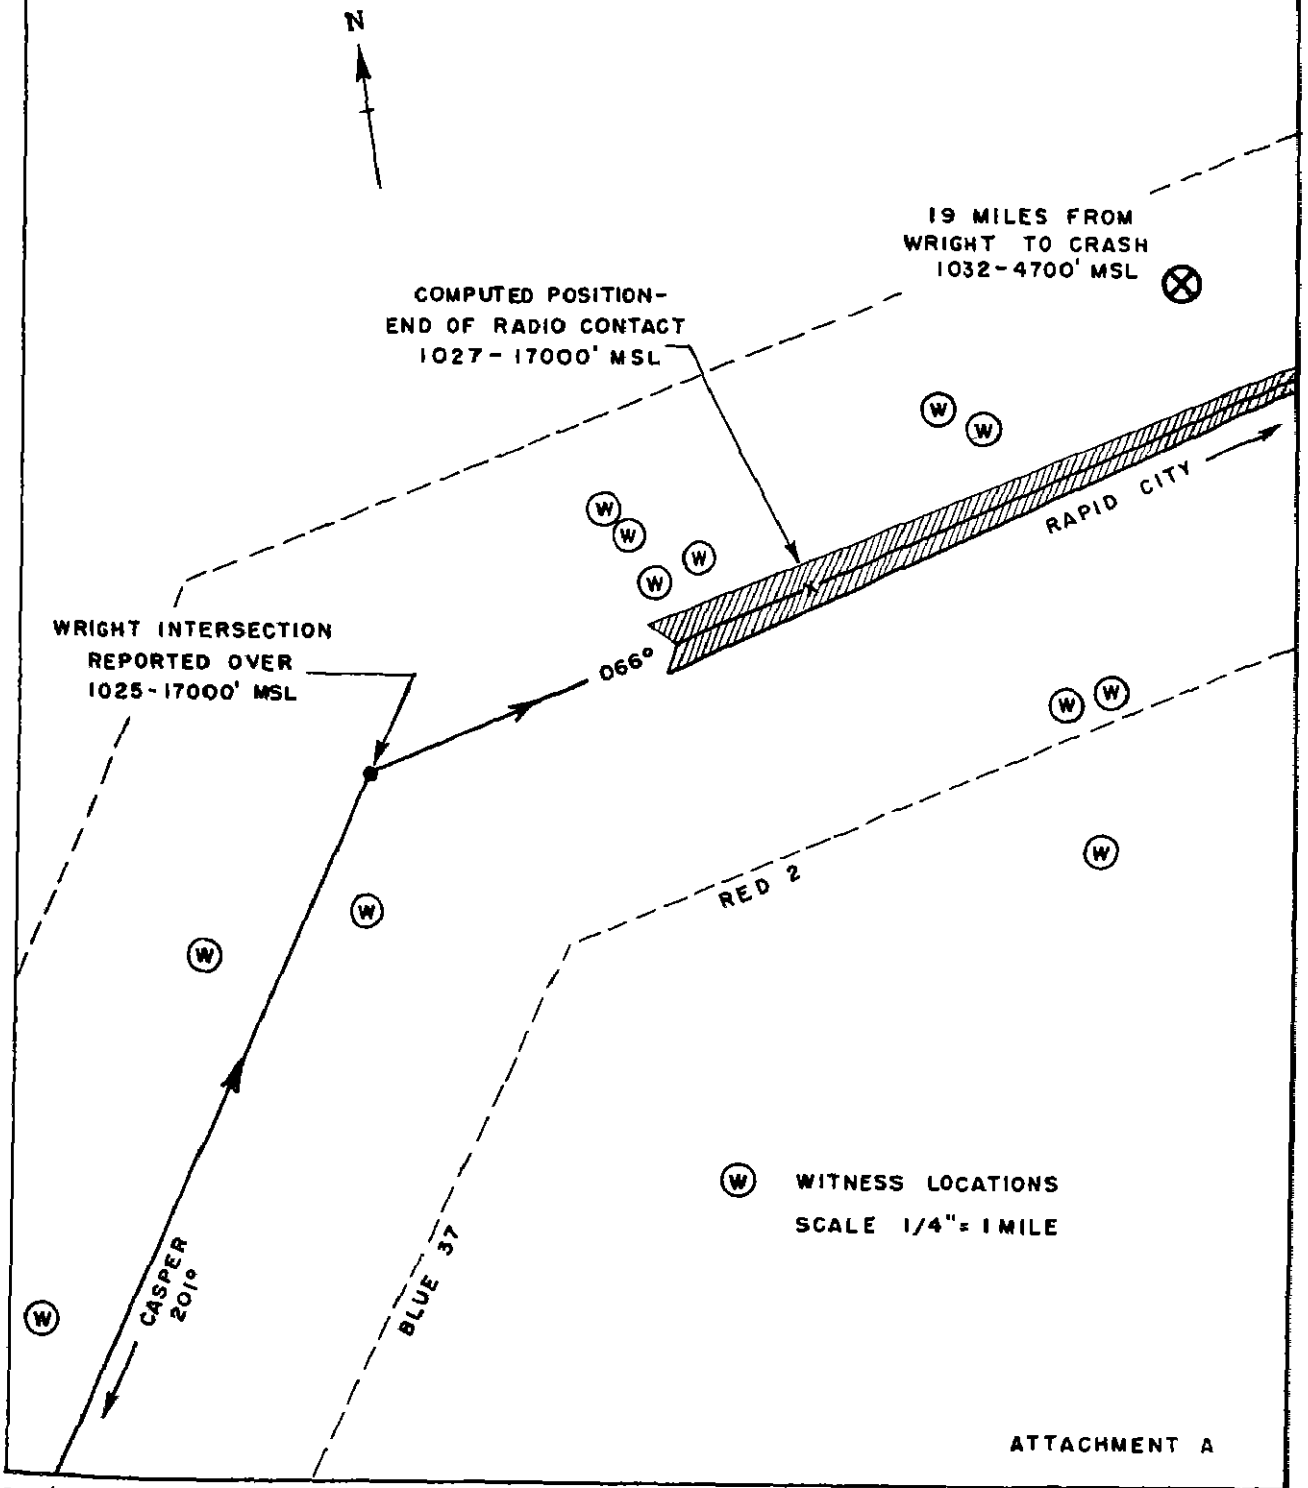
# WESTERN AIR LINES, INC., CONVAIR 240 N 8407H NEAR WRIGHT WYOMING, FEBRUARY 26, 1954

The aircraft first contacted the frozen ground on a heading of 22 degrees magnetic. The angle of impact was nearly flat with the aircraft in a slightly left-wing-low attitude. The impact force was of great magnitude as shown by the completely disintegrated and widespread wreckage which was found in an area 1,500 feet long and 450 feet wide. Within this area a few small flash ground fires occurred. Search was made for fallen parts back along the flight path with negative results; no components of the aircraft were found away from the impact area.

Due to the severity of weather conditions only a limited examination of the wreckage could be made at the scene; the wreckage parts were identified or numbered and their location plotted on a distribution chart. All wreckage was then transported to Ellsworth Air Force Base, Rapid City, South Dakota.
