CIVIL AERONAUTICS BOARD

ACCIDENT INVESTIGATION REPORT

PIEDMONT AIRLINES, TRI-CITY AIRPORT, BRISTOL,
TENNESSEE, FEBRUARY 28, 1954

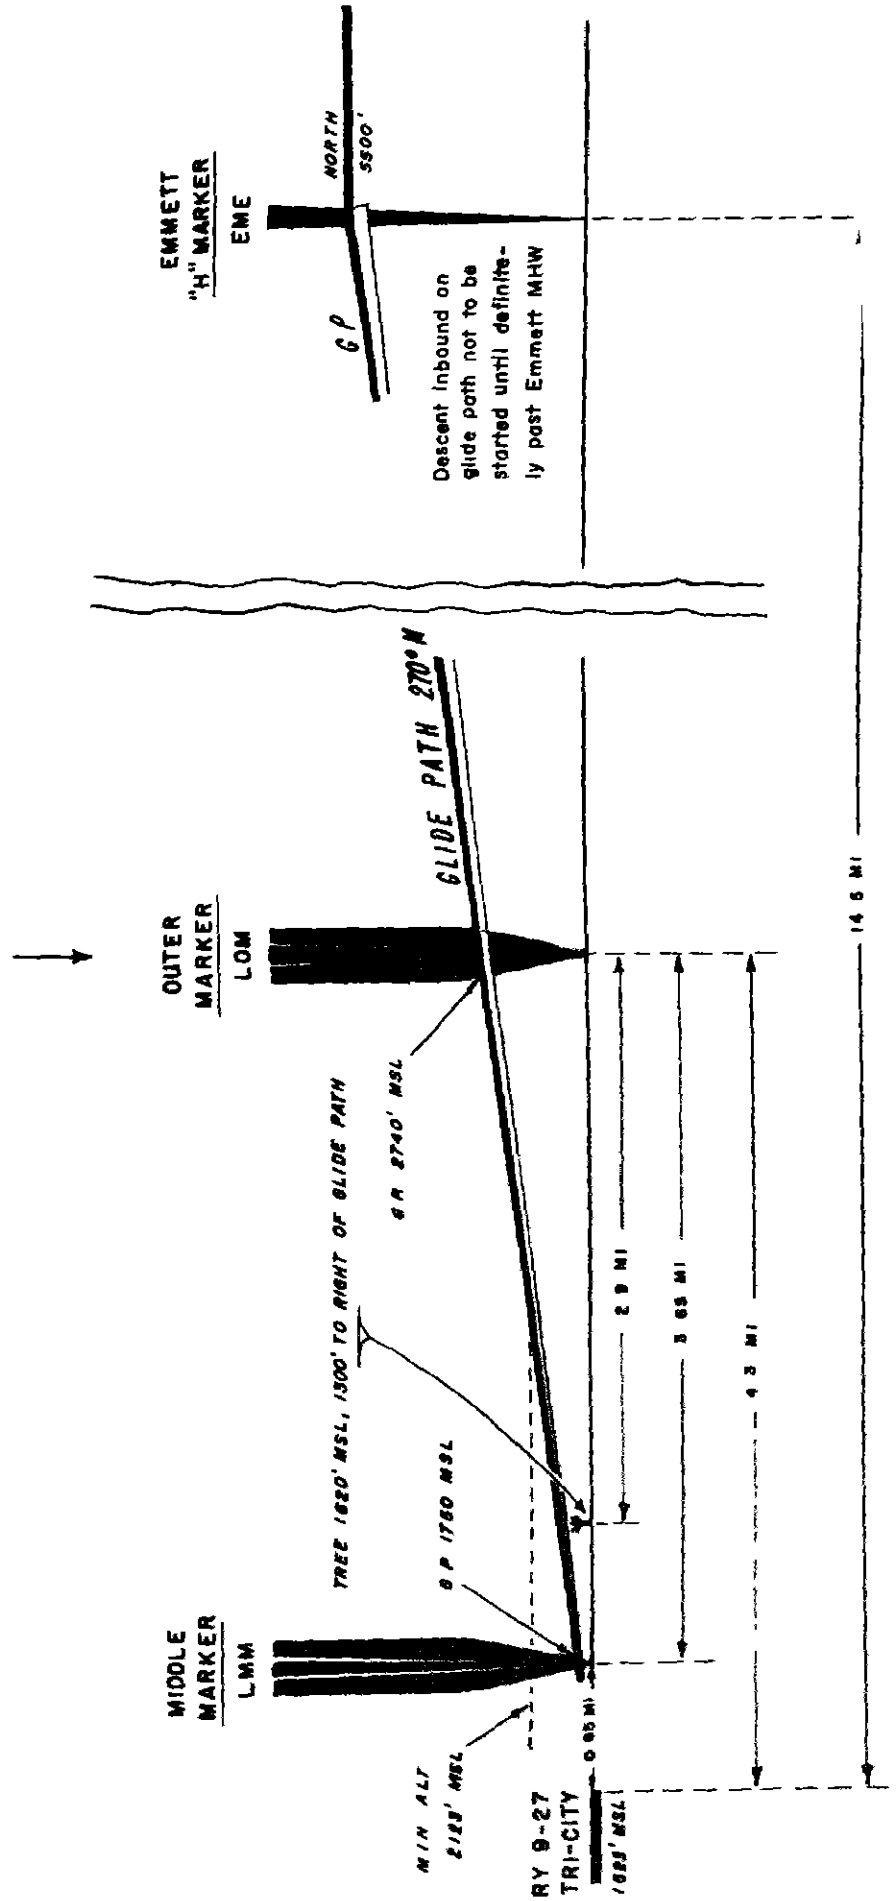
PIEDMONT AIRLINES, N43V, FEB 28, 1954
TRI-CITY AIRPORT, BRISTOL, TENN.
ILS GLIDE PATH SHOWING RELATIVE POSITION
AND ALTITUDE OF TREE STRUCK BY N43V

Investigation disclosed that the aircraft contacted a tree during the approach instead of the ground as reported by the crew. This tree was located on a bearing of 80 degrees, 7,500 feet from the approach end of Runway 27 and 1,300 feet north, to the right, of the extension of the localizer course. The tree is at an elevation of 1,560 feet MSL (mean sea level); the top of the tree is 60 feet above the ground and about 100 feet above the runway level which is 1,523 feet MSL. The top of the tree was 319 feet below the glide path and the upper ten feet of it was severed by the aircraft. Contact with the tree damaged the left engine, the left propeller and the leading edge of the left wing.

a fraction of a minute. Therefore, it seems improbable that the flight encountered the single severe downdraft described by the crew as forcing the aircraft downward several hundred feet to a position well below the glide path. It seems more probable that with the aircraft over the outer marker nearly 500 feet above the glide path the descent was steepened in an attempt to get on the glide path and the aircraft went through and below the glide path before the "pull-up" was made. According to the captain contact with the top of the tree occurred within 30 seconds after he had started his missed approach. The tree which was struck is 2.9 miles west of the outer marker and 1,300 feet to the right of the localizer course and 319 feet below the glide path. If the captain had maintained a constant air speed of 120 m.p.h. and a constant descent of not over 535 feet per minute after passing the outer marker inbound, according to his testimony he would have been several hundred feet above the top of the tree and above the glide path. It is obvious, considering that the point of impact was 1,300 feet to the right of the localizer course, that the aircraft had deviated seriously from the intended course.
