## CIVIL AERONAUTICS BOARD

**ACCIDENT INVESTIGATION REPORT**

NORTHEAST AIRLINES, INC. - NEAR BERLIN, NEW HAMPSHIRE,  
NOVEMBER 30, 1954

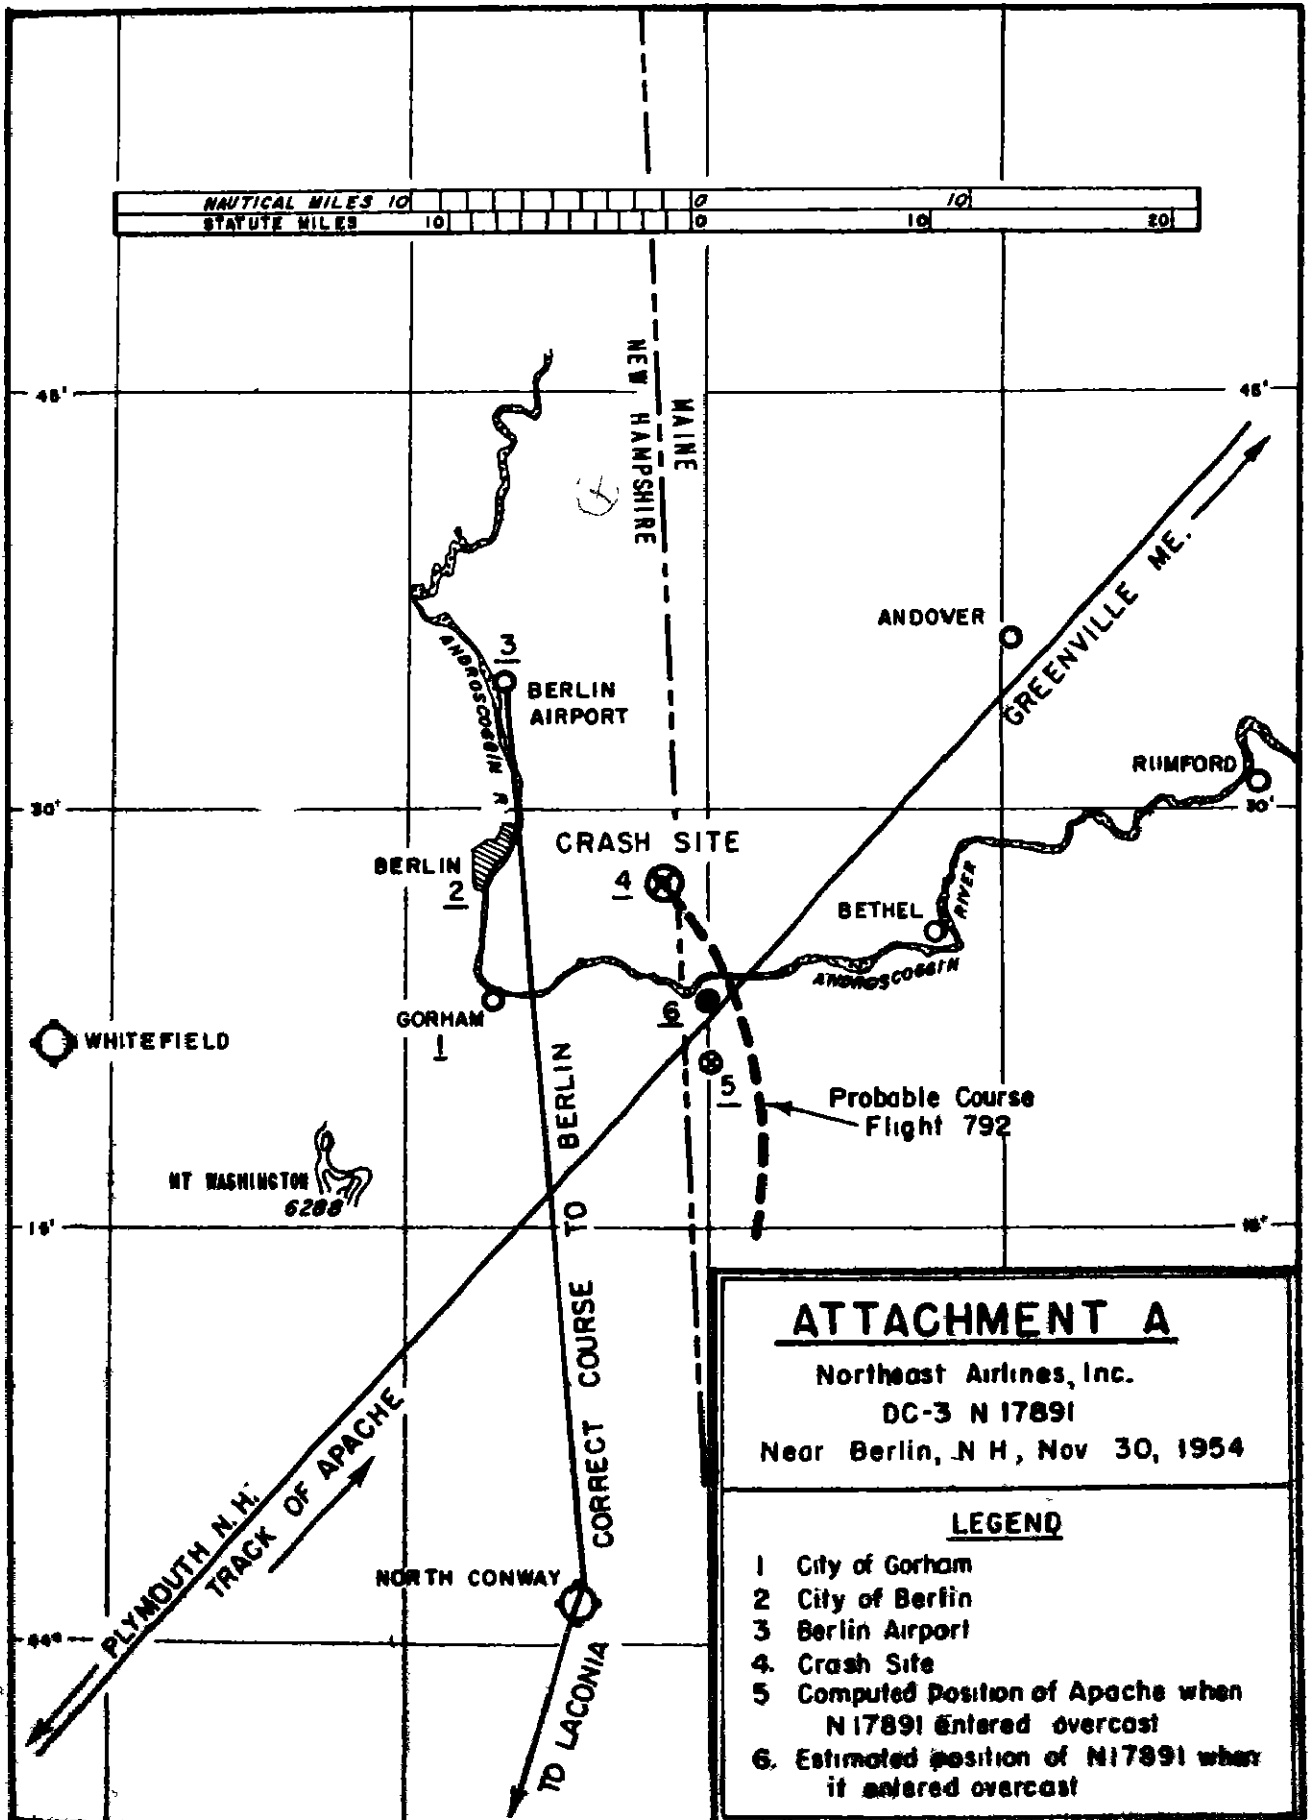
**ATTACHMENT A**  
 Northeast Airlines, Inc.  
 DC-3 N 17891  
 Near Berlin, N H, Nov 30, 1954

The Apache pilots landed at their destination and learned that Northeast Flight 792 was missing. Believing it was the DC-3 they had seen, they immediately computed their position and the approximate time when they saw it enter the overcast. The position was 18 statute miles southeast of the Berlin Airport; the time was 1105. (See attachment A.)

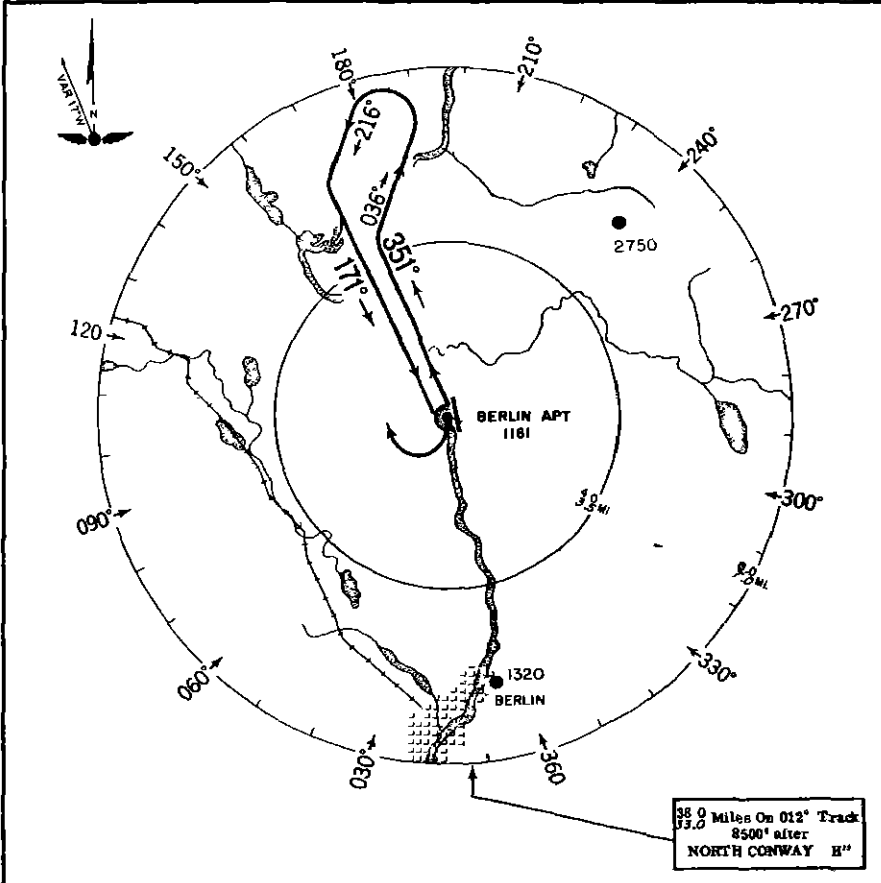
**ATTACHMENT B**  
 Northeast Airlines, Inc.  
 DC-3 N 17891  
 Near Berlin, N H., Nov. 30, 1954

Captain Carey stated, in substance, that he climbed to 8,000 feet altitude as called for in his clearance, while en route to Berlin. At this altitude he was above broken clouds until he was approximately 18 miles south of the airport. Beyond that point he was above a solid overcast. He had been using his ADF in obtaining a tail bearing on the Conway beacon and when about halfway to the city of Berlin, tuned it to the frequency (281) of the Berlin Airport beacon. The needle swung ahead and he followed it. He testified that he did not stay at 8,000 feet (his assigned cruising altitude and also the minimum en route altitude for that segment of the flight) until he overheaded the Berlin beacon as required in the company's operations manual and as shown on his Jeppesen Berlin Plate. (See attachment B.) Instead, he started descent before reaching it.
