CIVIL AERONAUTICS BOARD

ACCIDENT INVESTIGATION REPORT

JOHNSON FLYING SERVICE, INC. - NEAR PITTSBURGH, PENNSYLVANIA,
DECEMBER 22, 1954

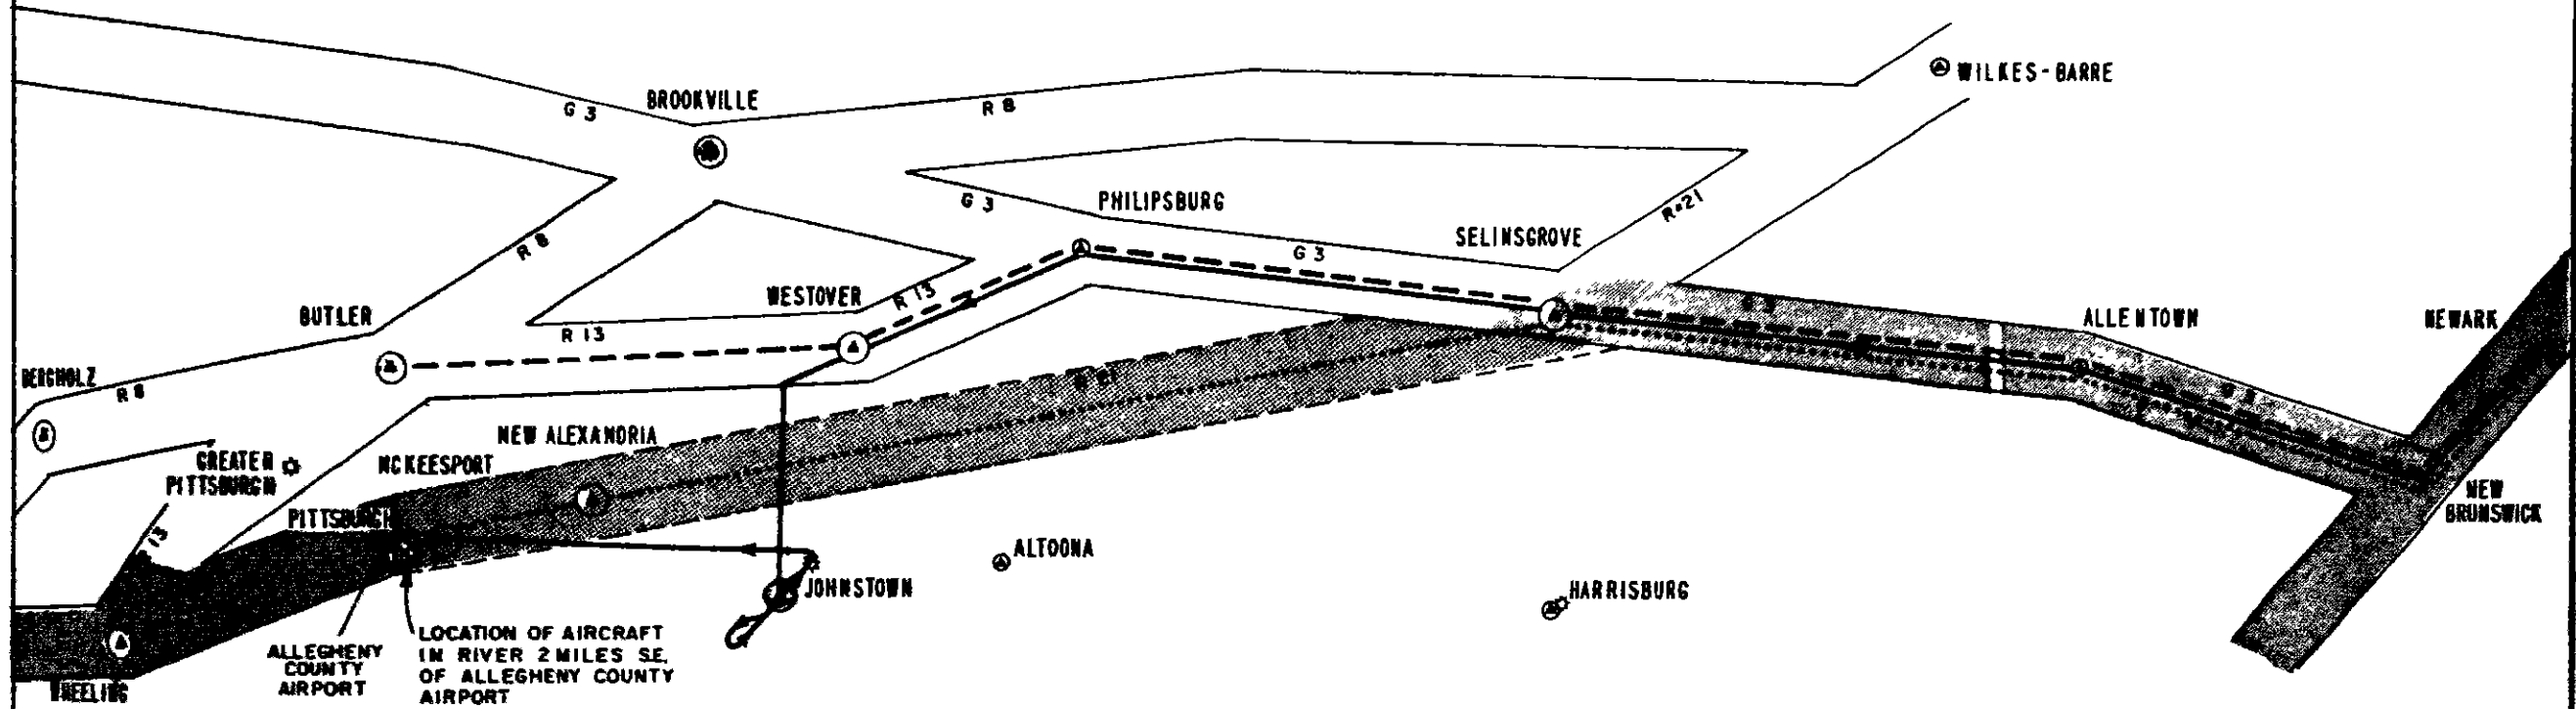
AIRCRAFT ACCIDENT - PITTSBURGH, PENNSYLVANIA

_____ FLIGHT ROUTE ACCORDING TO CREW AND POSITION REPORTS TO CAA.
 - - - - - FLIGHT ROUTE AS SHOWN ON FLIGHT PLAN AND LOG A 7, G 3, R 13, R 8, R 13
 FLIGHT ROUTE FILED BY CAPTAIN POE ALONG A 7, G 3, R 21

NOTE.
 AIRWAYS SHOWN ARE THOSE LISTED ON FLIGHT PLAN AND LOG, AND AIRWAYS SPECIFIED IN FLIGHT PLAN FILED WITH CAA
 RED 21 AIRWAY WAS DISCONTINUED IN DECEMBER, 1953 FROM PITTSBURGH TO SELINGSGROVE AREA
 RED 21 AIRWAY STILL EXISTS NE OF SELINGSGROVE TO WILKES-BARRE
