CIVIL AERONAUTICS BOARD

ACCIDENT INVESTIGATION REPORT

CONTINENTAL AIR LINES, INC., AND HINES FLYING SERVICE,
HOBBS, NEW MEXICO, AUGUST 29, 1955

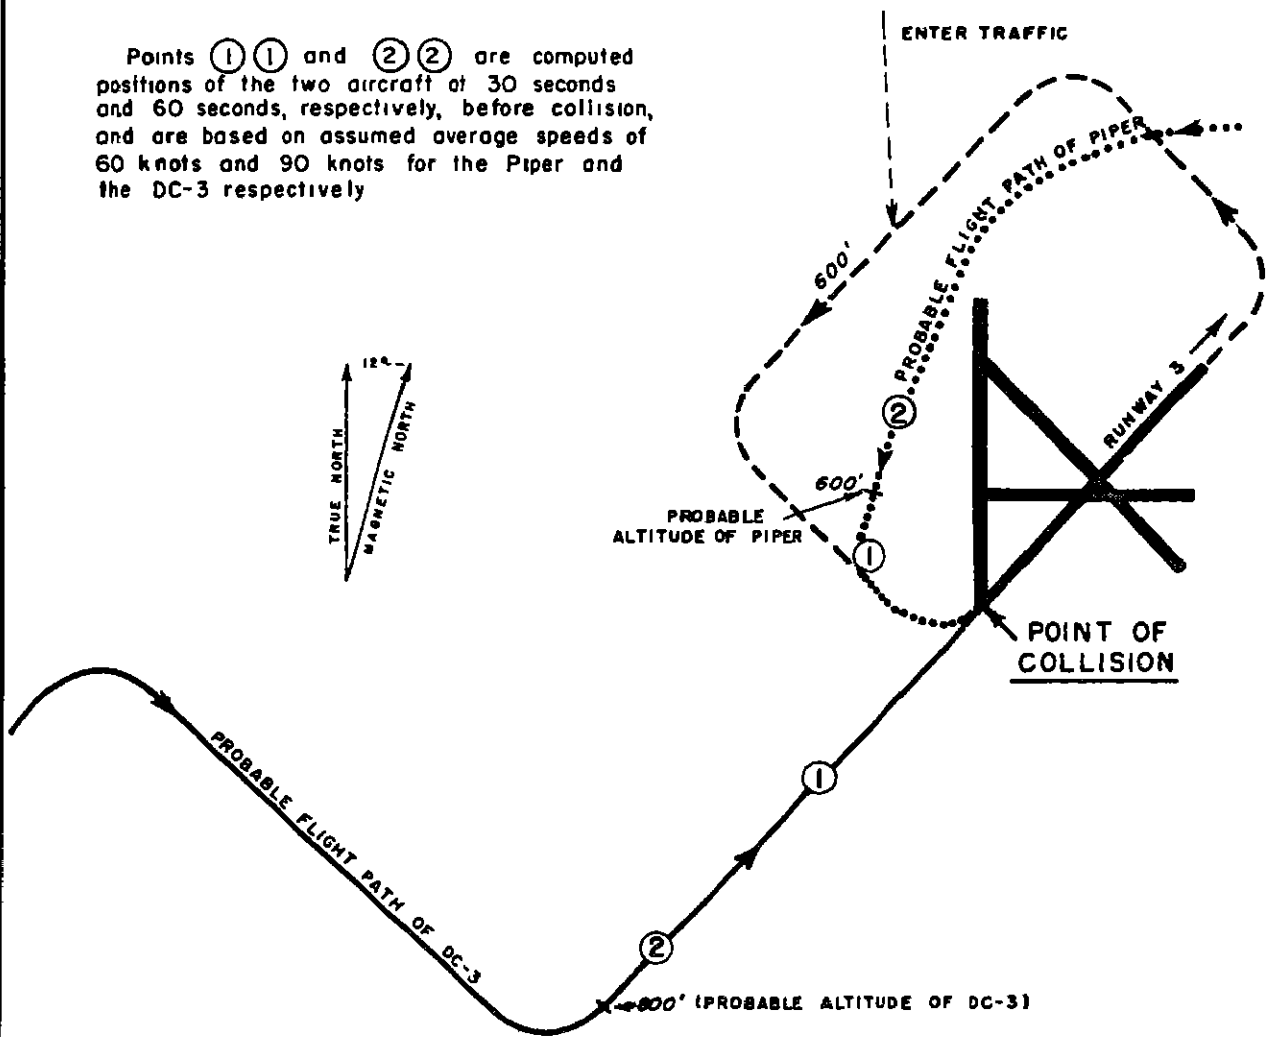
ATTACHMENT A

The Piper approached the airport from a direction substantially opposite that of runway 3 and to the northwest of that runway. It was then flown on the downwind leg in a direction approximately opposite runway 3 to a point about abreast of its approach end. Consequently approximately 180 degrees of left turn was necessary to align with that runway. Testimony of competent ground witnesses indicates that this turn was continuous or nearly so, with the aircraft banked appreciably throughout the turn. It also indicates that the Piper was the higher of the two aircraft as both approached the runway, the DC-3 in straight descending flight and level laterally, the Piper in a rather sharp left turn merging into a left forward slip just before collision. These flight paths were confirmed shortly after the accident by ground observations of simulated approaches of two identical aircraft. (Refer to Attachment A.)

Points ①① and ②② are computed positions of the two aircraft at 30 seconds and 60 seconds, respectively, before collision, and are based on assumed average speeds of 60 knots and 90 knots for the Piper and the DC-3 respectively
