## CIVIL AERONAUTICS BOARD

**ACCIDENT INVESTIGATION REPORT**

CURREY AIR TRANSPORT, LTD., DC-3C, N 74663,  
BURBANK, CALIFORNIA, SEPTEMBER 8, 1955

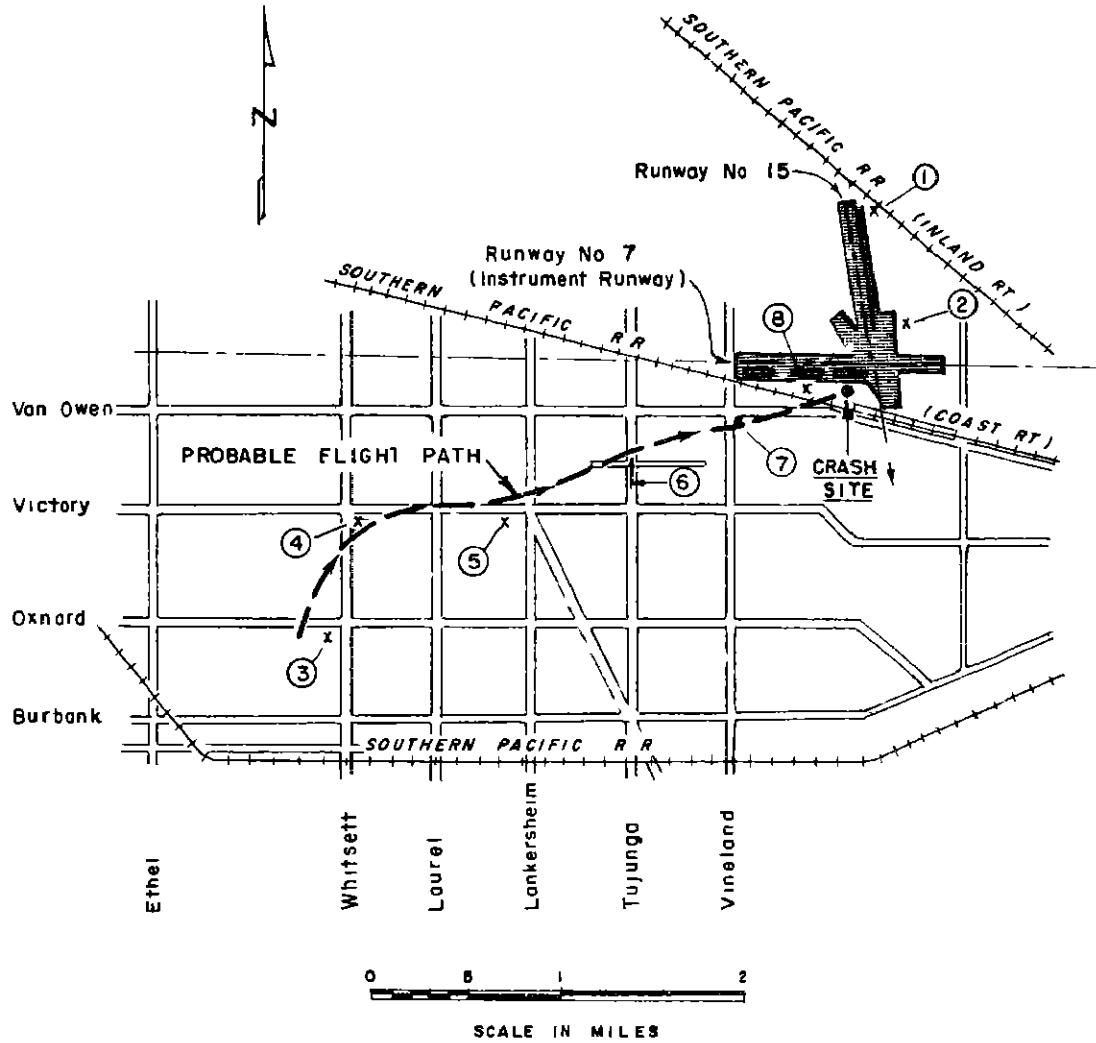
# PROBABLE FLIGHT PATH

Testimony of eyewitnesses made it possible to plot the path of N 74663 back about 3-1/2 miles from the point of impact. Attachment A shows this portion of the flight path in relation to the runways and to the takeoff path. The position of the aircraft at the time the crew became aware of the emergency and immediately thereafter is not definitely known and that portion of the flight path is not shown.

The observed portion of the flight path, charted in Attachment A, does not include the base leg of the approach.

Encircled numbers show location of ground witnesses to approach
