## CIVIL AERONAUTICS BOARD

**ACCIDENT INVESTIGATION REPORT**

UNITED AIR LINES, INC., DOUGLAS C-54B-DC, N 30062  
MEDICINE BOW PEAK, WYOMING, OCTOBER 6, 1955

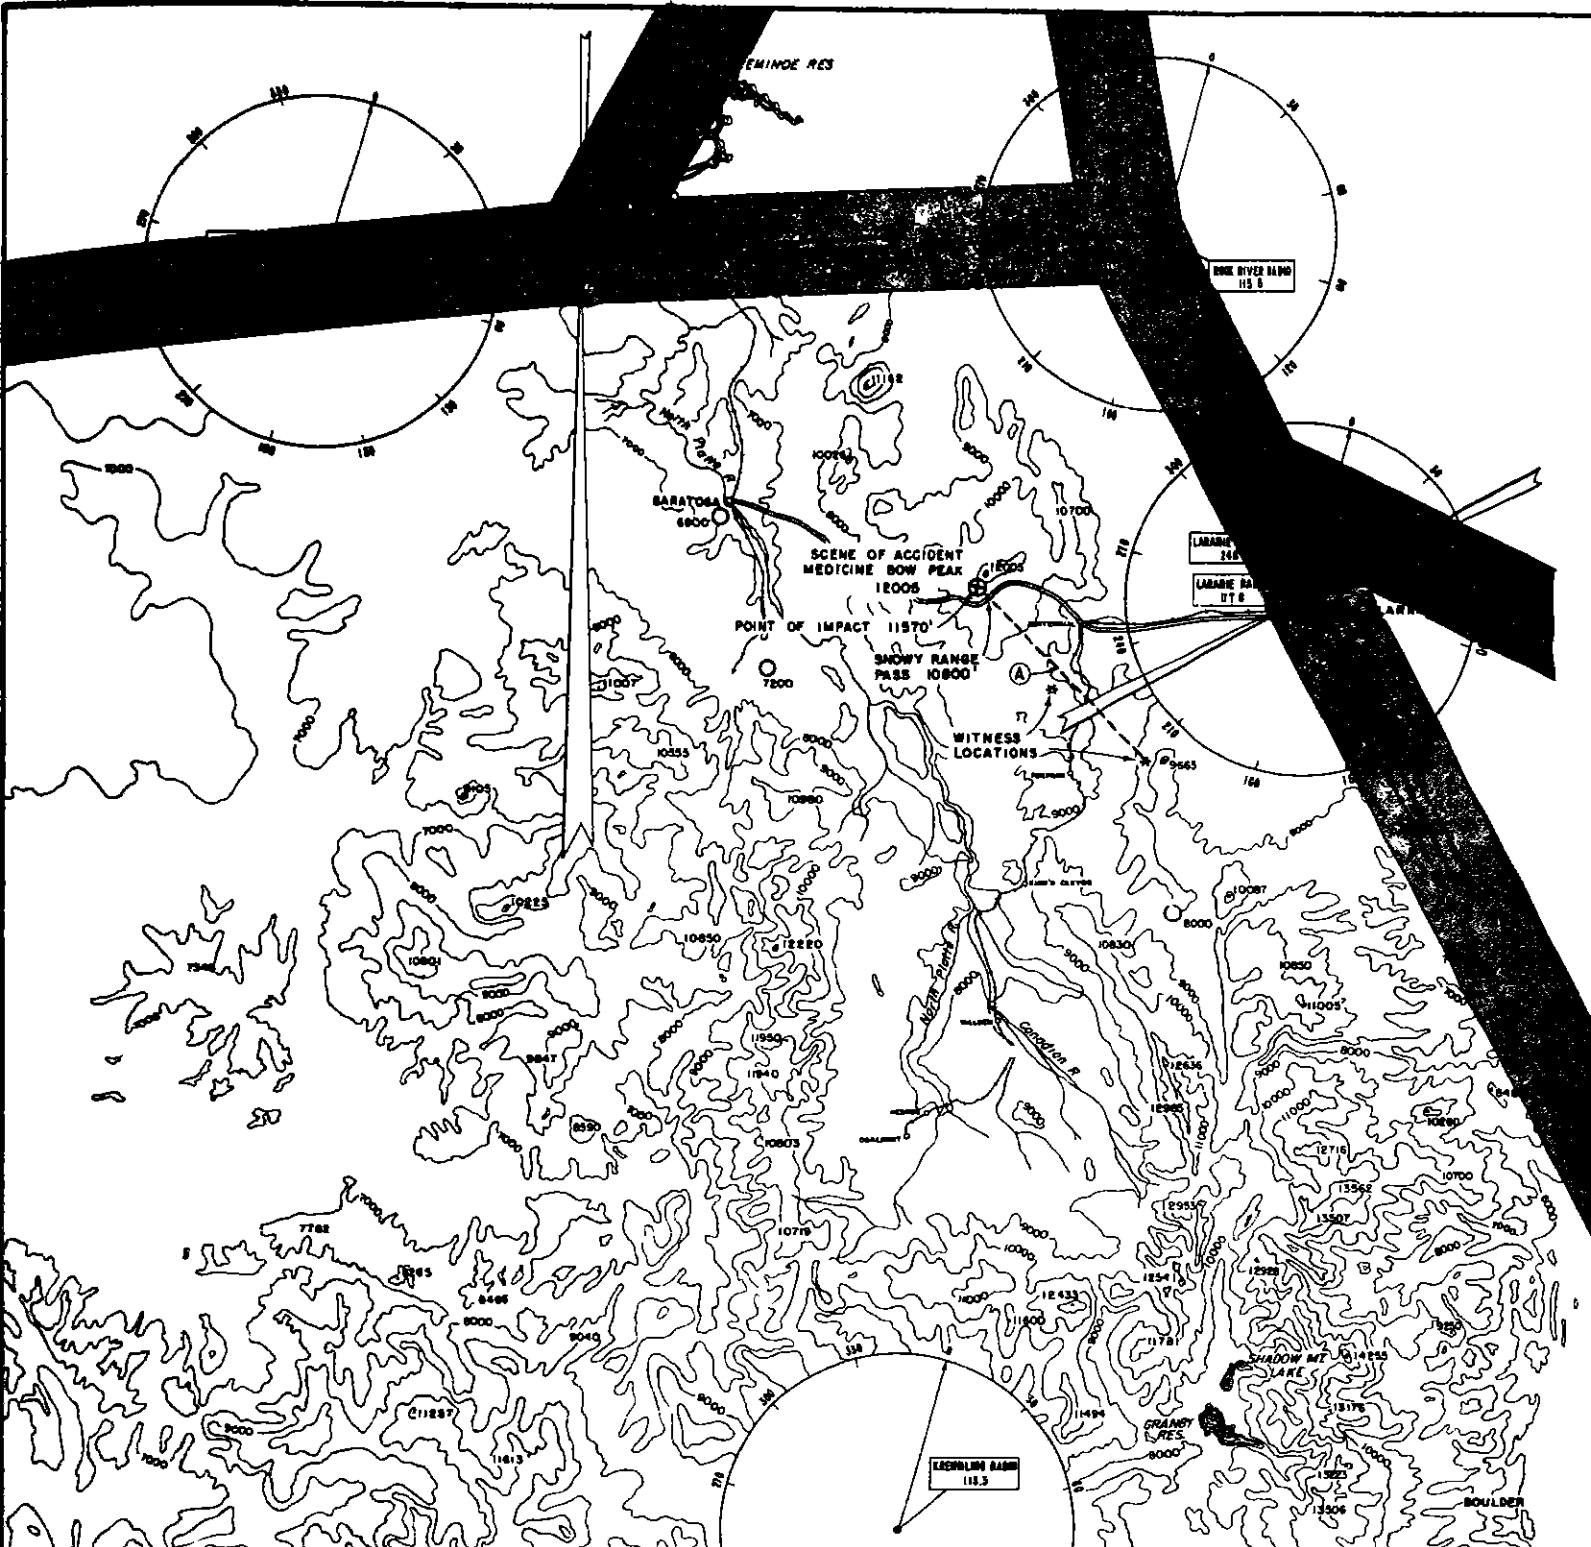
ATTACHMENT A  
 DEPARTURE ROUTE AND PROBABLE FLIGHT PATH  
 ACCIDENT AT MEDICINE BOW PEAK, WYOMING  
 ON OCTOBER 6, 1955  
 INVOLVING UAL DOUGLAS C-54B-DC. N30082

As a result of information obtained from the witnesses, a probable flight path was constructed. (See Attachment A.) This flight path, projected from the accident site on a magnetic heading of 120 degrees, covered a distance of approximately 23 miles. An extension of this flight path to the southeast crosses the planned route in the vicinity of Ft. Collins, Colorado, and to the northwest again crosses it near Rawlins, Wyoming.

It is obvious from the established flight path that the aircraft deviated from the planned route a number of miles to the west of course. Although witnesses close to the scene of the accident were unable to positively identify the aircraft they saw, in the light of known facts it is reasonable to assume that the aircraft seen was the United C-54. Therefore, it can be concluded that considering the weather conditions and mountainous terrain the aircraft was flying at a dangerously low altitude at that time.

A UAL captain testified that it was normal procedure for UAL pilots, during a climbout from Denver under VFR conditions, to fly several miles east of the airway. He said this was done to avoid incoming low-flying aircraft which usually begin their letdown near Fort Collins, Colorado. This fact was considered in computing probable flight data for Flight 409, from which it was determined that the flight reached its cruising altitude of 10,000 feet approximately 25 miles north of Denver. From this point a heading of approximately 315 degrees magnetic would have been required to fly to Laramie. From this same location a magnetic heading of 300 degrees would have been necessary to fly directly toward Medicine Bow Peak.
