CIVIL AERONAUTICS BOARD

ACCIDENT INVESTIGATION REPORT

BEECH BONANZA, N 5825C, NORTH HOLLYWOOD, CALIFORNIA,
OCTOBER 17, 1955

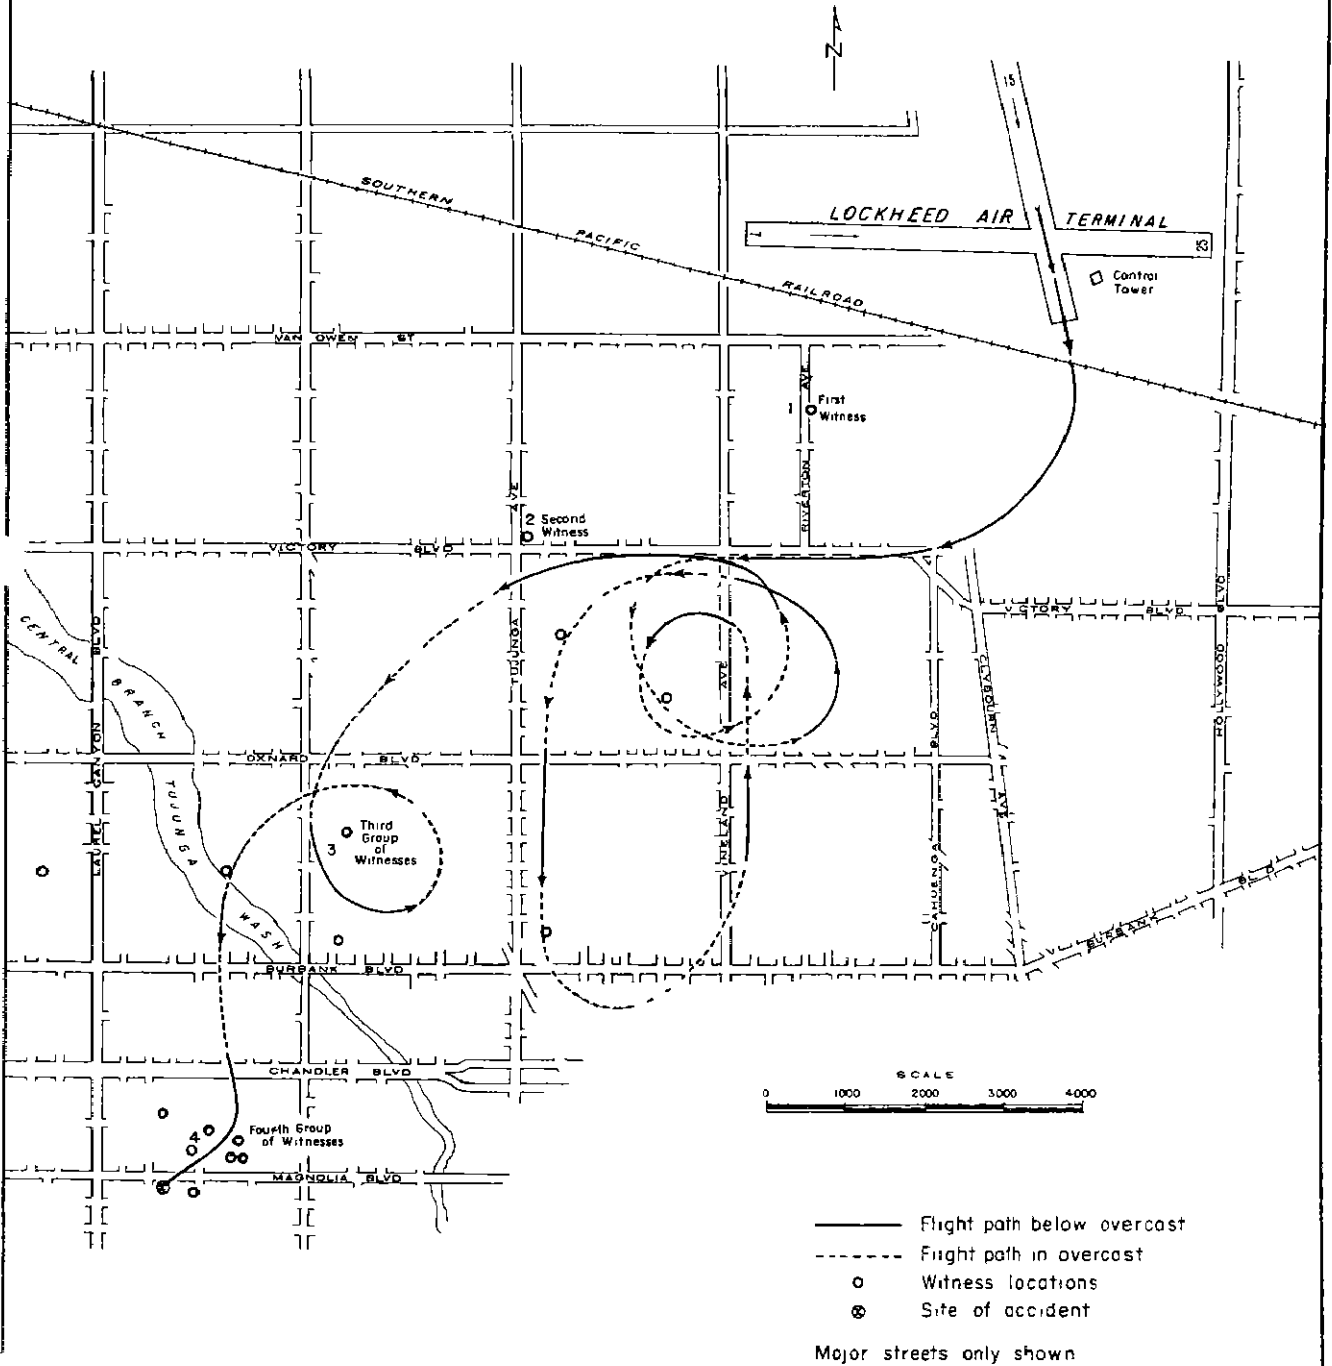
PROBABLE FLIGHT PATH OF BEECH BONANZA N-5825C NORTH HOLLYWOOD, CALIFORNIA

Many ground witnesses located south and southwest of the airport saw and/or heard N 25C in flight before it crashed into the apartment building. A representative group of these witnesses testified at the Board's public hearing concerning their observations and many others furnished formal statements during the investigation. From this source of information the probable flight path of the aircraft was reconstructed as accurately as possible and is shown as attachment A.
