CIVIL AERONAUTICS BOARD

ACCIDENT INVESTIGATION REPORT

RIDDLE AIRLINES, INC., C-46F, N 9904F, HOLLYWOOD, SOUTH CAROLINA
DECEMBER 17, 1955

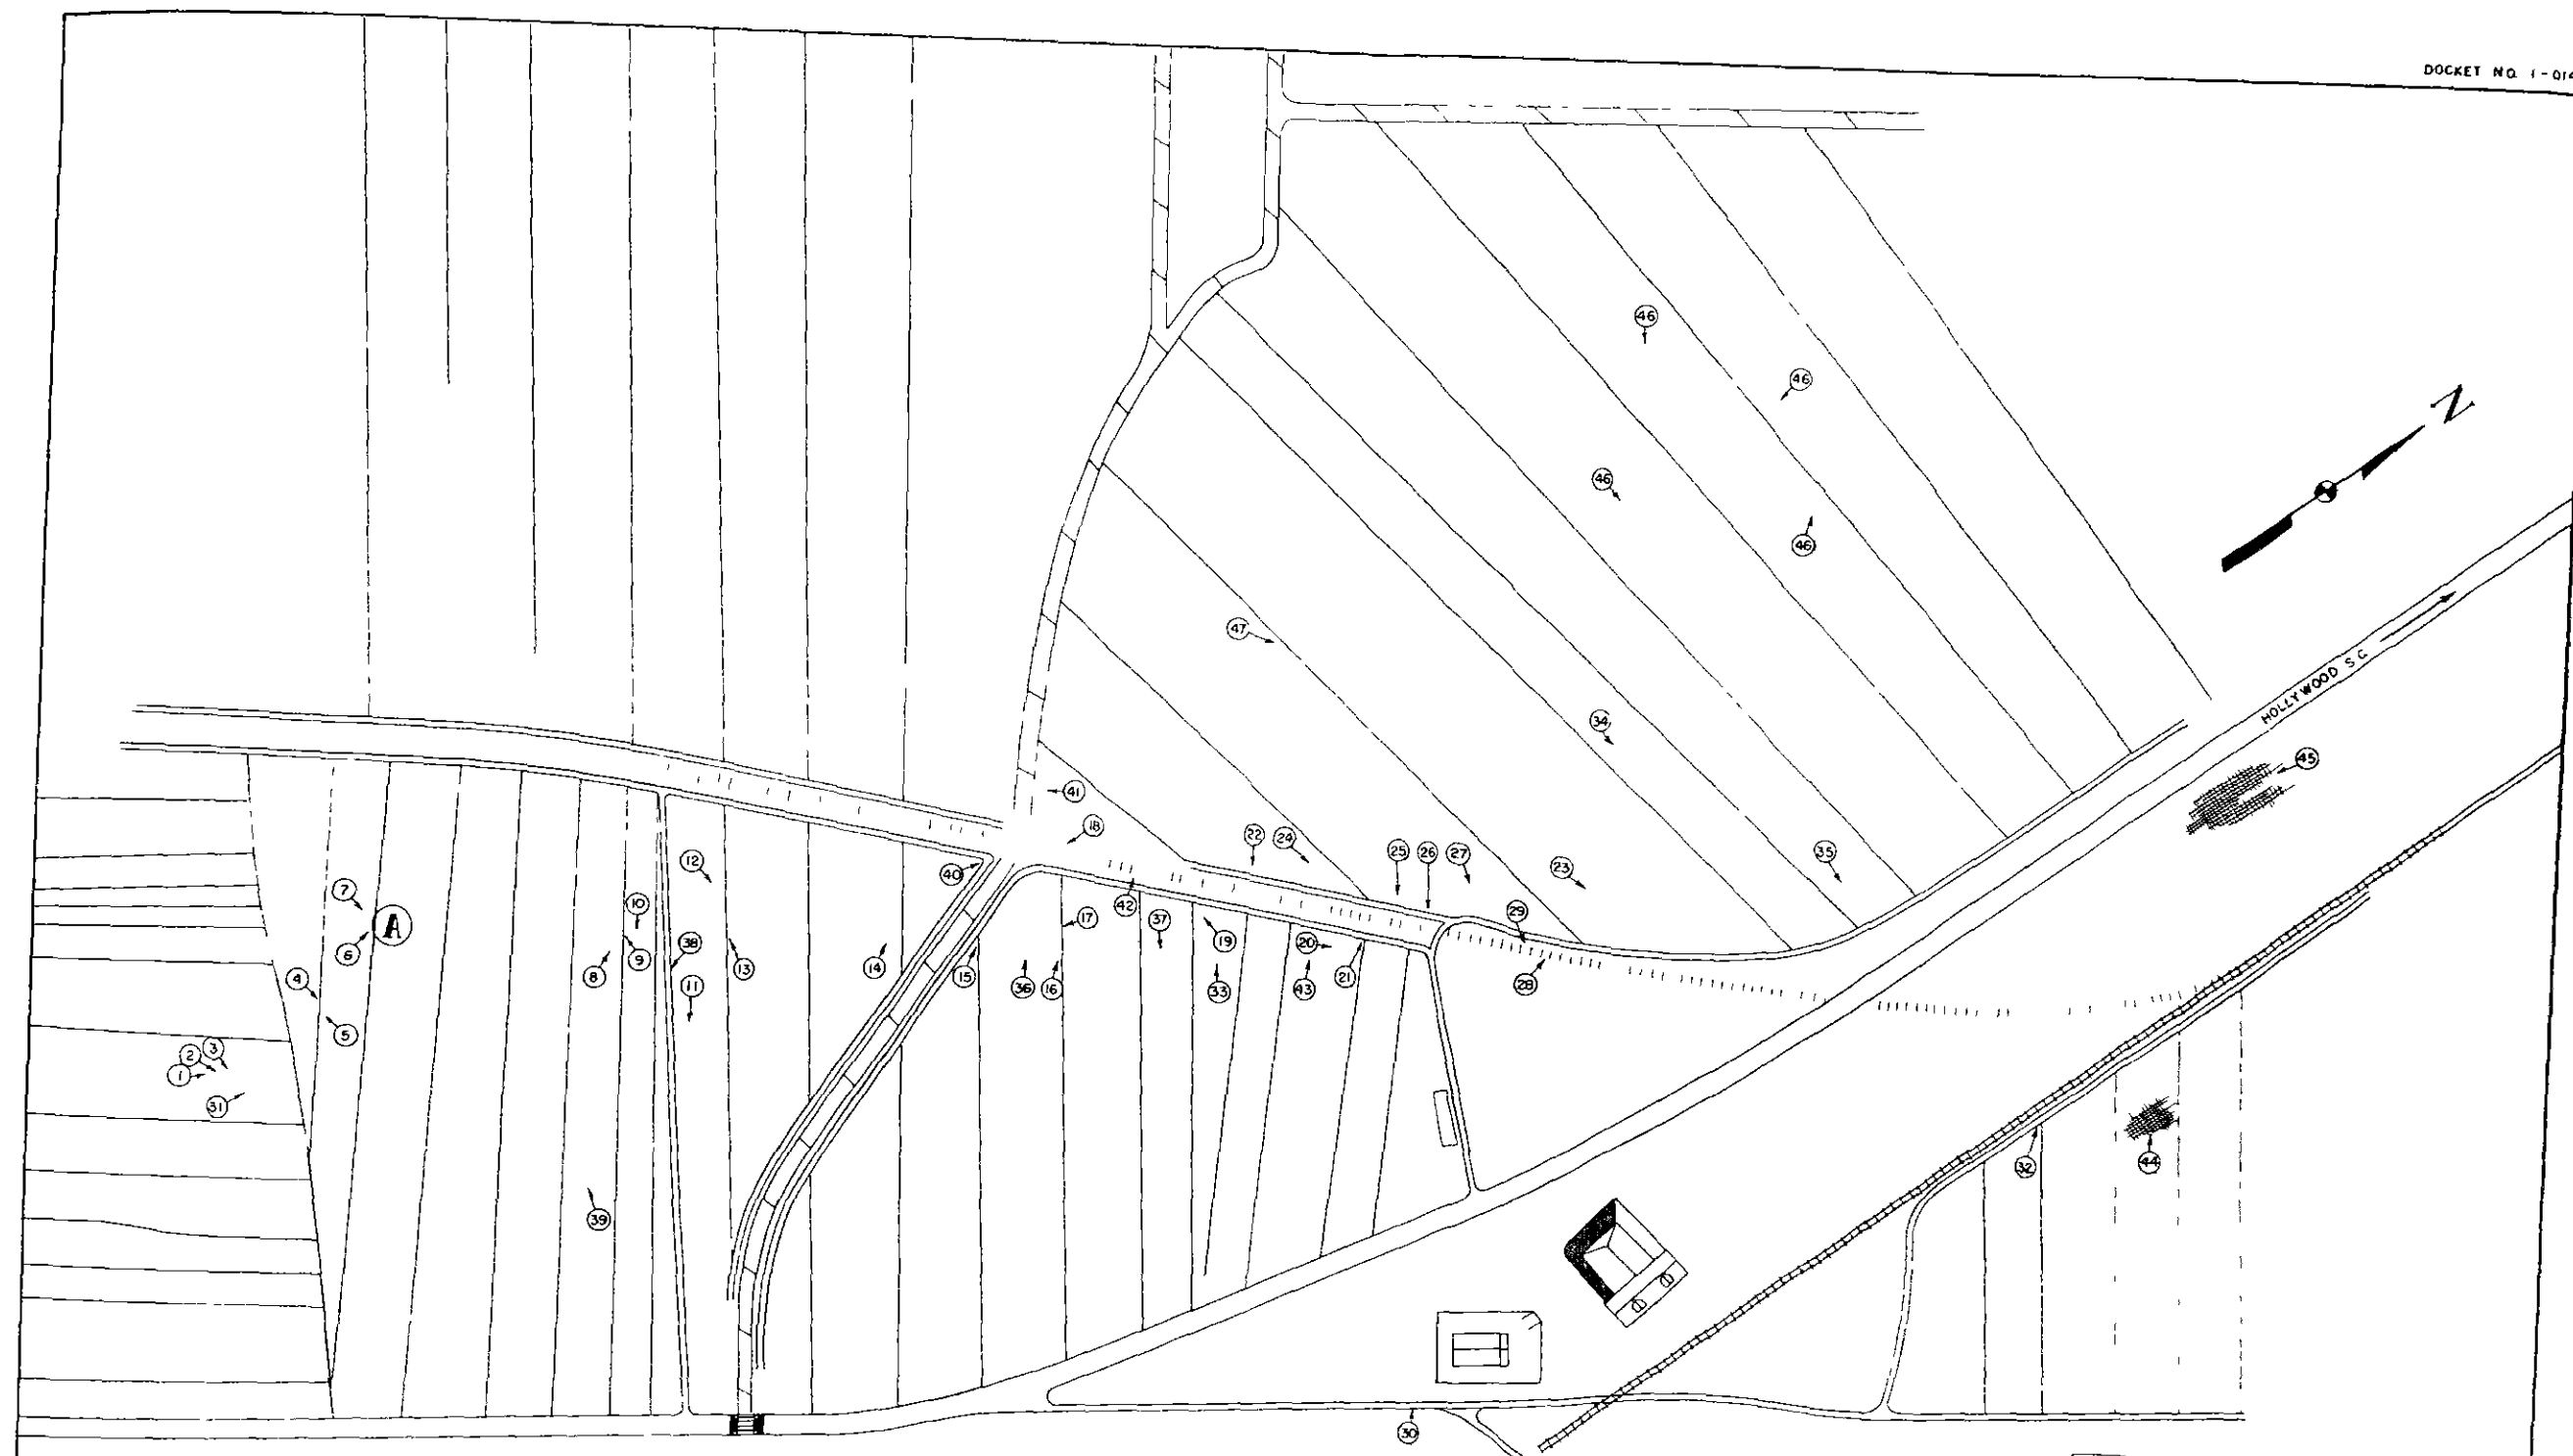
ATTACHMENT 1

The aircraft fragments fell to the ground within an area measuring approximately 2,500 feet north to south and 700 feet east to west. Distribution of the larger fragments and the identity of each are shown in Attachment 1.

The right wing was found 1,118 feet northeast of the main wreckage, the vertical fin approximately 937 feet northeast, the right stabilizer and an inboard elevator section approximately 1,380 feet northeast by east, and the left stabilizer and an inboard elevator section approximately 825 feet north. Most of the remaining empennage, sections of the flap and right wing, left wheel well doors, the three right wing fuel tanks, sections of windshield, and various other small parts were strewn over the same general area.

The main wreckage consisted of the fuselage, wing center section, right engine and propeller assembly, landing gears, and left wing. The entire left power package, including the engine, propeller, cowlings, and the nacelle forward of the wing front spar, was found approximately 312 feet south of the main wreckage.
