CIVIL AERONAUTICS BOARD

ACCIDENT INVESTIGATION REPORT

GULF OIL CORPORATION, LOCKHEED LODESTAR, N 33366,
NEAR LONDONDERRY, OHIO, DECEMBER 29, 1955

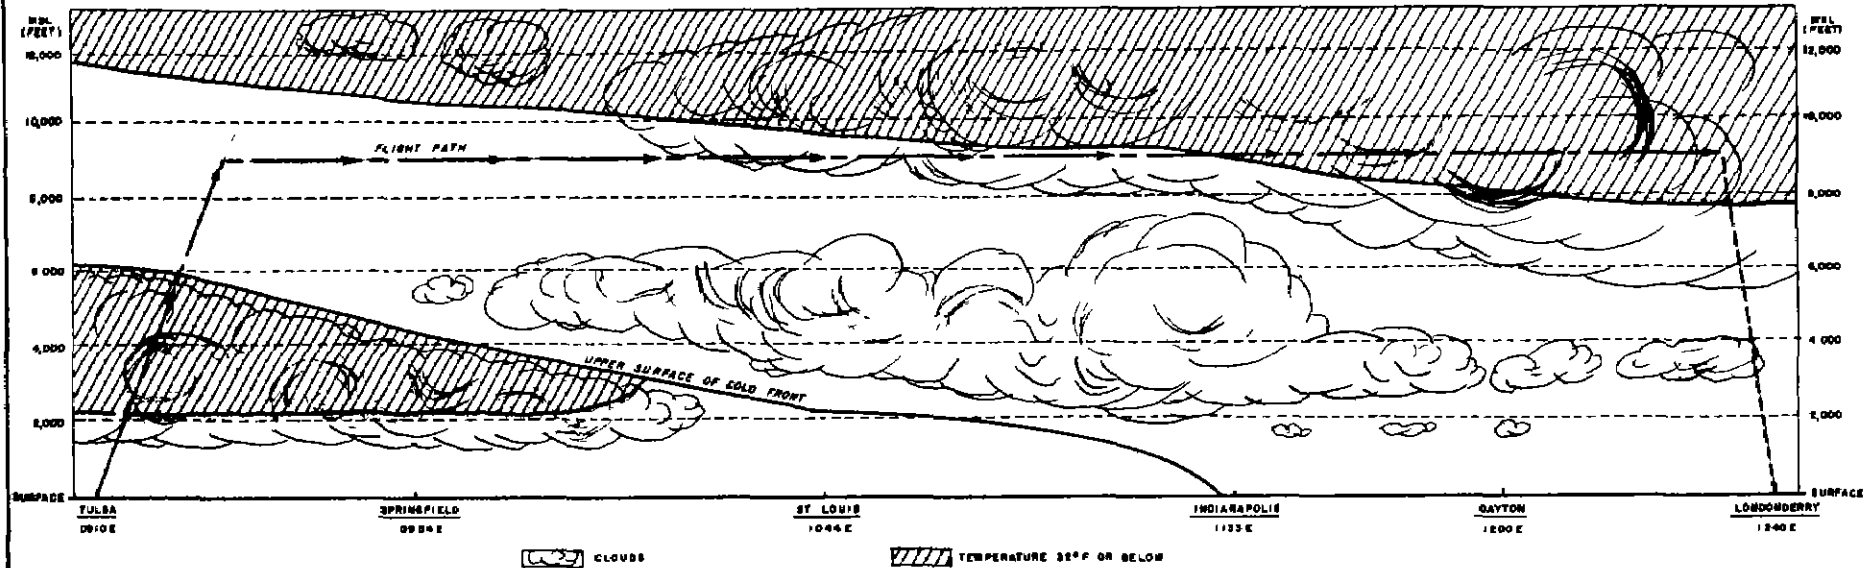
VERTICAL CROSS SECTION OF ROUTE TULSA, OKLAHOMA TO LONDONDERRY, OHIO
 SHOWING THE PROBABLE FLIGHT TRACK OF LOCKHEED LODESTAR N33366 AND THE WEATHER
 DECEMBER 29, 1966

Although icing was forecast for only the altitudes from 10,000 feet up, it actually occurred at altitudes as low as 8,000 feet. After flying in an icing condition in excess of 30 minutes, Pilot Silva received clearance to descend to 8,000 feet, and at 1237 he reported leaving 9,000 feet. This was his last communication.
