CIVIL AERONAUTICS BOARD

ACCIDENT INVESTIGATION REPORT

PIEDMONT AIRLINES, DC-3C N 45V,
NEAR SHELBY, NORTH CAROLINA, JUNE 13, 1956The Accident

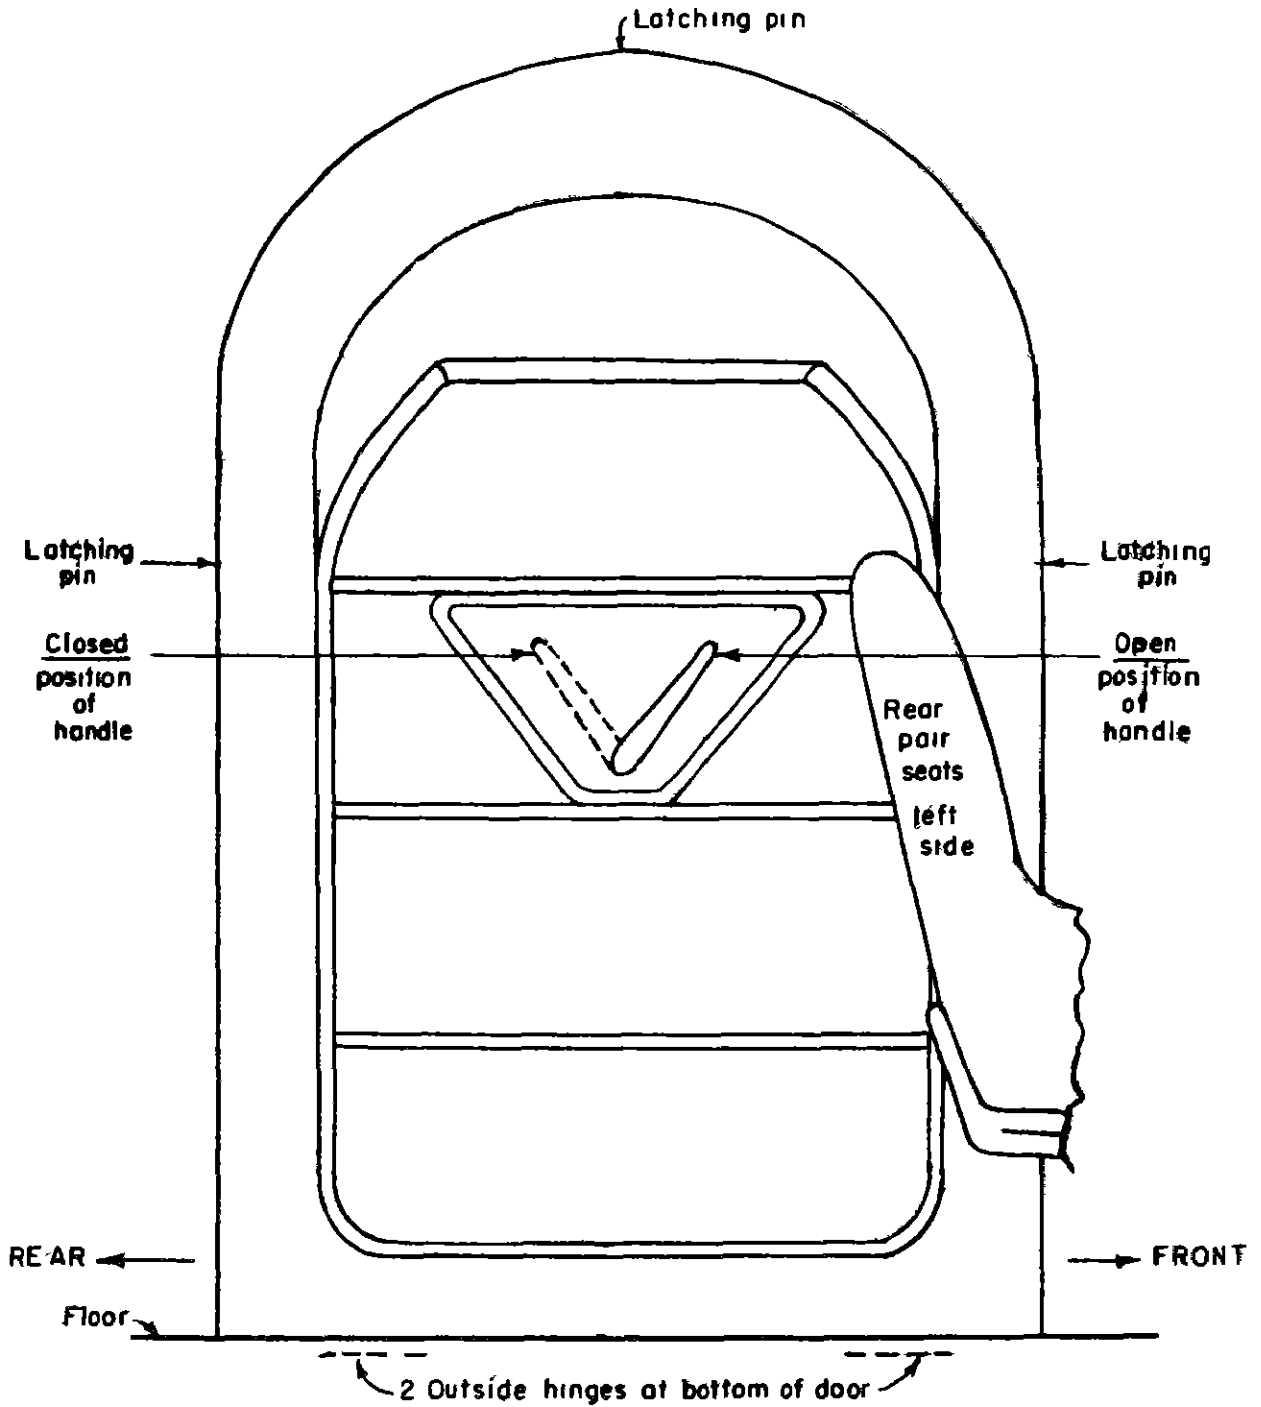
ATTACHMENT A

The door latch mechanism is actuated by a five-inch lever handle pivoted at its lower end and recessed in the center of the step riser between the second and third step from the top of the door when viewed from the closed position. The handle is approximately waist-high when the door is closed. Latching of the door is accomplished by rotating the lever handle approximately 90 degrees counterclockwise through an arc of approximately 6-1/2 inches. This extends three tapered latch pins 1-3/4 inches into the doorframe in the fuselage. Inspection windows are installed in the fuselage so that engagement of the latch pins can be checked. The lever handle is held in the locked or unlocked position by a detent-type friction plate, which is also a part of the latching mechanism. There are three warning lights installed - one near the outside of the door, another at the purser's station in the cabin, and a third on the pilot's instrument panel. When the door is closed and latched all warning lights go off. When the lever handle is moved clockwise or toward the open position approximately one-half inch, the three warning lights come on. The handle movement continues more than two inches before the latch pins start to move slowly from their closed position. When the pins are retracted sufficiently for the door to open the lever handle has traveled 70 or 75 degrees of the full 90-degree movement. This 90-degree movement is 45 degrees on either side of vertical. (See attachment A.)

In the main cabin door installation of N 45V there was no means of preventing the door from fully opening if the latches were inadvertently actuated. Investigation revealed that the door can be opened accidentally. Many operators of DC-3 aircraft equipped with air stair doors have a safety device installed, such as a quickly removable chain preventing full door opening, or a means of retarding movement of the unsafeguarded door latch handle.

There have been several accidental openings of the air stair door on aircraft operated by other air carriers. These incidents were without fatality or injury because of the installation of safeguards on the door. Since this accident Piedmont Airlines has installed on its entire fleet a means of safeguarding against accidental opening of the door. As a result of its investigation of this accident, the Civil Aeronautics Board recommended to the Administrator of Civil Aeronautics that an Airworthiness Directive be issued requiring correction of this unsafe condition.
