CIVIL AERONAUTICS BOARD

ACCIDENT INVESTIGATION REPORT

TRANS WORLD AIRLINES, INC., LOCKHEED 1049A, N 6902C, AND
UNITED AIR LINES, INC., DOUGLAS DC-7, N 6324C,
GRAND CANYON, ARIZONA, JUNE 30, 1956

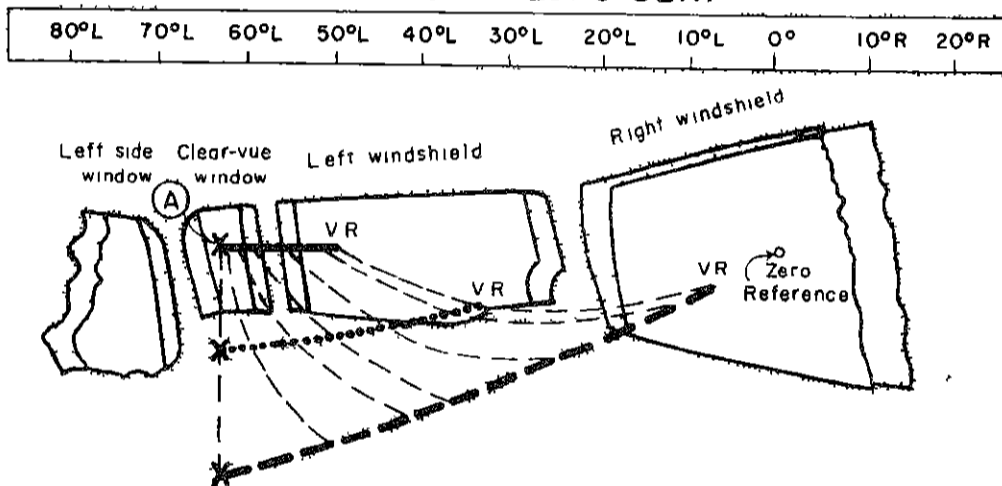
VIEW FROM CO-PILOT'S SEAT

With respect to the DC-7 first officer's position, the L-1049 was within the angular limits of the DC-7 window area during two of the limit considerations and during the early part of the other two. In the "no cloud" factor situations the L-1049 would have been near maximum visual range in two conditions, without relative motion in one, and with relative motion in another. Time opportunity without intervening clouds and with both aircraft straight and level was 120 seconds. For the other three considerations, including the intervening cloud condition, the opportunity varied from 12 seconds to 50 seconds.
