C I V I L A E R O N A U T I C S B O A R D
ACCIDENT INVESTIGATION REPORTAdopted: April 22, 1957Released: April 25, 1957CONTINENTAL AIR LINES DC-3A, N 33315, AND CESSNA 170B,
N 8143A, BARTLESVILLE, OKLAHOMA, SEPTEMBER 9, 1956The Accident

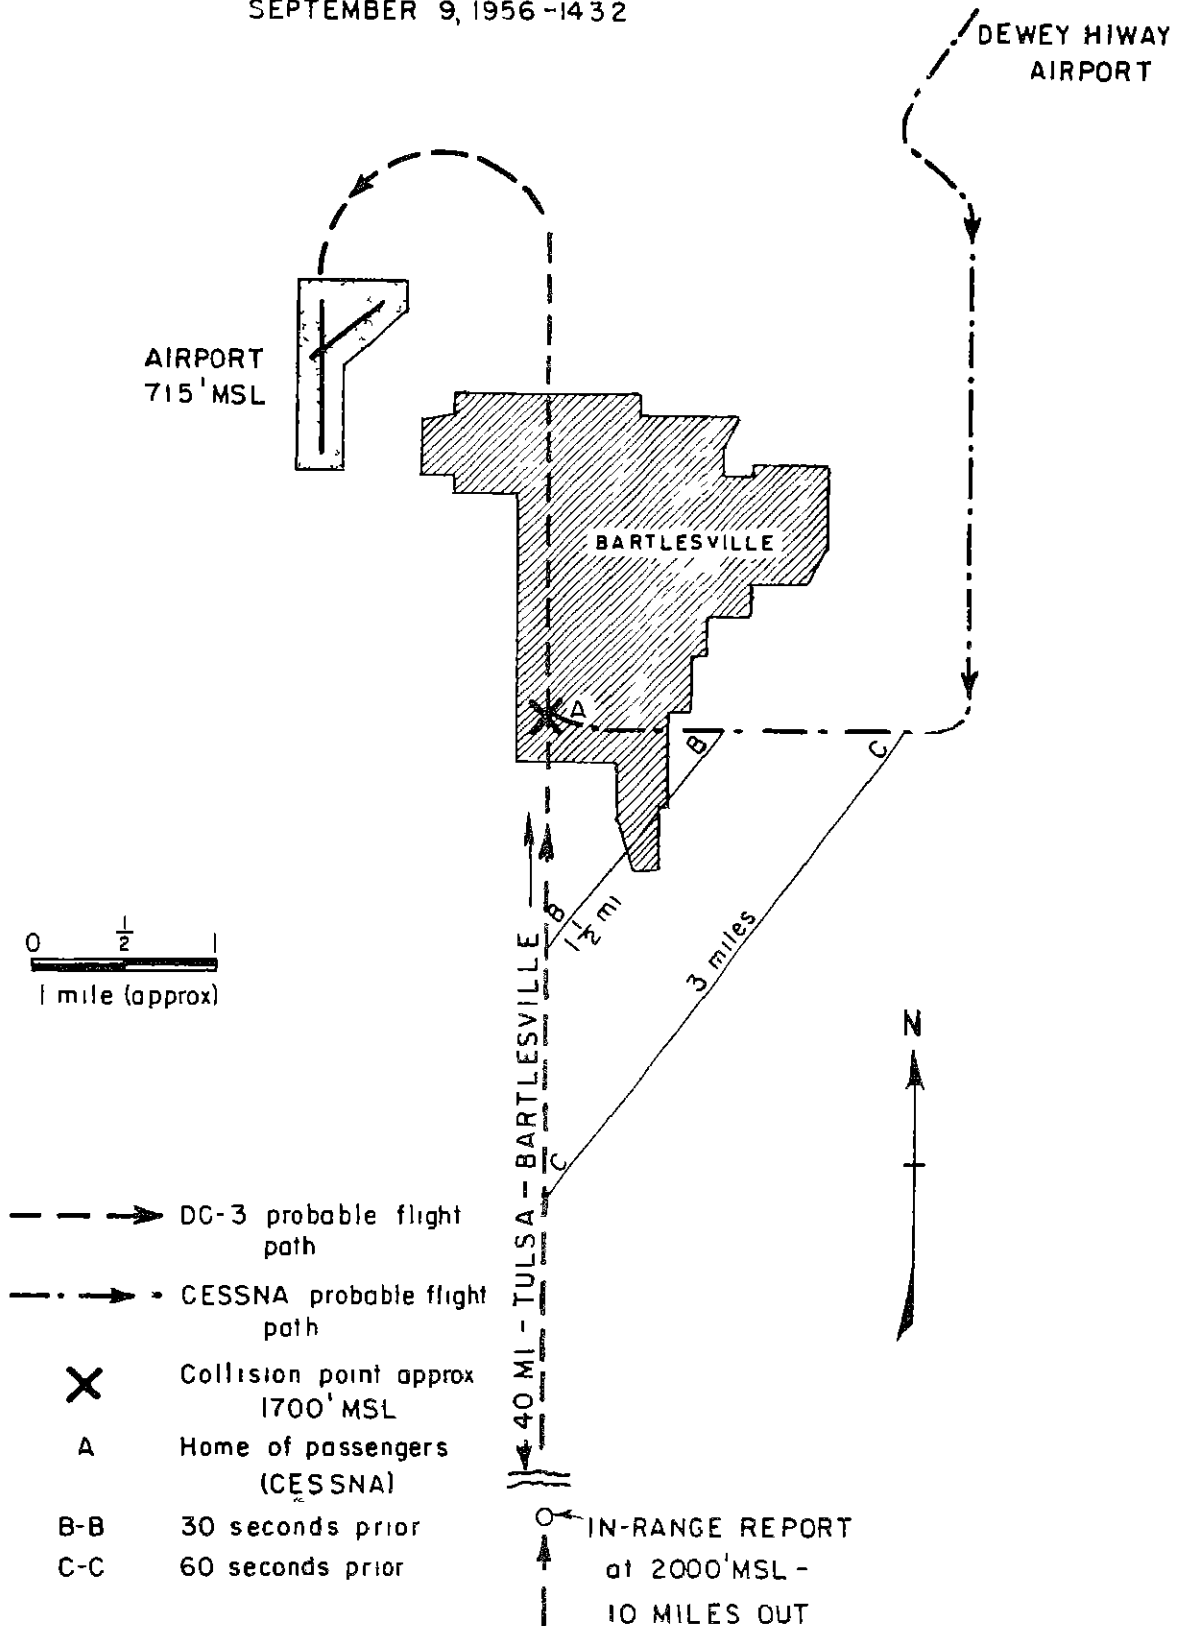
CAL DC-3 N33315 AND CESSNA N8143A
 BARTLESVILLE, OKLA
 SEPTEMBER 9, 1956 -1432

Computations, using the angles of the propeller cuts on the DC-3 aileron and tail surfaces, the Cessna propeller r. p. m. and diameter, and the furnished airspeeds, produce the following results: Angle of convergence of the two aircraft - 44 degrees; rate of closure - 98 m. p. h. (144 feet per second); viewing angle of Cessna from DC-3 - 52 degrees to the right; viewing angle of DC-3 from Cessna - 84 degrees to the left.

westward, 60 seconds before the collision,^{2/} the DC-3 was three miles away and about 45 degrees to the left of the forward view from the Cessna. Thirty seconds before the collision the DC-3 was 1-1/2 miles away at the same bearing. The altitudes of both aircraft could not have differed more than 100-200 feet during this time. Regardless of the sun's position and the reported haze, it seems that regular scanning of the horizon by the Cessna pilot during the last minute or so before the collision would have revealed the DC-3.
