## CIVIL AERONAUTICS BOARD

**ACCIDENT INVESTIGATION REPORT**

NORTHEAST AIRLINES, INC., DC-6A, N 34954,  
RIKERS ISLAND, NEW YORK, FEBRUARY 1, 1957

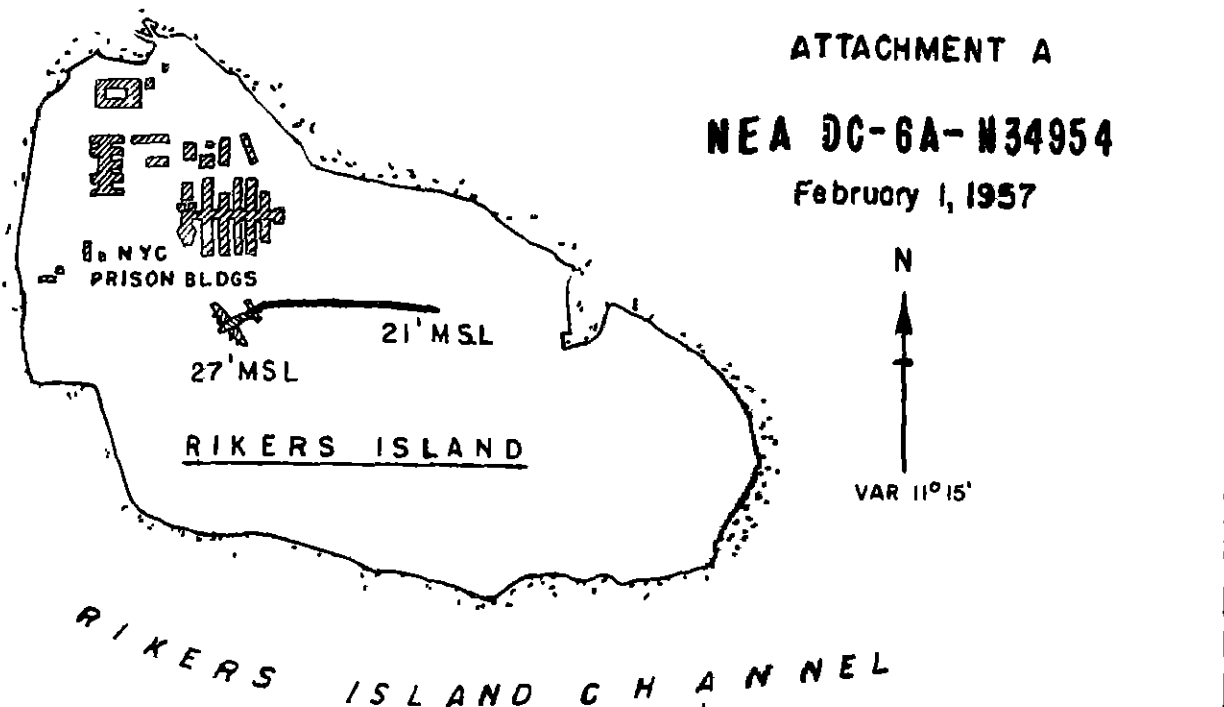
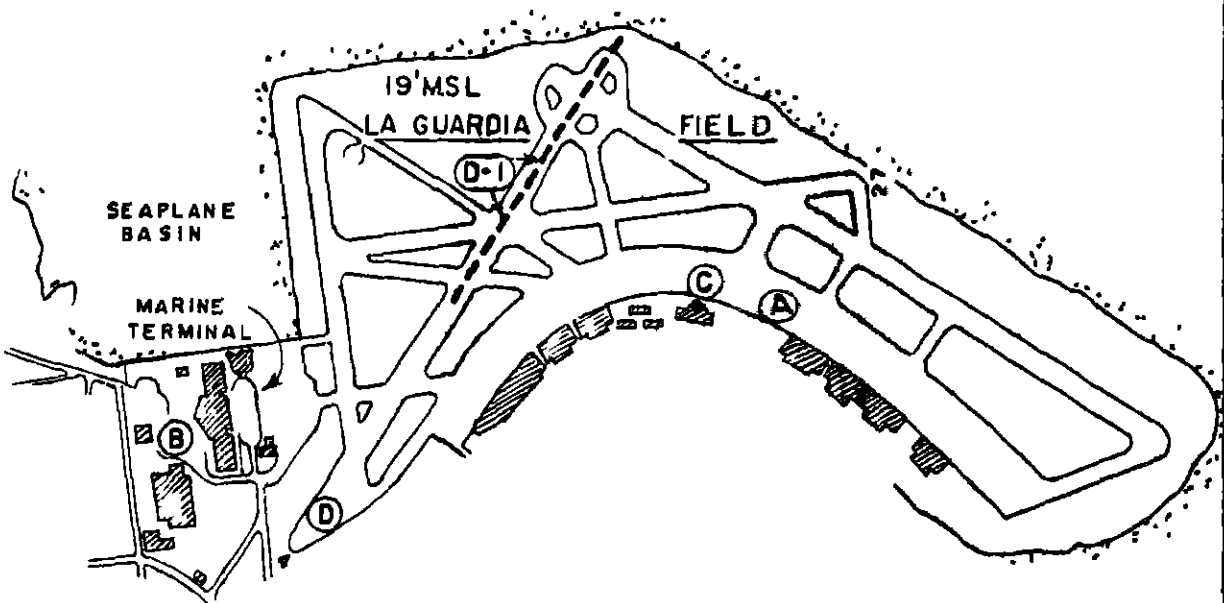
- A Passenger loading position
- B Nose hangar area (snow removal)
- C La Guardia control tower
- D Start of take-off (D-1) airborne
- Take-off observed from tower
