ACCIDENT INVESTIGATION REPORT

NEW YORK AIRWAYS, INC., BELL HELICOPTER MODEL 47H, N 2492B,
FARMINGDALE, L. I., NEW YORK, OCTOBER 19, 1957

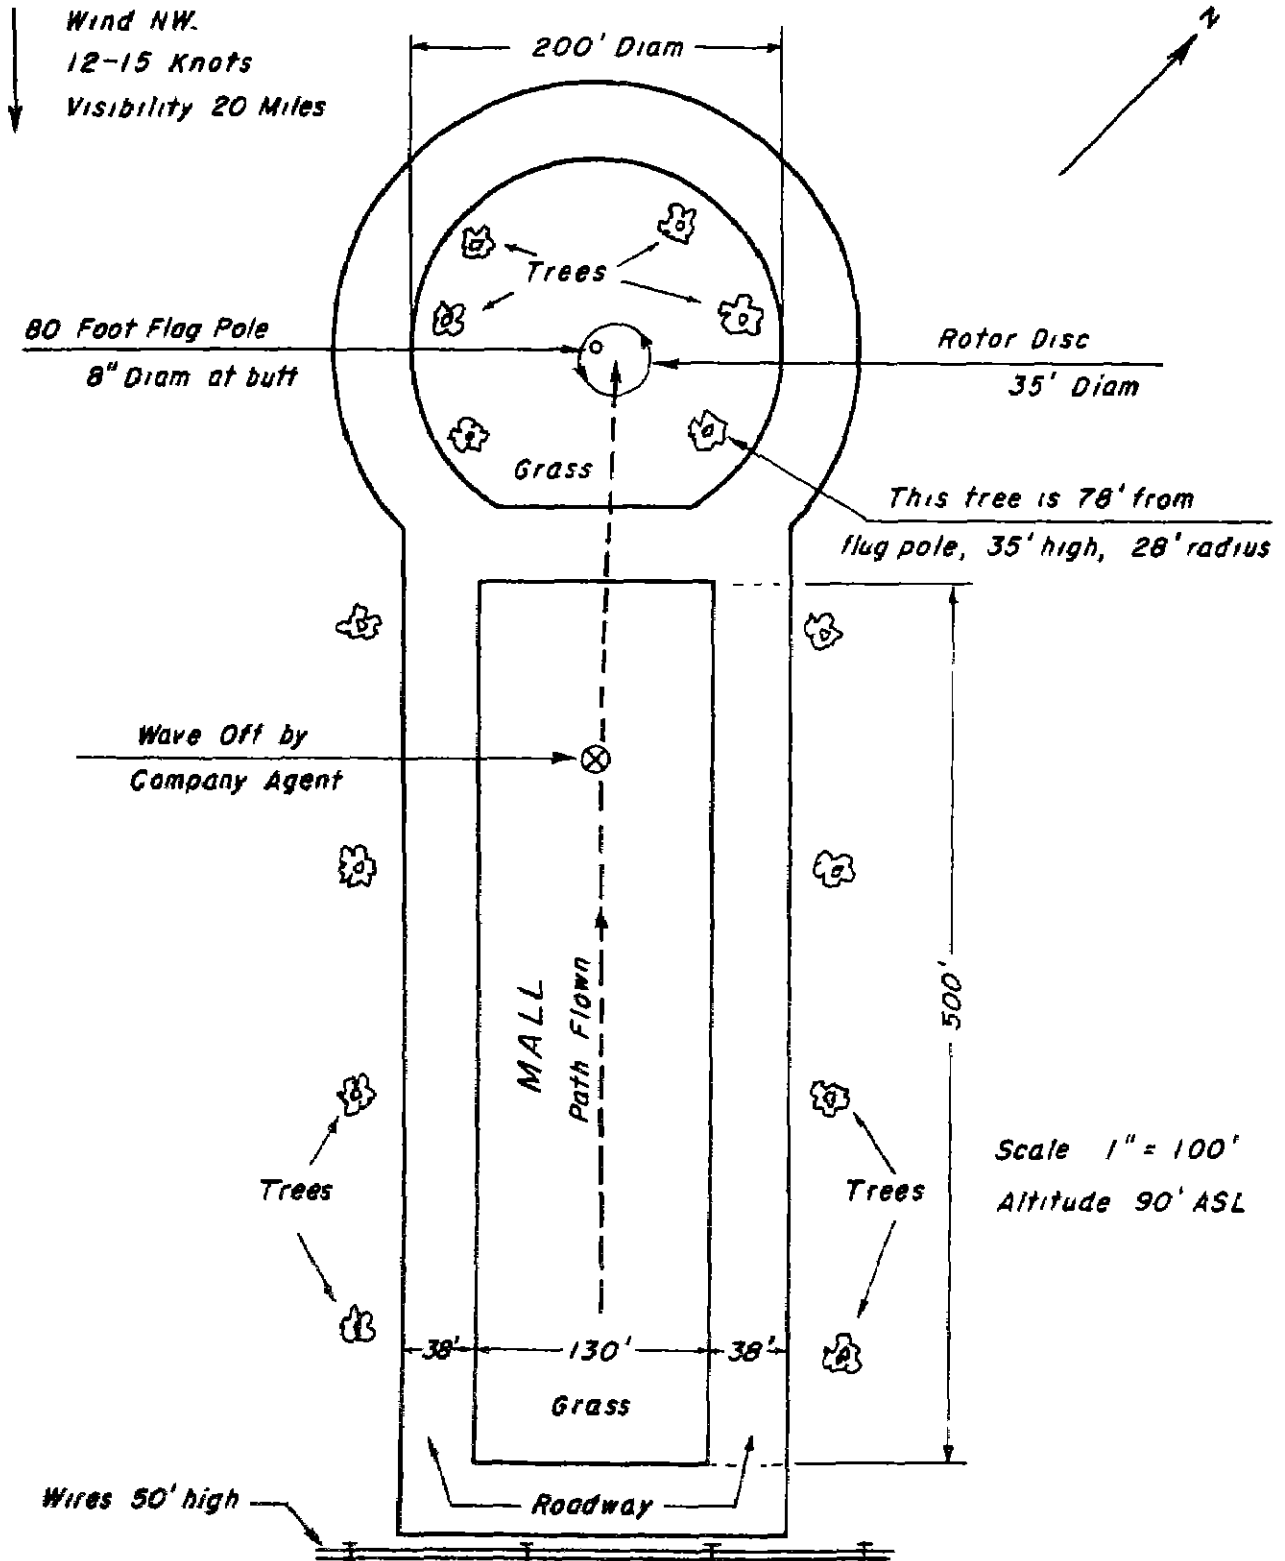
ATTACHMENT "A"

The descent approach into the mall was steep, over wires, and into the wind. (See attachment A.) The ground agent on the mall had not received instructions to display the landing signal, so he waved off the flight, the nearby bed sheet remaining folded compactly on the ground. Captain Rushton, observing the signal not to land, brought the helicopter to a height of about 10 feet and flew down the mall. After passing over the ground agent, the helicopter continued ahead climbing slightly and also turning slightly to its right. (Again refer to attachment A.) The main blades struck the flagpole on the left side of the aircraft (blades retreating).

Reference to the attachment, which is to scale, will show that there was actually room for the helicopter to have passed between the flagpole and the nearest tree, located in the circle, 78 feet east of the flagpole.

Captain Rushton testified that following his descent into the mall, over the wires and into the wind as shown on attachment A, he started to air taxi toward the company agent. The descent was steep using about 18 inches of manifold pressure at an airspeed of 30-40 knots. Almost at once he saw the wave-off signal. He applied the maximum engine speed of 3,100 r. p. m. and 28 inches of manifold pressure in preparation to climb and circle the area while waiting for the signal to land. At this time, the captain testified, he became aware of a 200 r. p. m. drop. About this time people on the ground noticed a slight lateral oscillation in the tail section. Captain Rushton reduced collective pitch and nosed down to maintain speed. The r. p. m. came back to a normal 3,100 and he then again increased the collective pitch to resume climbing. The captain's testimony continues that the r. p. m. again dropped about 200, whereupon he became concerned with finding a landing spot ahead. He did not start an autorotation type of descent because of danger to people who were, so the captain stated, moving into his path ahead. Instead he decided to try to reach a point to the right of and beyond the flagpole which was clear of people. At this time the rotor blades struck the pole. No backfiring or engine roughness was noted at any time by the pilot, the surviving passenger, the ground agent, or by people on the ground.
