CIVIL AERONAUTICS BOARD

AIRCRAFT ACCIDENT REPORT

BRANIFF AIRWAYS, INC., DOUGLAS DC-7C, N 5904,
MIAMI, FLORIDA, MARCH 25, 1958

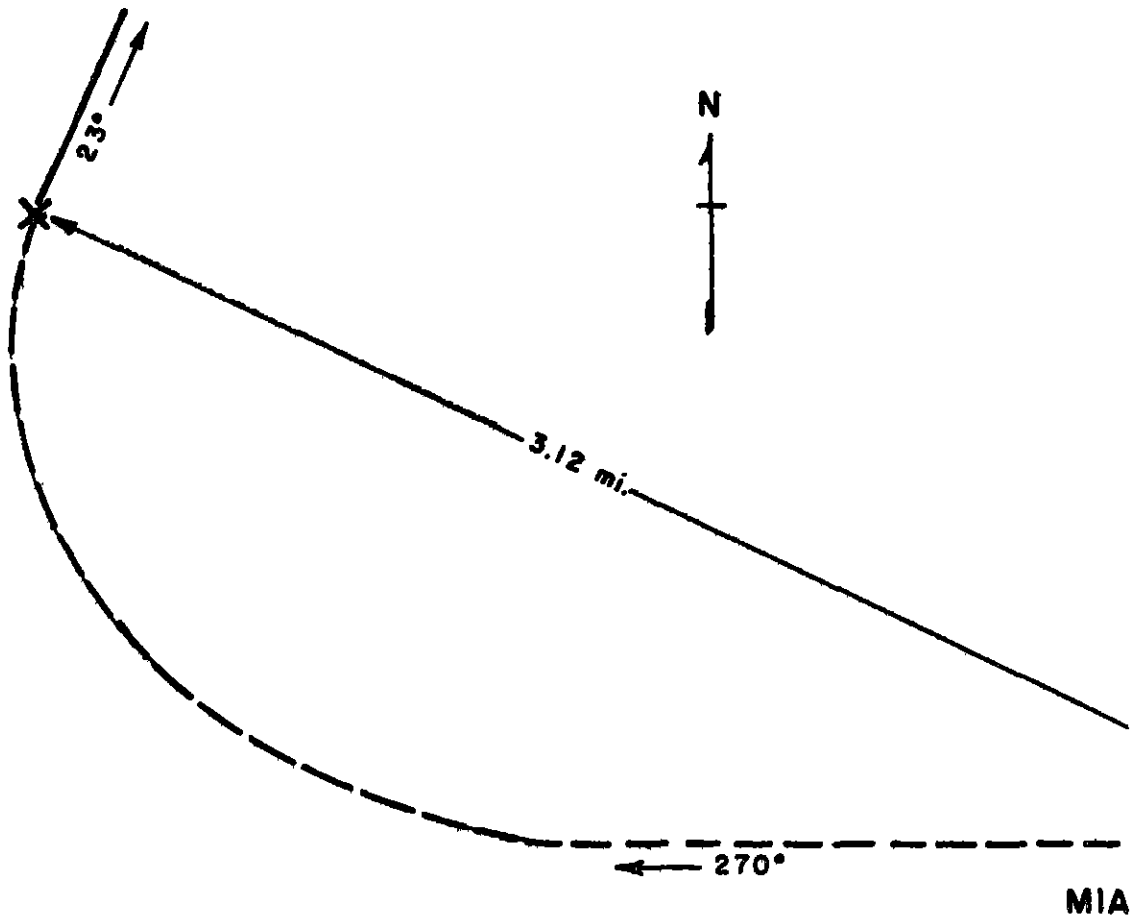
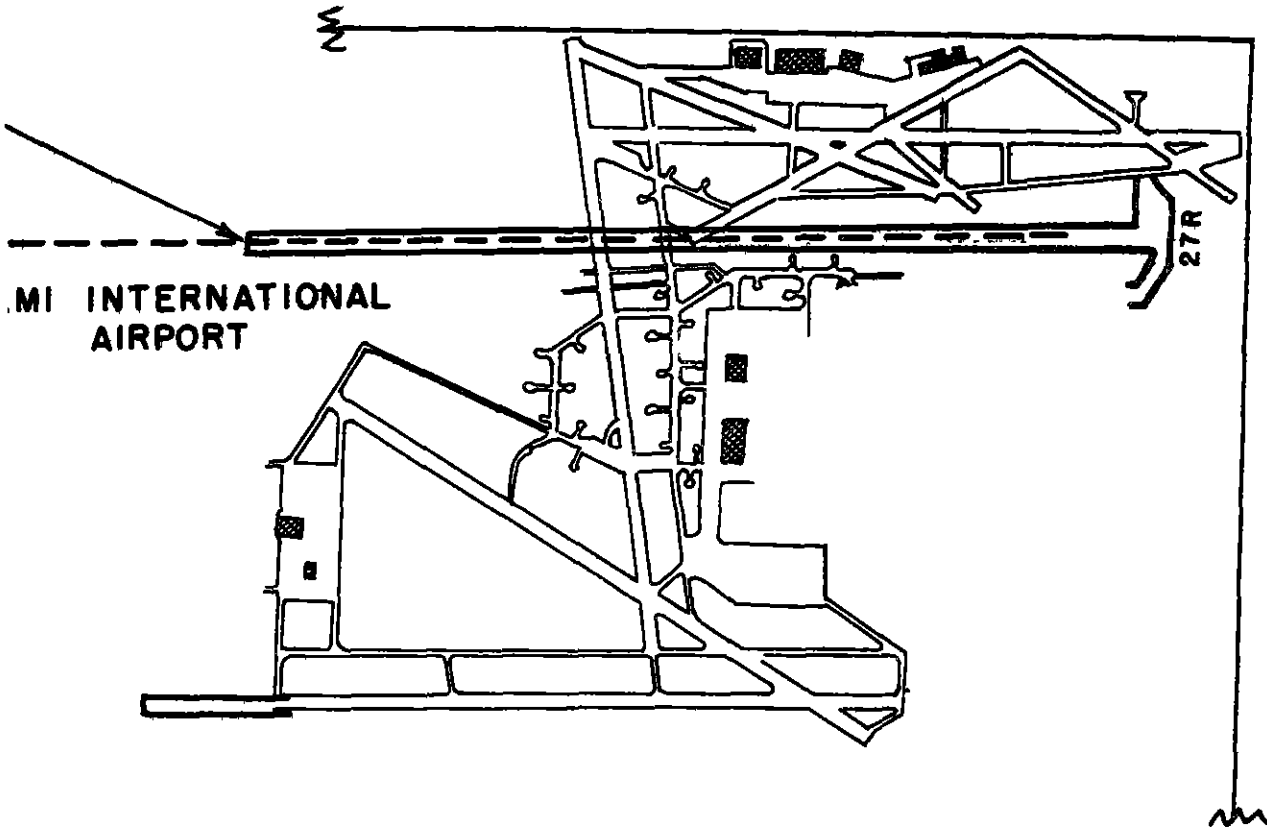
ATTACHMENT A.

The wreckage was strewn along a half-mile track^{2/} on a heading of 023 degrees. The fuselage structure broke into three major sections. After separating at station 600 the aft section, with the tail surfaces still attached, skidded and rolled almost the entire length of the main ground path. This portion came to rest on its left side about 100 yards to the left of the ground path on an easterly heading. The vertical and horizontal surfaces separated and were found nearby. The cockpit and forward portion of the fuselage, broken at station 440, was found in an upright position approximately 1,800 feet from the point of initial impact, on a heading of 285 degrees. The damage to the top of the forward fuselage section was relatively light. The lower forward part of this section was ground down and destroyed during the skid. The middle portion of the fuselage, a part of which remained attached to the wing center section, was found approximately 2,100 feet from the point of initial contact. This section, which was inverted during a portion of the ground skid, came to rest right side up. During the time it was inverted the entire upper portion of the fuselage down to the wing fillets was destroyed. The left-hand wing center section was consumed by an intense ground fire.

----- Take off and probable flight path
————— Wreckage path
