CIVIL AERONAUTICS BOARD

AIRCRAFT ACCIDENT REPORT

AAXICO (AMERICAN AIR EXPORT AND IMPORT COMPANY), CURTISS C-46,
N 5140B, DYESS AIR FORCE BASE, ABILENE, TEXAS, SEPTEMBER 2, 1959

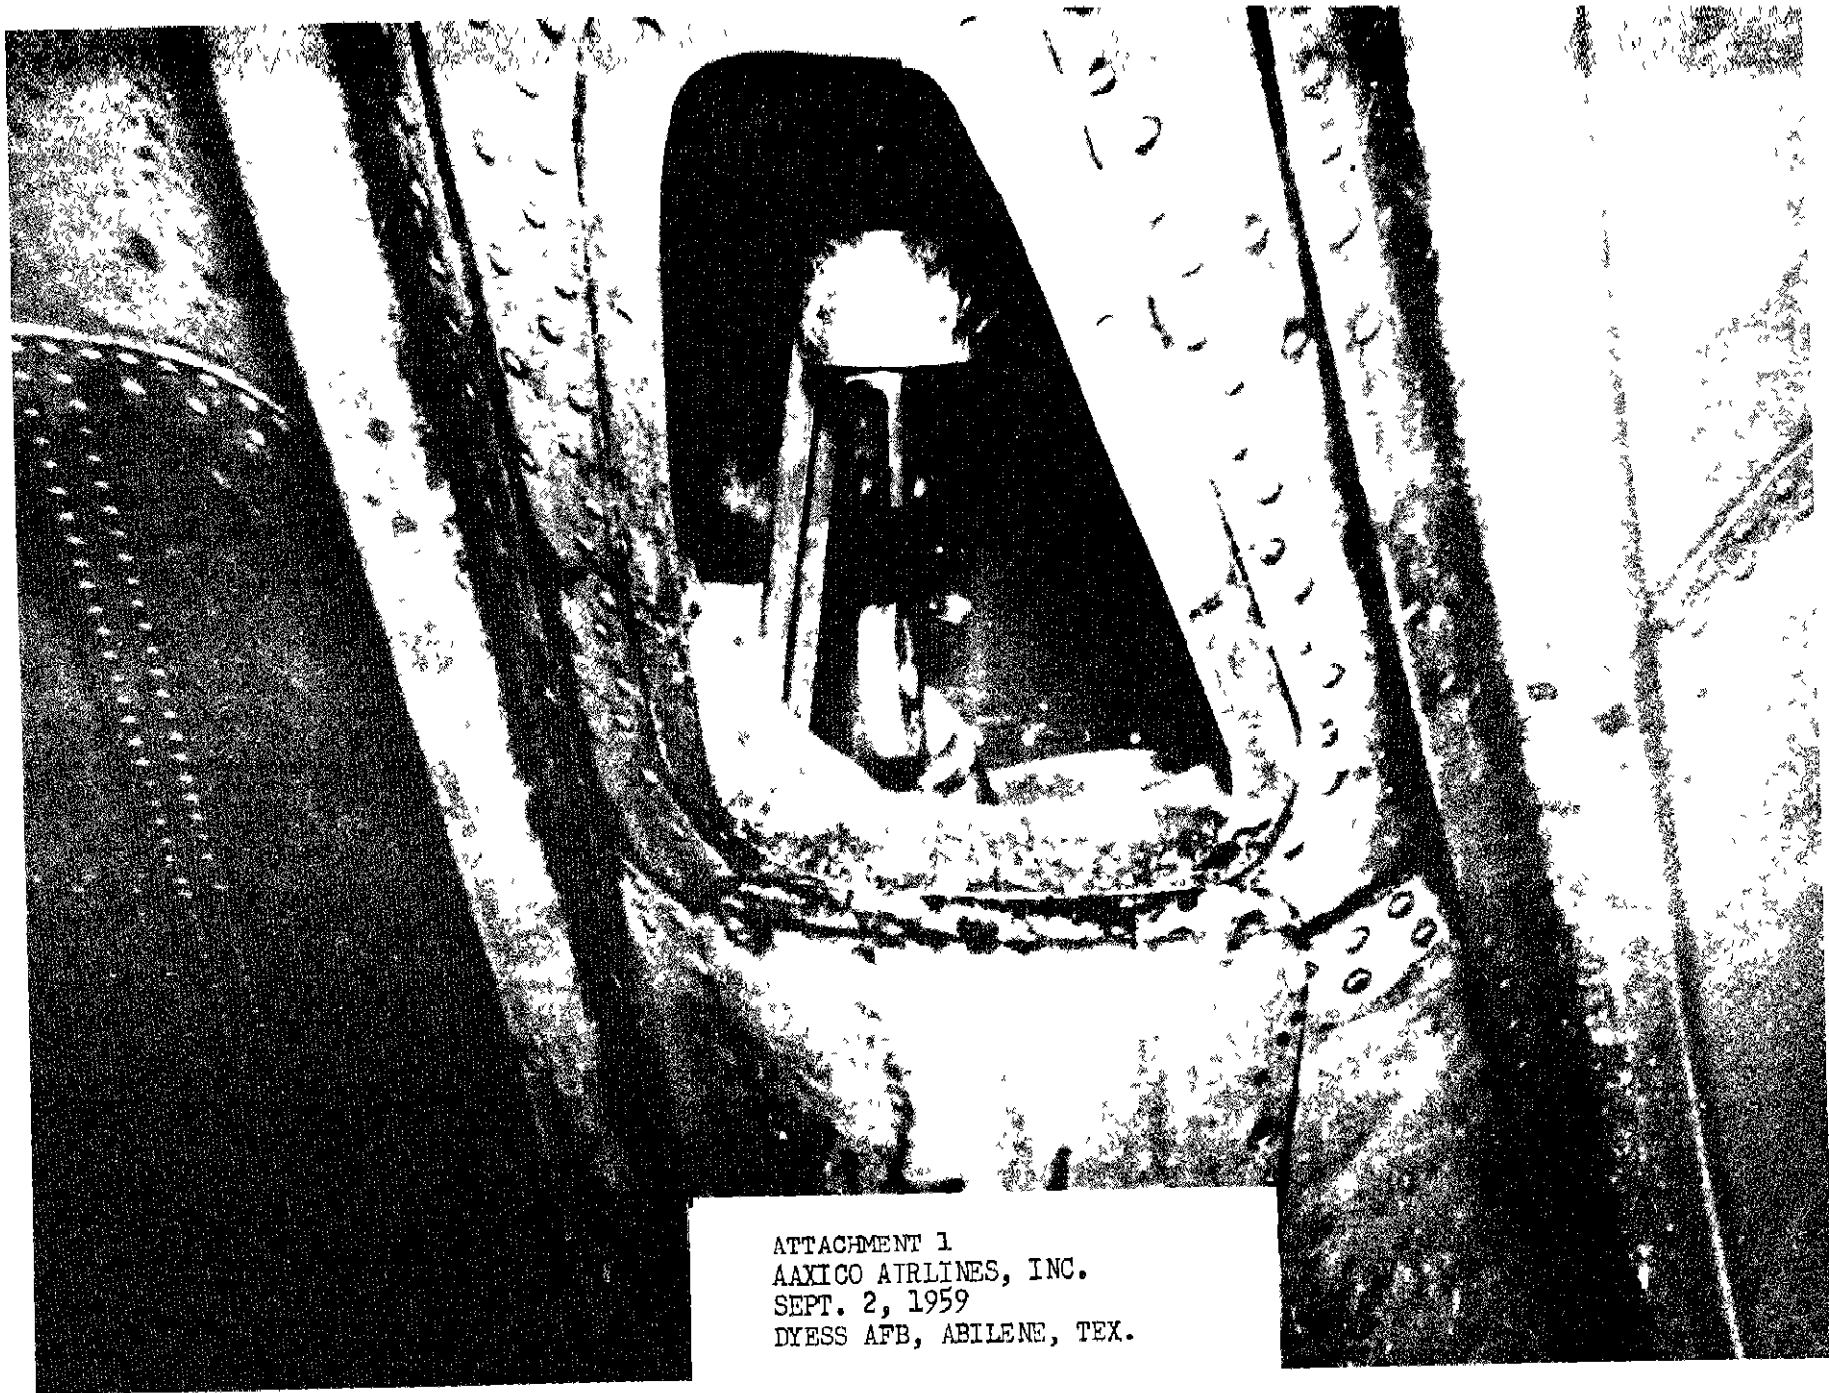
ATTACHMENT 1
AAXICO AIRLINES, INC.
SEPT. 2, 1959
DYESS AFB, ABILENE, TEX.

Examination of the longitudinal control system of the aircraft disclosed that the aft end of the aft link assembly was disconnected from the clevis in the elevator control horn assembly. This condition would render the elevator control inoperative.

Because Captain Bagus had indicated an elevator control failure, investigation was immediately directed to the longitudinal control system of the aircraft. Upon removal of the yoke assembly access panel, it was immediately noted that the aft or bearing end of the link assembly was not connected to the clevis in the elevator control tail section assembly. (See attachment 1.) The bolt which normally connects the clevis and link assembly was missing.

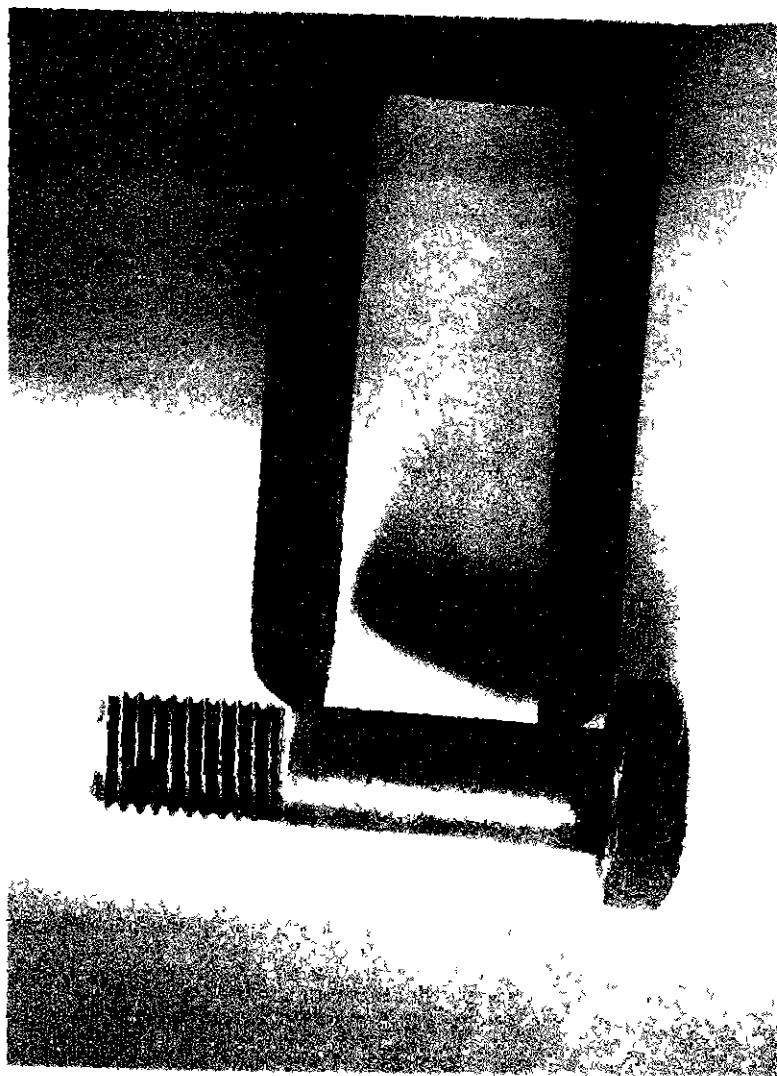
ATTACHMENT 2-A
AAALCO AIRLINES, INC.
SEPT. 2, 1959
DYESS AFB, ABILENE, TEX.

At the request of the Board, the recovered bolt, clevis, and link assembly were examined by the National Bureau of Standards. From the examination it was not possible to identify the bolt with the specific link assembly and clevis from N 5140B. It was possible, however, to determine from marks on the bolt that it had been installed in an assembly with the same dimensions as the clevis forks and bearing bore of the link assembly. (See attachment 2-A.)

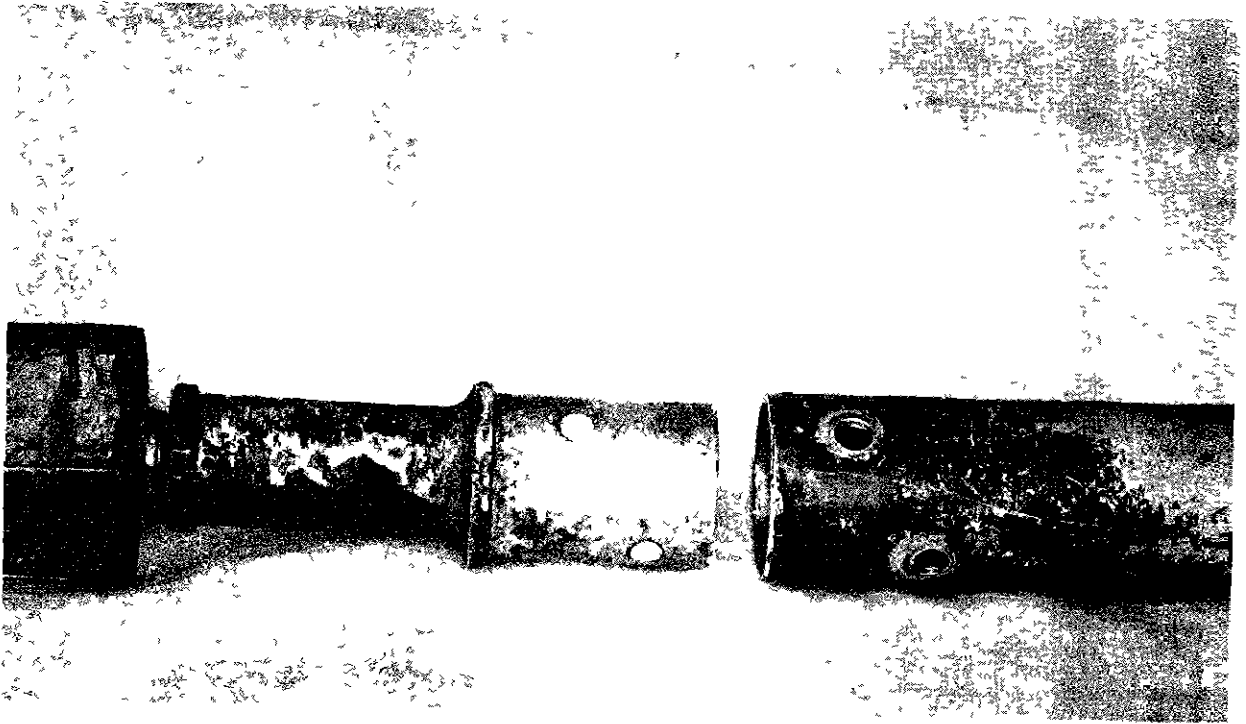
ATTACHMENT 3-A
AAJICO AIRLINES, INC.
SEPT. 2, 1959
DYESS AFB, ABILENE TX.

The tests to failure confirmed the stress analysis data. With the attachment assembled, compression loading caused the aluminum alloy push-pull tube to buckle. (See attachment 2-C.) ^{4/} Under tension loading applied to the assembly, the rivets attaching the forked-end component to the forward end of the push-pull tube sheared and the unit pulled off. (See attachment 3-A.) At the end of these tests the AN5-12 bolt used was marked but otherwise undamaged. Another test was then made in which loading was applied to the Clevis unit and bearing end fitting with the bolt in place. The units were positioned in the test as they are installed in the aircraft. This test resulted in a failure of the shank of the clevis unit and a complete functional destruction of the bearing. (See attachment 3-B.) At the completion of the test the bolt was only slightly bowed.
