AIRCRAFT ACCIDENT REPORT ✓

ALLEGHENY AIRLINES, INC., MARTIN 202, N 174A,
NEAR WILLIAMSPORT, PENNSYLVANIA, DECEMBER 1, 1959

SYNOPSIS

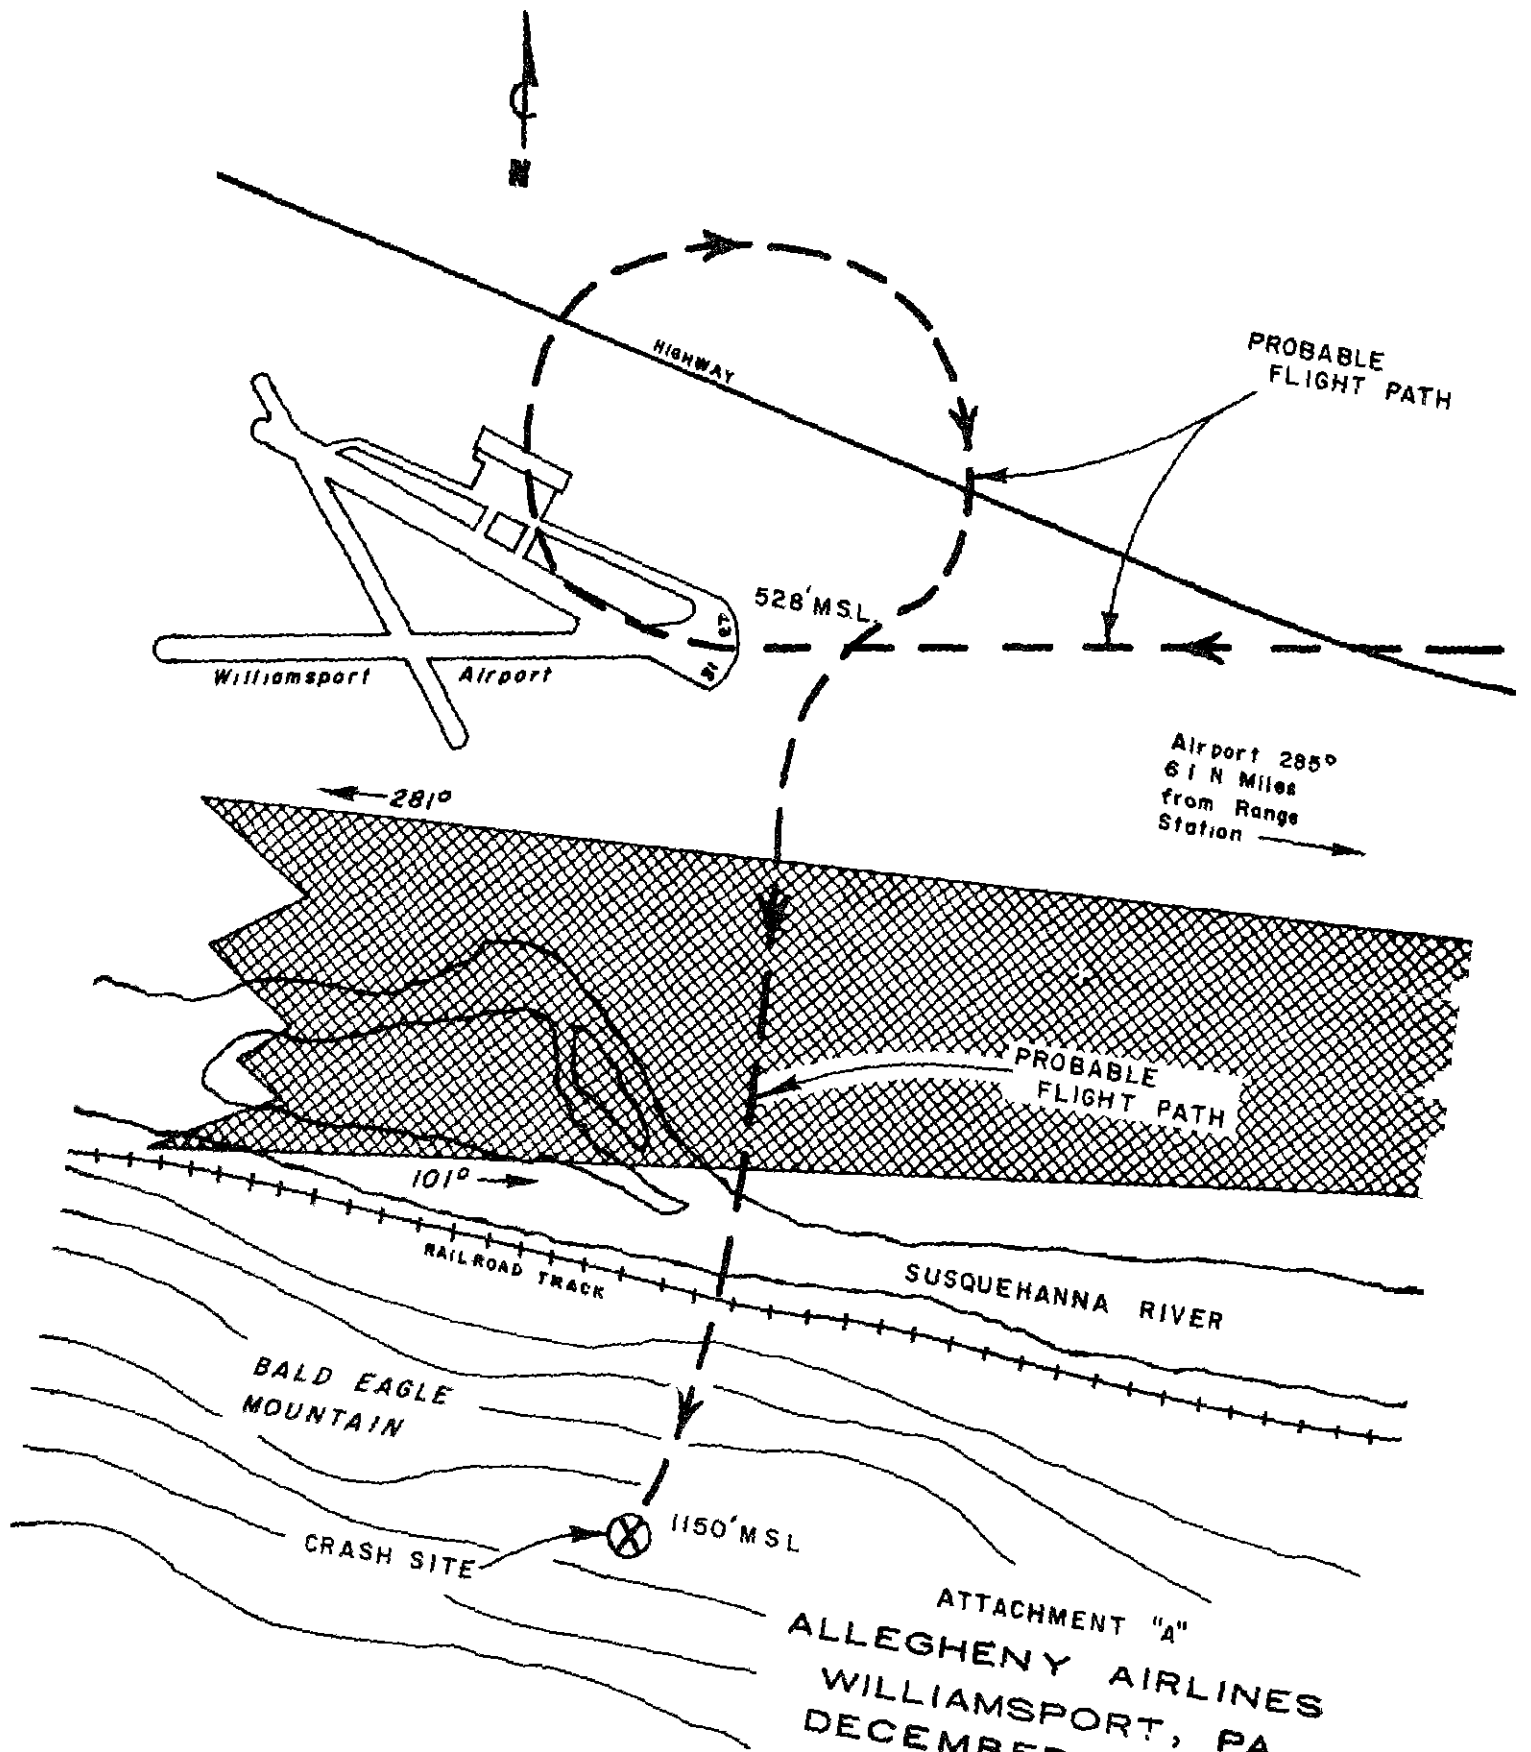
ATTACHMENT "A"
 ALLEGHENY AIRLINES
 WILLIAMSPORT, PA.
 DECEMBER 1, 1959

A short while after Flight 371 was seen to disappear into the snow showers and clouds on a southerly heading a loud explosive-type noise was heard at approximately 0947. After all attempts to contact Flight 371 had failed, search and rescue at Olmstead Air Force Base, Middletown, Pennsylvania, was advised of a possible crash. At approximately 1120 the wreckage of Flight 371 was sighted on Bald Eagle Mountain at an elevation of 1,150 m s l. on a 172-degree magnetic heading from and about one and one-third miles south of the approach end of runway 27. (See Attachment "A")

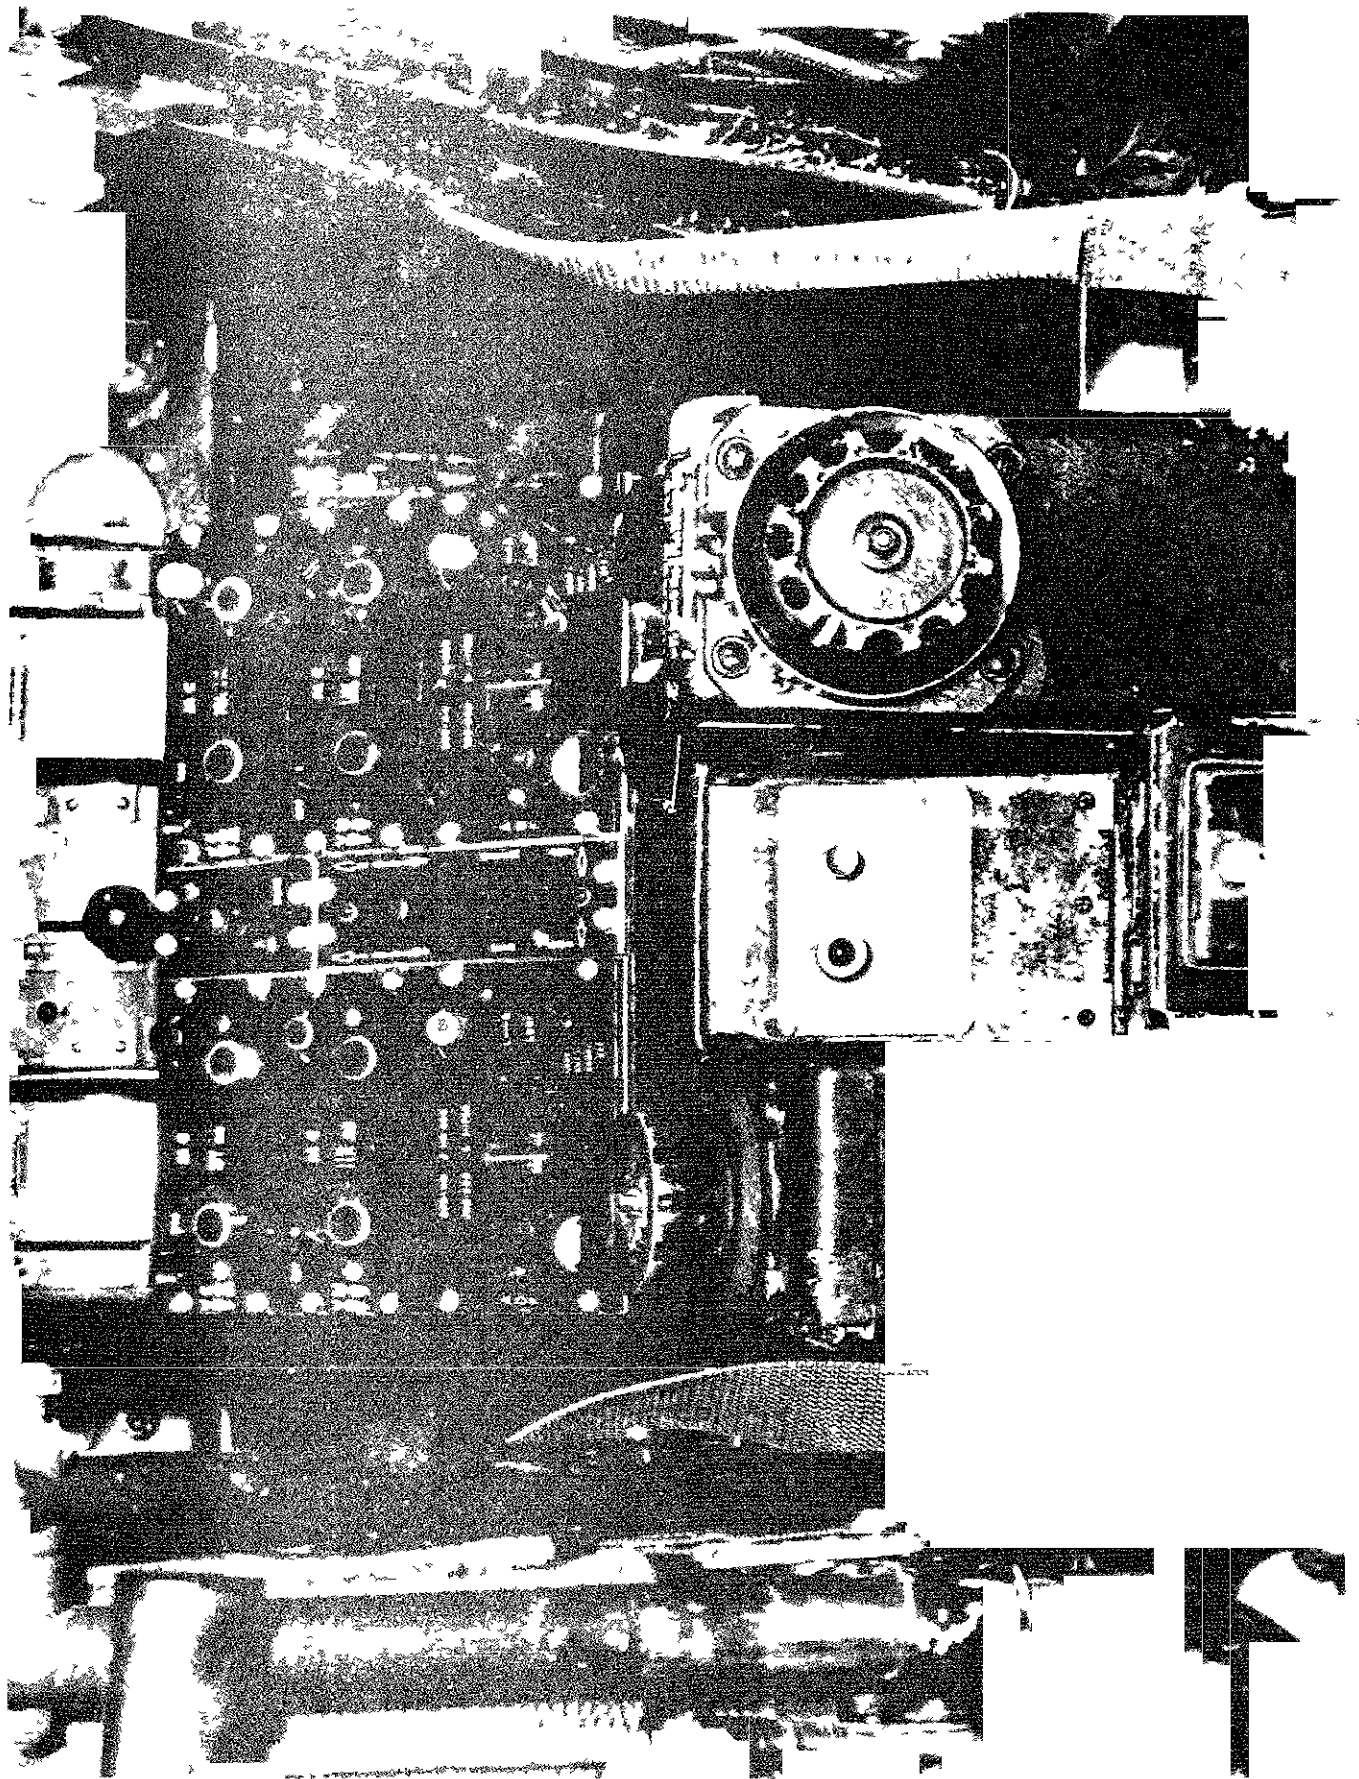
During the investigation of this accident it was determined that an inadvertent caging of the fluxgate compass was possible owing to the position in which the caging switch was mounted, coupled with the fact that no guard was provided for this switch. (See Attachment "B")

The position of the caging switch on the back of the pedestal (see Attachment "B") coupled with the lack of a guard for this switch left it exposed to accidental actuation by any person occupying the jump seat

Analysis of the fact situation revealed by this investigation indicates that the caging switch could have been accidentally actuated by the foot of the crew member occupying the jump seat during the initial part of the base leg. This is considered likely since at this segment of the approach the crew members would be attempting to locate the landing runway and it is probable that the crew member in the jump seat would have been leaning forward in an effort to locate the runway and would thus have made some contact with the rear of the pedestal because of its proximity to the jump seat

Allegheny Airlines, immediately after learning of the possible effect of an accidental caging of the fluxgate compass, installed guards on the four aircraft in its fleet which had similar fluxgate compass caging switch installations.

A recommendation has been made by the Board to the Administrator of the Federal Aviation Agency that suitable guards be required on all aircraft that have fluxgate compass caging switches located in a position which would permit inadvertent actuation.
