AIRCRAFT ACCIDENT REPORT

MIDAIR COLLISION INVOLVING
BEECHCRAFT, C-35, N 1839D, AND WYOMING AIR NATIONAL GUARD F-86L, 52-3662,
NEAR CHEYENNE, WYOMING, MUNICIPAL AIRPORT, DECEMBER 15, 1959

AIRCRAFT COLLISION ACCIDENT CHEYENNE, WYOMING

Beechcraft C-35, N1839D and
Wyoming ANG F-86L, 55-3662

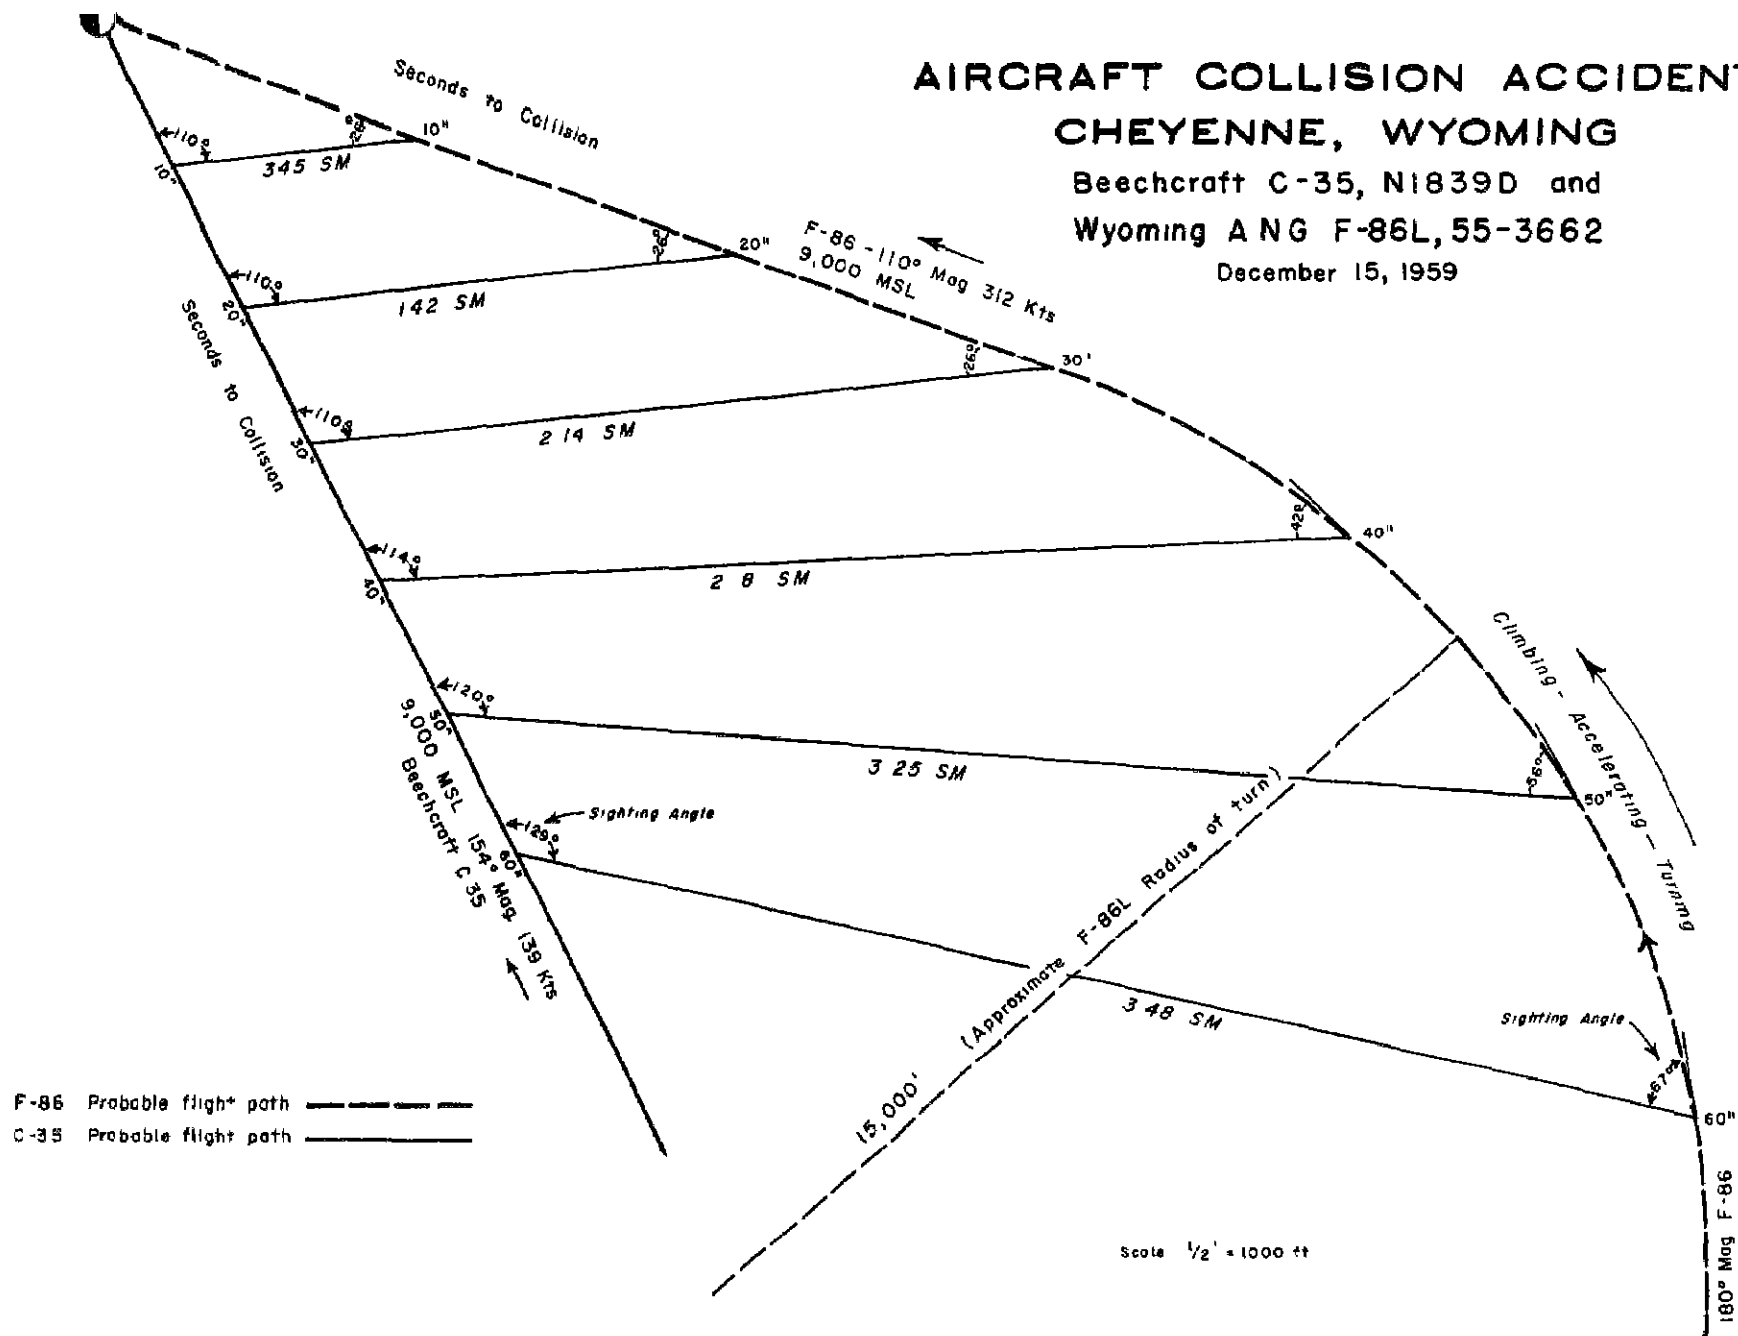
The study shows that at the beginning of the 60-second period the colliding aircraft were separated 3.48 statute miles. At this time the Beechcraft was located 67 degrees to the left of the nose of the jet formation leader's aircraft. It would have been slightly above the leader and visible to him through the canopy glass, presenting a quartering rear profile. During the first 30 seconds, while the F-86L's were turning, the angular position of the C-35 gradually shifted to a position about 26 degrees to the left of the nose of the leader's aircraft and to approximately eyelevel. During the final 30 seconds, with formation straight and level, the position of the Beechcraft would remain unchanged.

The study also shows that at the beginning of the 60-second period the F-86L formation was positioned 129 degrees to the right rear of the nose of the Beechcraft, or approximately 40 degrees to the rear of the 90-degree position. The jets would have been below the level of the Beechcraft. During the first 30 seconds the position of the jet formation would gradually shift forward until it was positioned level at a sighting angle of 110 degrees to the right rear of the nose of the C-35. During the final 30 seconds this position would remain unchanged.

F-86 Probable flight path
C-35 Probable flight path
