CIVIL AERONAUTICS BOARD

AIRCRAFT ACCIDENT REPORT

CHICAGO HELICOPTER AIRWAYS, SIKORSKY S-58C, N 879,
FOREST PARK, ILLINOIS, JULY 27, 1960

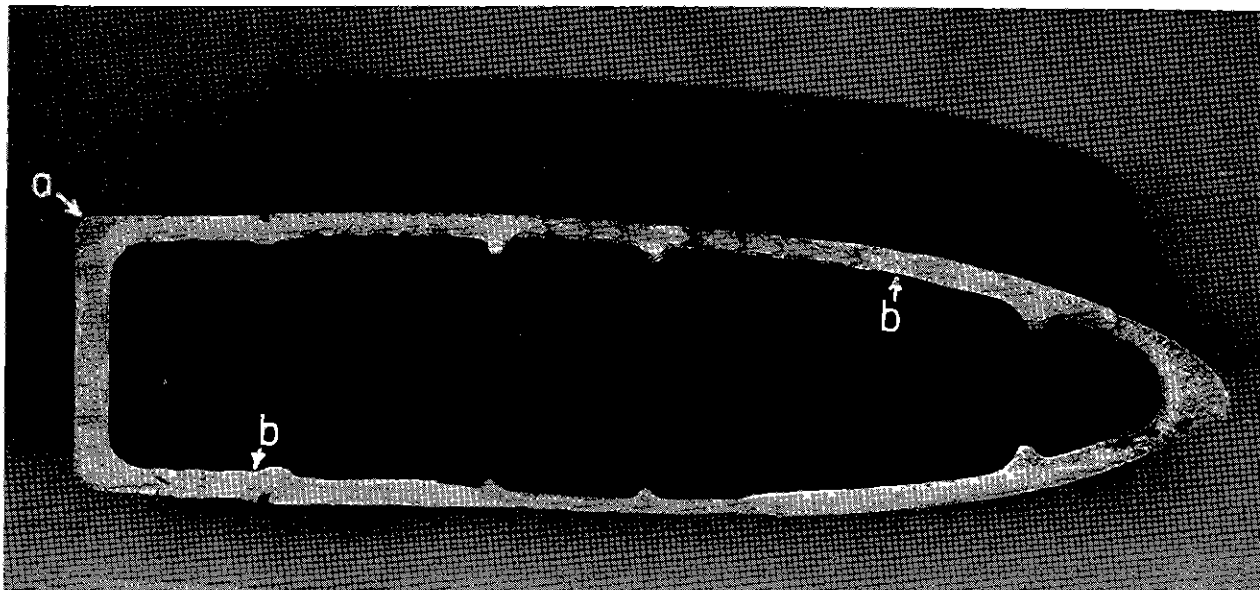
The blade had fractured 102 inches outboard from the center of rotation. There was no evidence of the fractured blade having hit any foreign object in flight. The fracture face on the part remaining with the aircraft was partially obliterated by ground impact, but the fracture face on the part that was found in the tree was unmarked.

Examination revealed the presence of a fatigue area which had its nucleus at the surface of the lower external back-wall radius of the spar. The fatigue had progressed up the back of the spar and 1.2 inches forward into the upper surface of the "D" shaped member. The fatigue had also progressed forward along the lower surface for about five inches. The fatigue zone comprised about 57 percent of the total cross-sectional area at the time of the final separation failure.

The fatigue crack started from an area of sanding scratches made from 60-80 grit abrasive paper used in the finishing process during original manufacture prior to bonding the pockets to the spar. The crack originated at one of these deeper scratches that was nearly perpendicular to the longitudinal axis of the blade.

Figure 1 Surface of the fracture in the blade from Chicago Helicopter Airways Arrow "a" indicates the origin and arrows "b" the ends of the fatigue fracture X 1

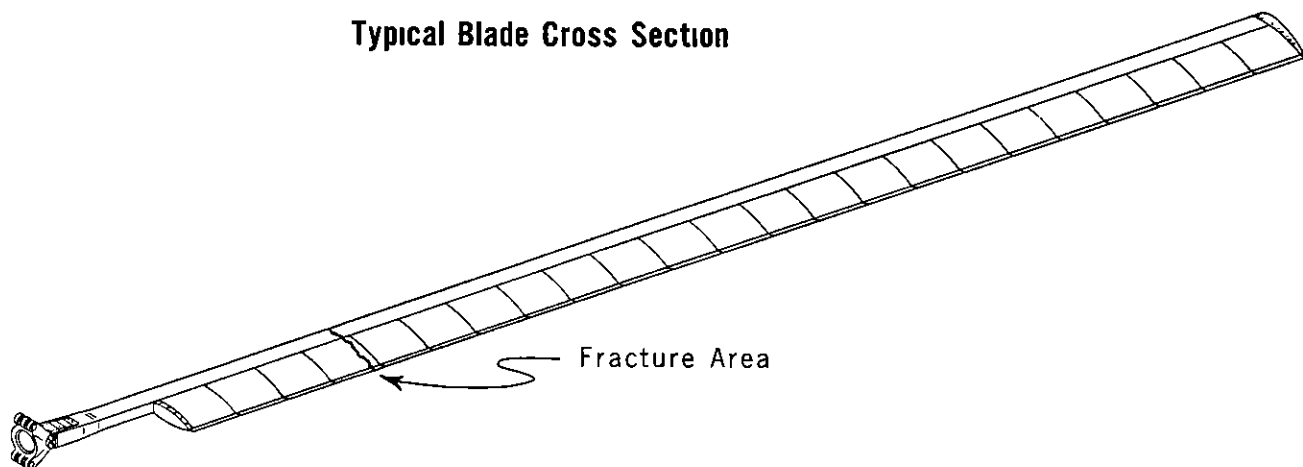
Figure 2 Main Rotor Blade

Typical Blade Cross Section
