CIVIL AERONAUTICS BOARD

AIRCRAFT ACCIDENT REPORT

TRANS WORLD AIRLINES, INC., LOCKHEED CONSTELLATION, MODEL 049,
N 86511, MIDWAY AIRPORT, CHICAGO, ILLINOIS
SEPTEMBER 1, 1961

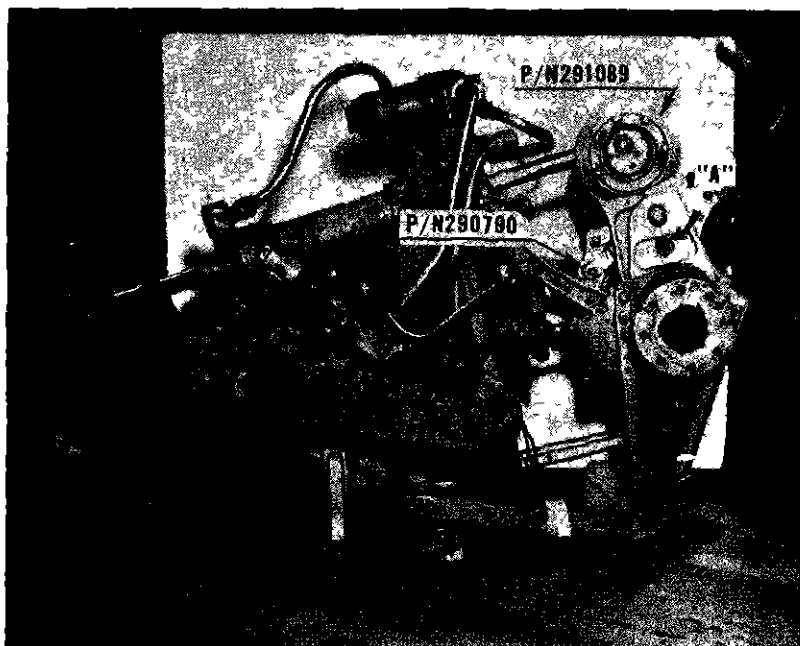
Examination of the parallelogram linkage of the elevator boost located in the extreme aft section of the fuselage revealed a 5/16 -inch AN-175-21 nickel steel bolt to be missing. (See Appendix A, Fig. 1.) This parallelogram linkage connects the pilot elevator input to the control valve of the elevator boost system. The bolt was not found in the wreckage despite a thorough search, including sifting of earth in the wreckage area.

FIG. 1. Elevator boost package. Bushing where bolt should have been is indicated by arrow "A".

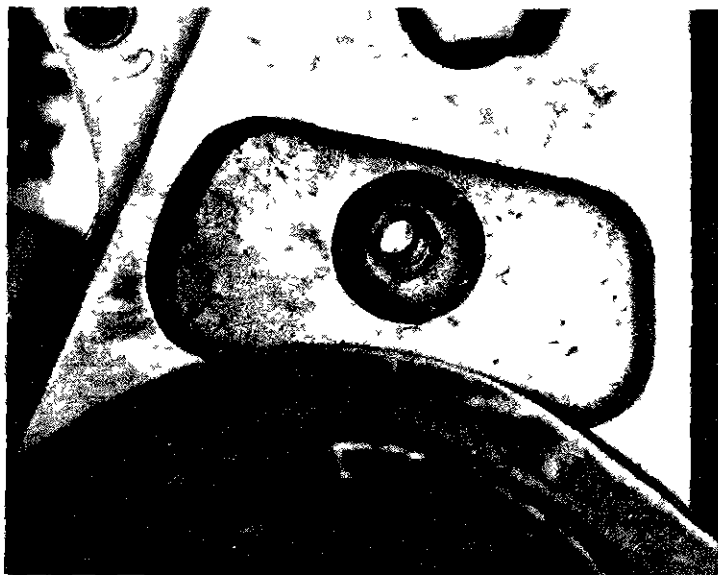
The arm assemblies, part No. 291089L, part No. 291089R, and link assembly, part No. 290790 (See Appendix A, Fig. 1), were examined to determine if the bolt was in place at time of impact. This bolt, when in its proper position, passes through the press-fit bushings of P/N 291089 arm assemblies and the P/N 290790 link assembly. The head of the bolt is installed against the outboard face of arm assembly P/N 291089L. On the outboard face of the bushing, which is flush with the face of the forged arm, there were two deposits of old thick grease having the consistency of modeling clay and 0.01 inch or more deep. (See Appendix A, Fig. 2.) The larger of the two grease deposits covered an arc of 120 degrees from the 11:00 to the 3:00 o'clock positions, ^{2/} and averaged 3/32 inch in width. The inner edge of this deposit was common with the inner circumference of the bushing, whereas the outer edge was, in places, slightly beyond the bushing's outer circumference; however, a slight outline of two sides of the bolt's hex-head was visible around its outer perimeter of the deposit. (See Appendix A, Fig. 2.)

FIG. 2. Close-up view before disassembly of bushing against which head of bolt should have been.

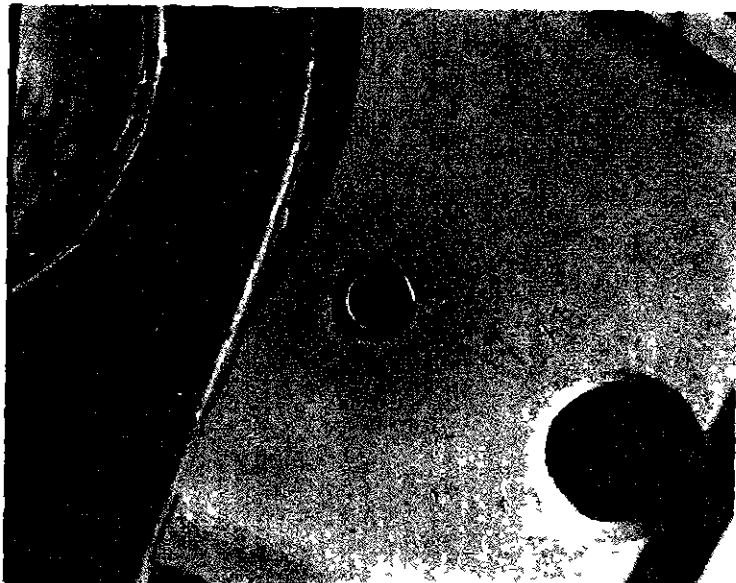
The nut of the missing bolt is normally installed against the outboard face of right arm assembly P/N 291089R. There was no deposit of grease on the outboard face of the bushing of the right arm, nor was there on the surface of this arm the heavy splatter of grease and dirt such as appeared on the left arm. Some grease was present, but only as a film. The outboard face of this bushing was unscarred except for slight concentric scratches. The outline of a washer could be seen on the face of the forging, but sufficient pressure had not been applied to remove the zinc chromate. The outboard one-third of the bushing's bore showed heavier corrosion than the other two-thirds and contained some irregular scoring. There were several threadlike score marks on the bore's inboard one-third from 9:00 through 3:00 o'clock. At several places near the 12:00 o'clock position these scorings were polished and flattened. The inboard face of the bushing was clean and a concentric impression of the link bearing was visible. There was a thin drag mark at the bushing's inner circumference at 9:00 o'clock, 0.005 inch wide by 0.10 inch long, parallel to the arm centerline. At the outer circumference of the bushing's inboard face at the 1:00 o'clock position there was a curved brinell mark 0.125 inch long by 0.015 inch wide. When viewed under magnification, another brinelling could be seen superimposed within the first one. The curvature of these marks, opposite in arc to the circumference of the bushing, exactly matched that of the circular end of the P/N 290790 link assembly. The flow of metal showed that both brinellings had been formed in a direction away from the bushing center. No elongation of the bushing hole could be found.

FIG. 4. Close-up of bushing against which nut should have been. Taken after disassembly, but before cleaning.

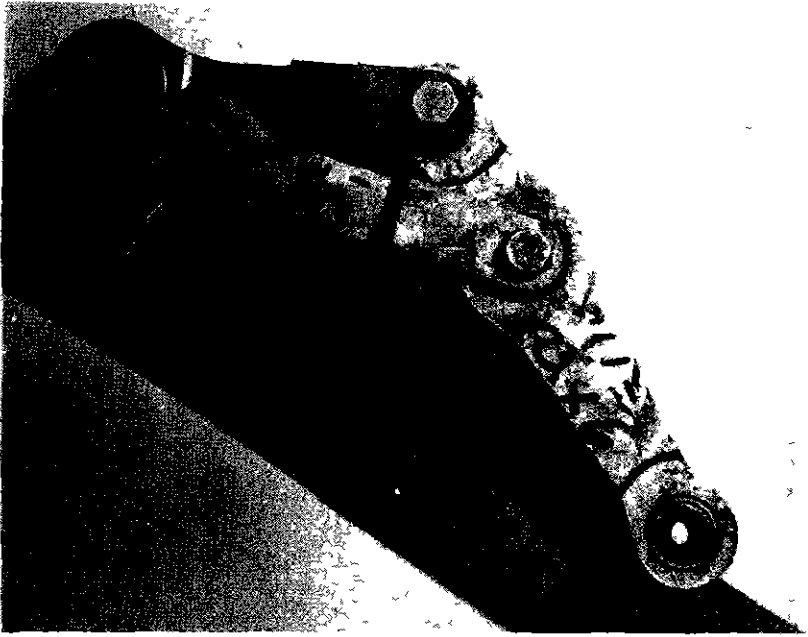
FIG. 5. Parallelogram, removed from boost assembly but reoriented to its position before removal. Note grease ring at arrow, made by bushing face.

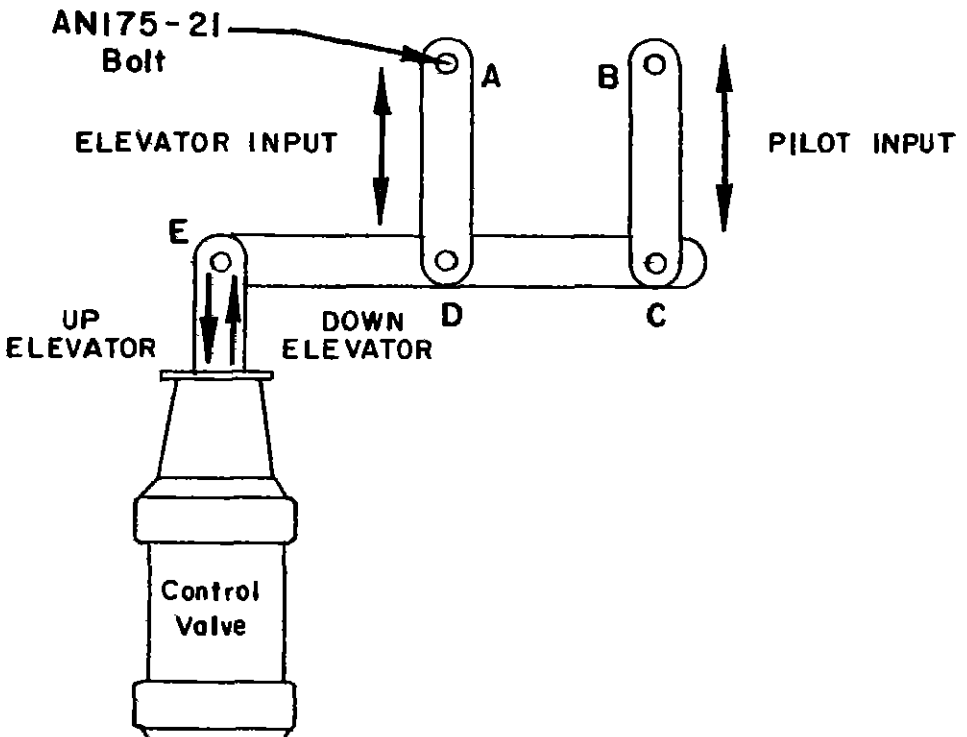
With reference to Appendix A, Fig. 6, it can be seen that pilot input moves link BC up or down which pivots link EDC as a walking beam about point D, causing point E to move down or up. This positions the control valve spool which is connected at point E. Elevator input moves link AD up or down which, in turn, pivots link EDC about point C. This action also positions the control valve spool. It should be noted that pilot and elevator inputs in the same direction are subtractive and inputs in opposite directions are additive to the valve spool.

If the AN-175-21 bolt at point A be removed, no support for the parallelogram is provided by link AD, and link EDC is free to pivot about point C. Since the valve is mounted in a near-vertical position, the weight of links AD and EDC and the weight of the spool are applied in the direction to move the spool toward up-elevator, to be resisted only by the friction in the valve and at points C and E, the total of which is negligible. Any friction above the normal would be overcome by vibration.

FIG. 6. Schematic diagram of parallelogram linkage and valve of elevator boost package.
