CIVIL AERONAUTICS BOARD

# AIRCRAFT ACCIDENT REPORT

NORTHWEST AIRLINES, INC.,  
LOCKHEED ELECTRA, L-188C, N 137US,  
O'HARE INTERNATIONAL AIRPORT  
CHICAGO, ILLINOIS, SEPTEMBER 17, 1961

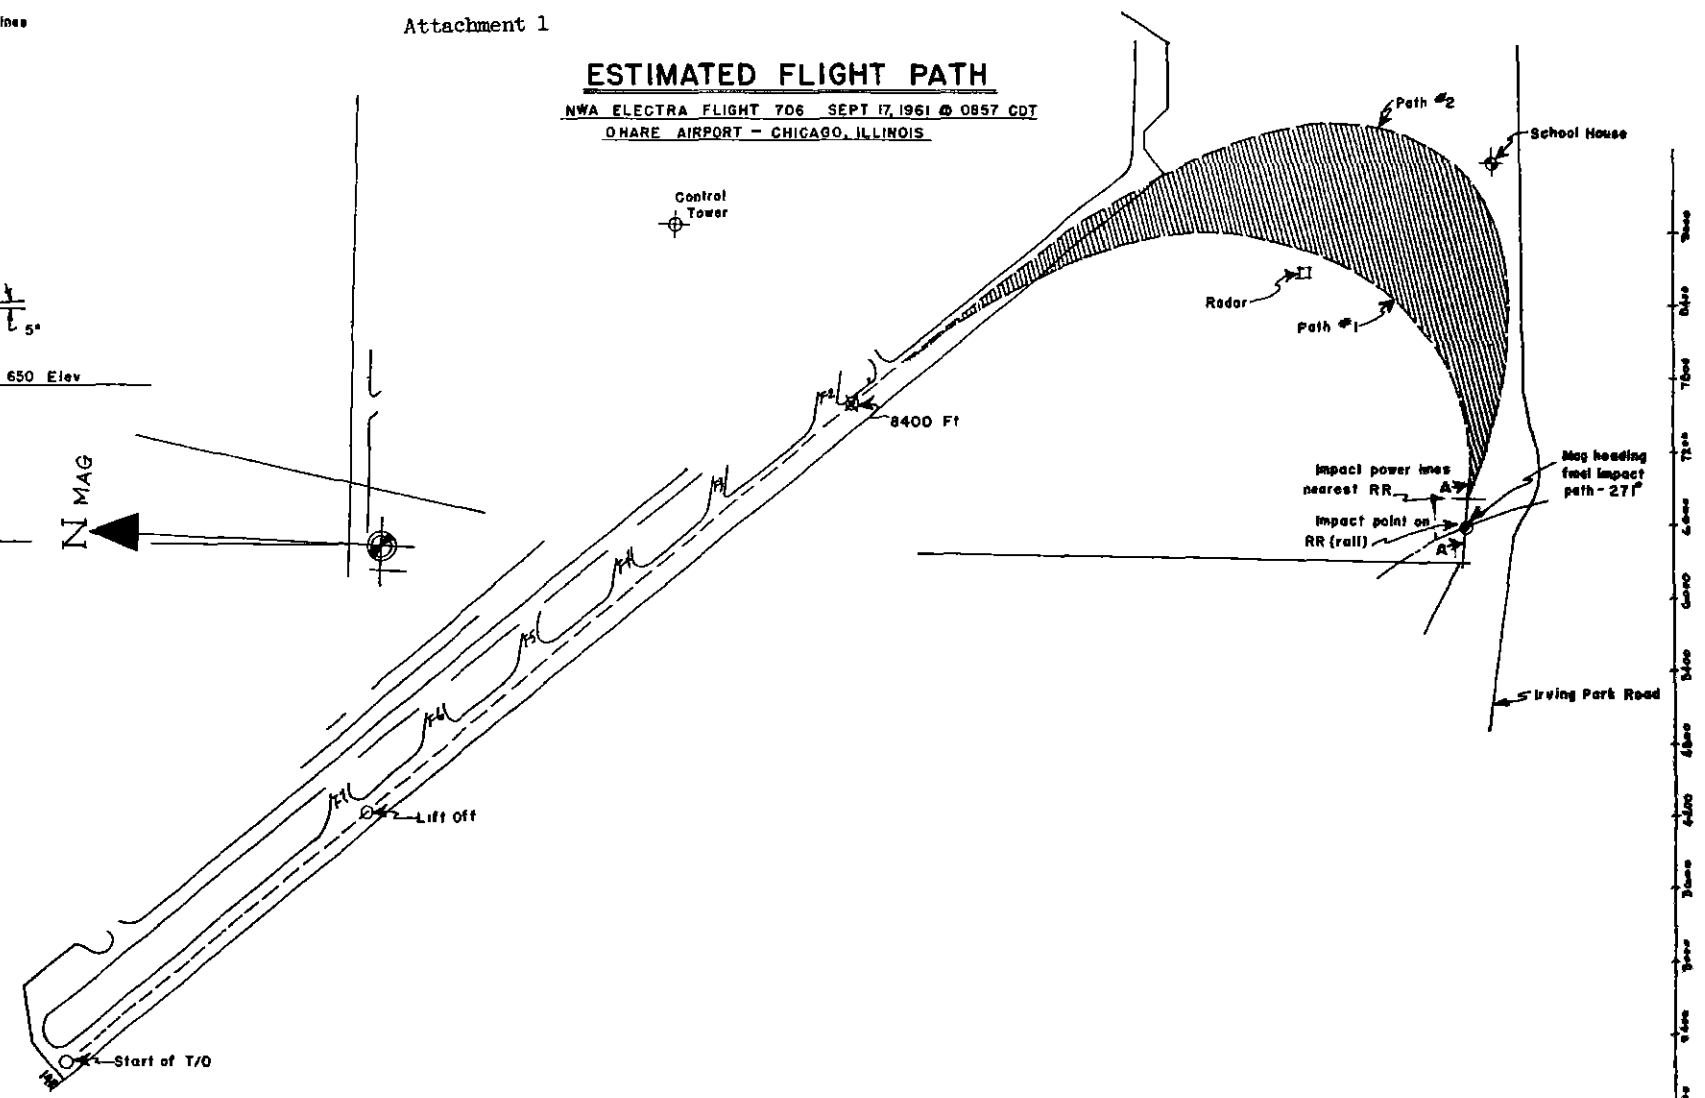
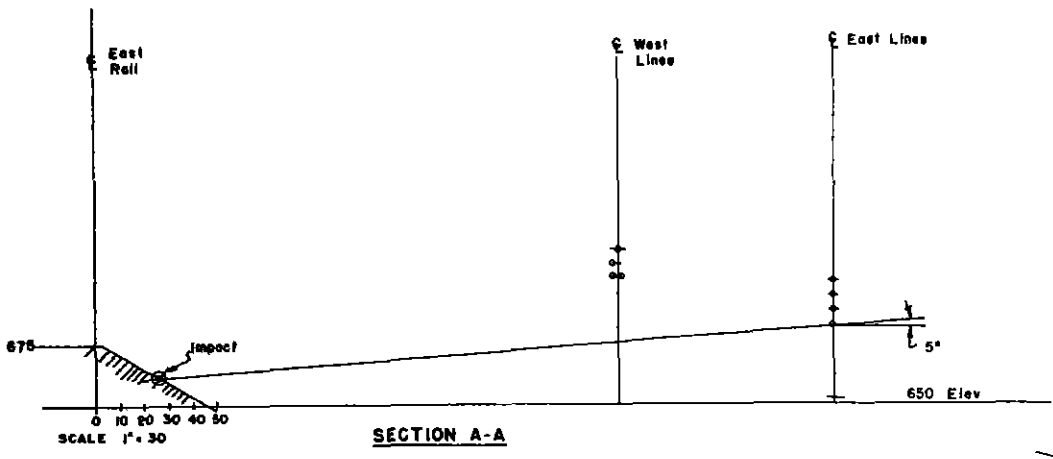
### ESTIMATED FLIGHT PATH

At the 8,000-foot marker the altitude of the aircraft was estimated to have been approximately 100 feet, which is a slightly lower altitude than Electra aircraft normally attain at this point during takeoff. Five witnesses noted a change in engine sound during this portion of the flight. Between the 8,000 and the 9,000-foot runway marker the aircraft was observed to commence an apparently coordinated right turn with a slowly increasing rate of bank. When the bank angle was 30 to 45 degrees, the crew made a short, garbled transmission. Immediately thereafter, at a bank angle of 50 to 60 degrees, the aircraft began to lose altitude. The maximum altitude attained in the entire turn was 200 to 300 feet.

To assist in developing a flight profile based on actual operation of Electra aircraft, tower personnel, at the request of Board investigators, conducted a survey of 44 Electra takeoffs. These takeoffs were sampled at random and were all observed when using runway 14R. The survey disclosed that the average lift-off was made when these aircraft were approximately 4,000 feet down the runway, and that when they reached the 8,000-foot marker, their altitude and airspeed indications were about 280 feet and 158 knots respectively. The airspeed was based on 28 pilot reports given to the tower. In addition, Lockheed Aircraft Corporation, in response to the Board's request, provided a study of the flightpath based both on L-188 performance data and information disclosed during the investigation. Their study encompassed a ground envelope of reported flightpaths but, based on performance data, the inner boundary was considered as the only possible flightpath. Based on the Lockheed study, Board investigators prepared the estimated flightpath chart. See Attachment #1.

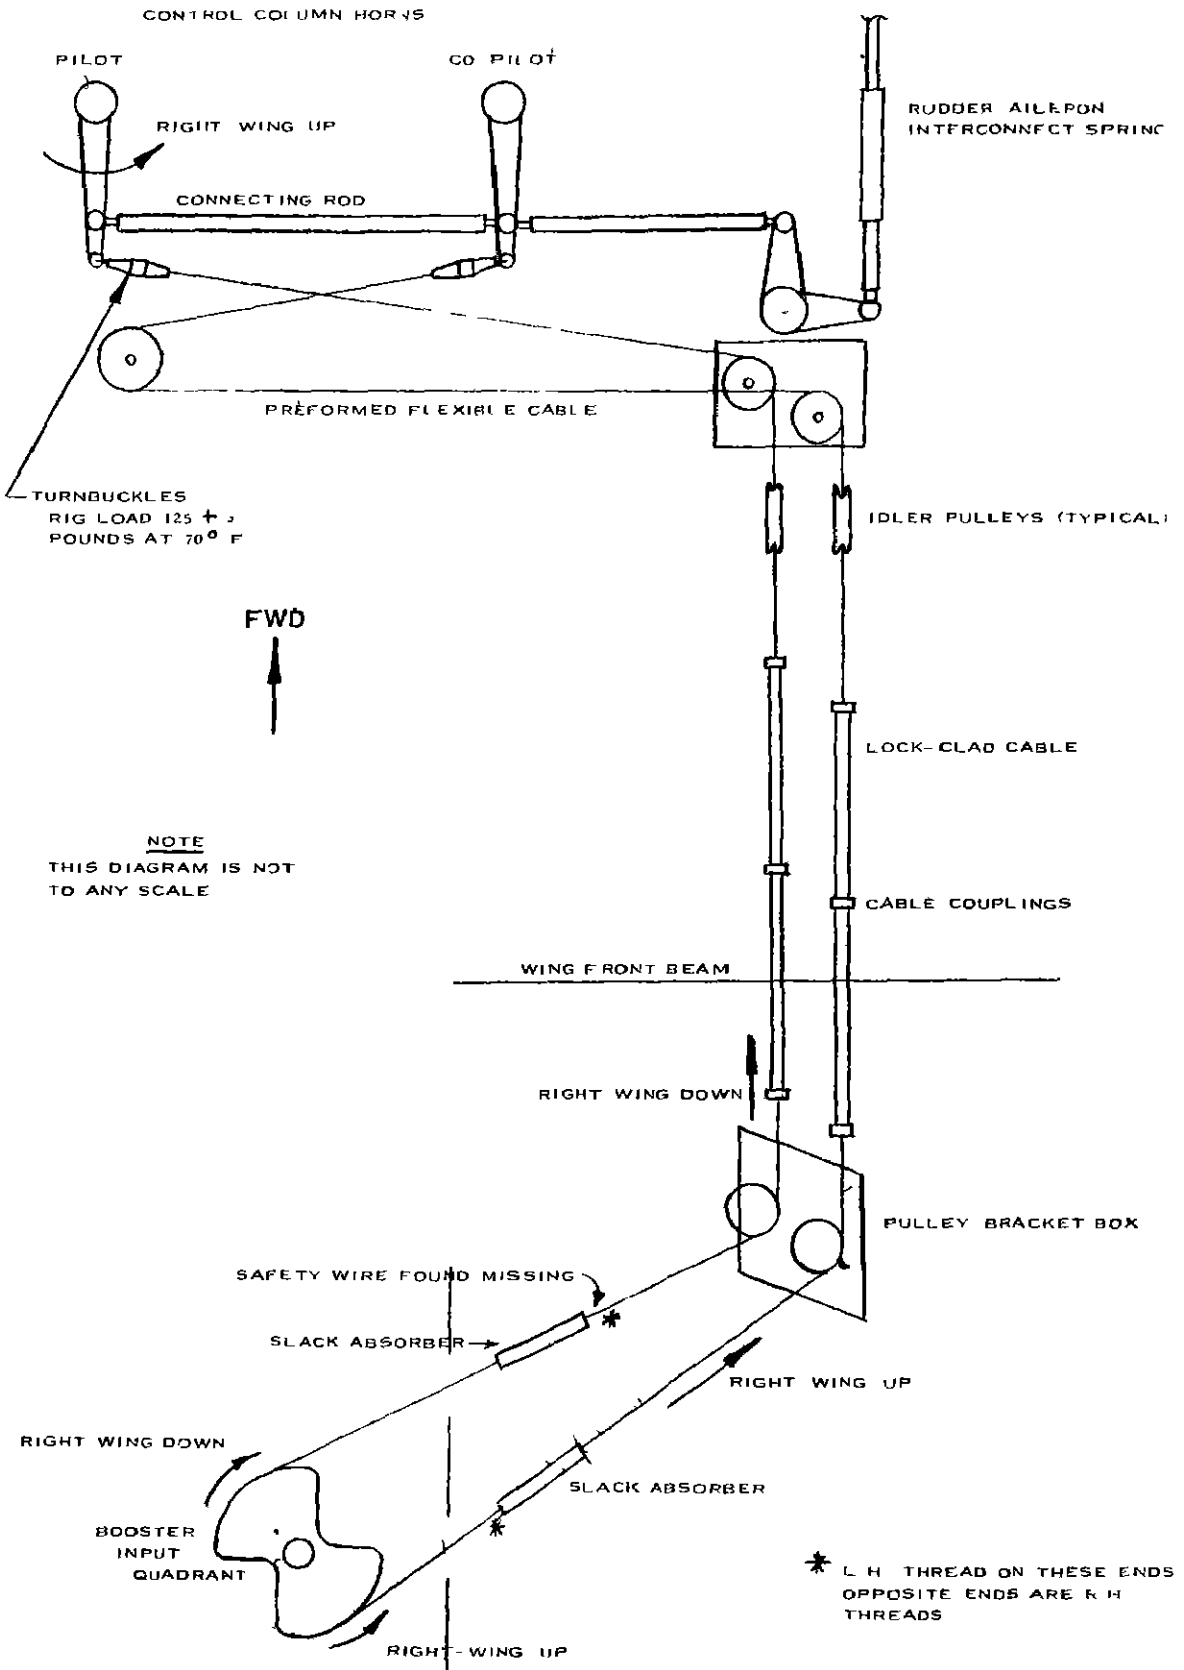
# AILERON PRIMARY CONTROL SYSTEM

<sup>3/</sup> A schematic diagram of this part of the aileron primary control system is shown in Attachment #2.

A previous description of the aileron primary control system showed that between the pilot's and copilot's control wheels and the aileron boost input quadrant, two cables run through a series of pulleys to the boost input quadrant, forming a closed loop; that the pilot's cable is in tension for a right wing down movement and the copilot's cable is in tension for a left wing down movement, and that these cables respond to movement of the control wheels either in the boost-engaged or the boost-disengaged condition. Furthermore, it has been established that if a disconnect or failure in either cable occurs, a loss in aileron control will result. It has also been shown that if a sudden disconnect or failure occurs in the copilot's cable, the rigging tension in the pilot's cable will displace the boost input quadrant, thereby imparting a signal to the aileron boost unit for a right wing down movement.

The pilot's and the copilot's cables run parallel to each other and pass through their respective guide holes in the pulley bracket. Each guide hole is 0.6 inch in diameter. The slack absorber terminal block is too large to be pulled forward through such a hole and the parted end of a flexible cable is not capable of making an indentation in the guide hole such as was found. The only object capable of making these marks, and which would also permit the missing copilot's cable to pass through the pulley bracket, was the connector on the aft end of the flexible cable which joins the forward terminal block of the slack absorber. Load tests have proved that failure in a cable and swaged connector system first occurs in the flexible cable itself, without any damage whatsoever to cable connectors and other components of the system. Other tests have proved also the natural tendency of a flexible cable to unscrew from its fitting when not secured to it by safety wire. This evidence indicates that the copilot's flexible cable connector completely disengaged from the slack absorber between the time the aircraft started its right turn and the time it crashed.

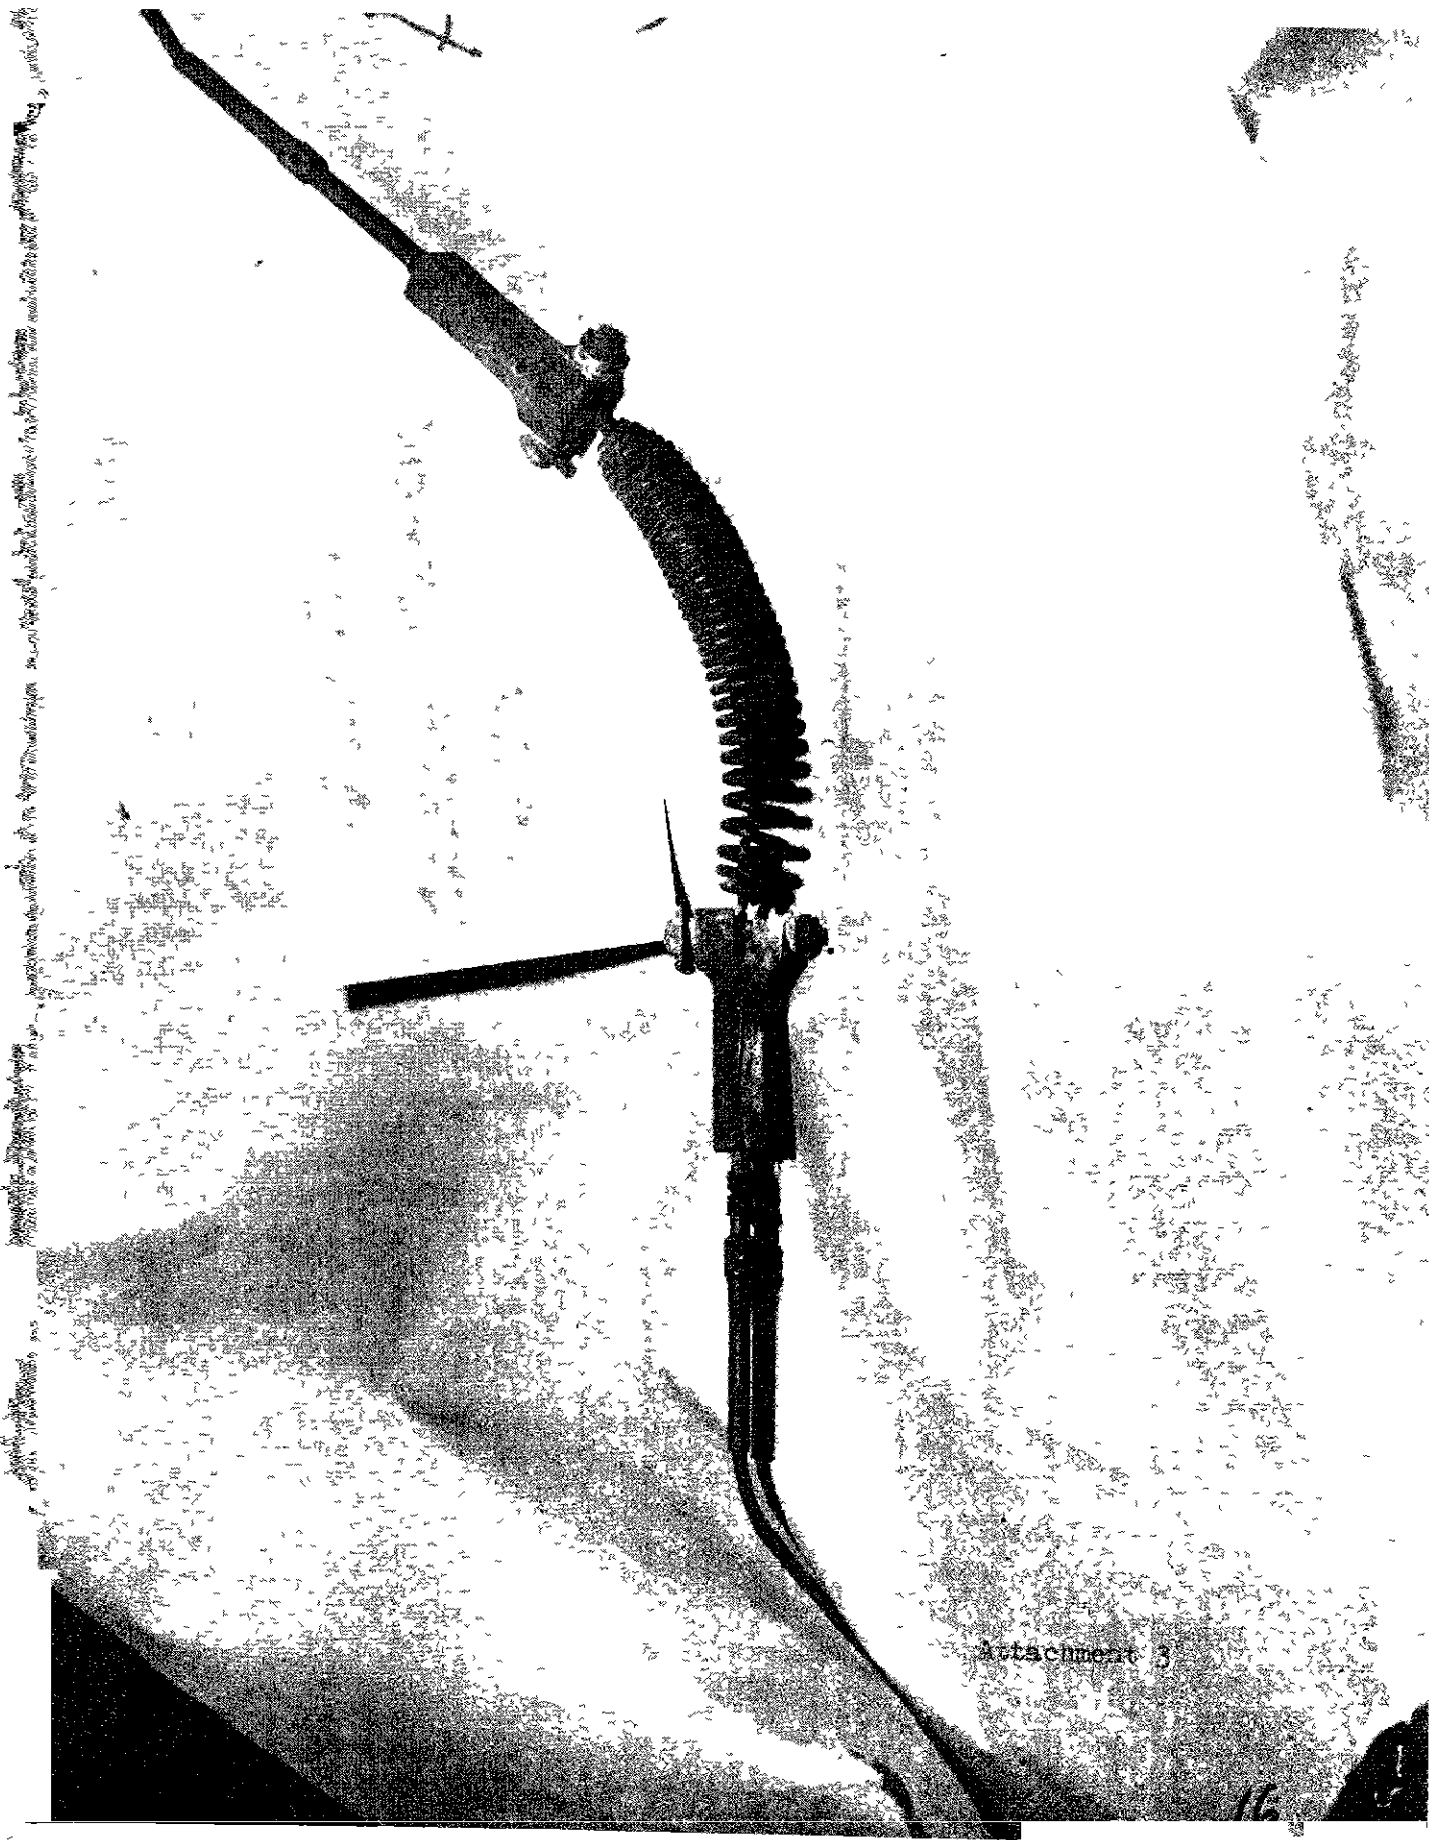
Attachment 3

Between the pilot's control column horn and the aileron boost input quadrant, all recovered cable connections were found to be normal except for the threaded connector of the slack absorber forward terminal block. This connector was found unsafetied and was backed out of the terminal block, showing five to seven threads

for a 0.40-to 0.45-inch engagement.<sup>5/</sup> This slack absorber unit, minus its aluminum side plates, is shown in Attachment #3. The forward connector (shown on the right in Attachment #3) should be safetied with steel wire exactly like the aft connector (on the left in Attachment #3). Distinctive lines on the surface of the slack absorber's aft connector showed where safety wire had shielded these surfaces from fire and soot. In contrast, no such distinctive lines could be found on the forward connector in question. Laboratory examination by the National Bureau of Standards and the Federal Bureau of Investigation revealed no evidence of safety wire having been recently installed on this connector.

As previously indicated, examination of the aileron primary control system revealed that the right wing down cable connector which screws into the forward terminal block of the pilot's slack absorber unit was not secured with safety wire and was unscrewed to an engagement of only 0.40 to 0.45 inches (normal engagement, 1.2 to 1.45 inches). This condition can be attributed to either the natural tendency of an unsafetied cable to unwind or that this was the position to which the connector was unscrewed during the aileron boost unit change. The pilot's cable was
